# GEOTECHNICAL ENGINEERING RECONNAISSANCE OF THE 2010 HAITI EARTHQUAKE

Version 1: February 22, 2010

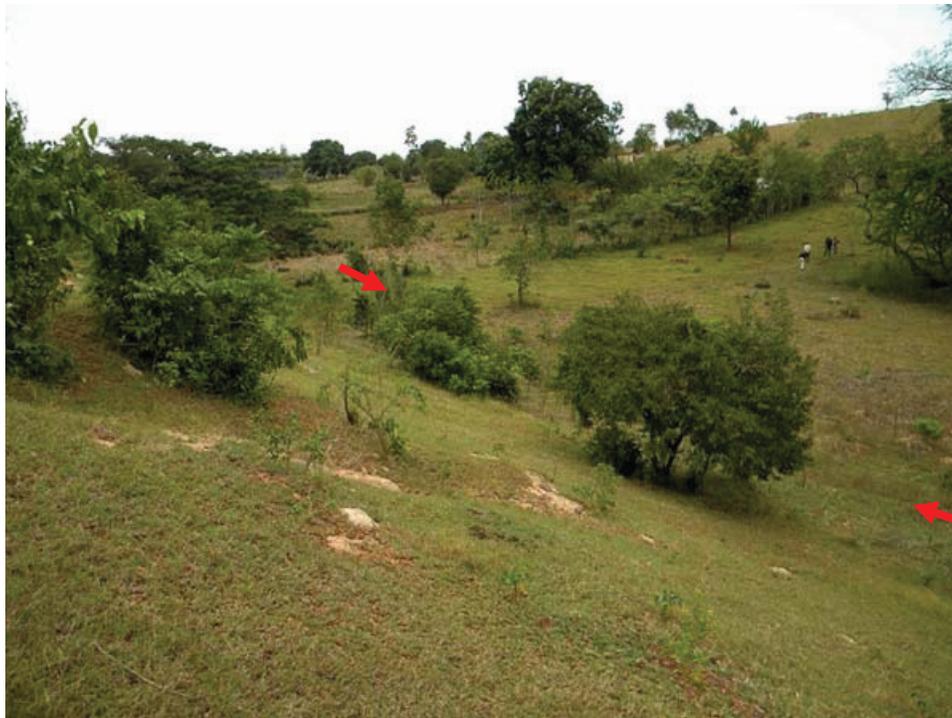
**Figure 4.4.** View west along trace of EPG fault at linear valley southwest of Dufort (west of Road 204). Fault trace likely between base of slope (between red arrows) and center of linear valley. No fractures or other evidence for fault rupture observed at this site (N18.444306, W72.643722,).

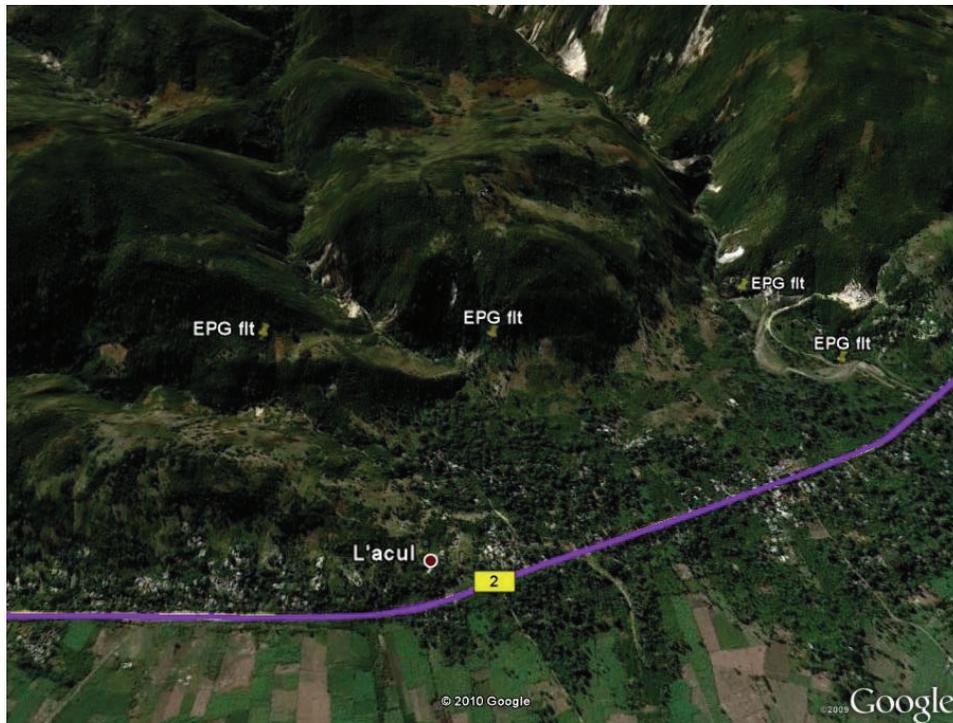
**Figure 4.7.** View south of shutter ridge blocking drainage (center) and offset stream channel (center right) along fault south of L’acul. Fault trace marked by push-pins labeled “EPG flt”.

The GEER team traversed Road 2 west of Road 204, where Road 2 is parallel to and crosses over the EPGFZ near L’acul, on several occasions between February 1 and 4 during additional reconnaissance investigations (Figure 4.7). No evidence of lateral road displacements or equivocal shear cracks was found on the roads across the fault crossing areas. However, a number of cracks and areas of settlement were observed along the road. These features were evaluated and we concluded to be the result of settlement of the road fill/embankment settlement over soft subgrade soils (see Section 8.0 Road Fill Performance), and possibly in some cases due to localized liquefaction. None of these features were found to represent surface fault rupture.

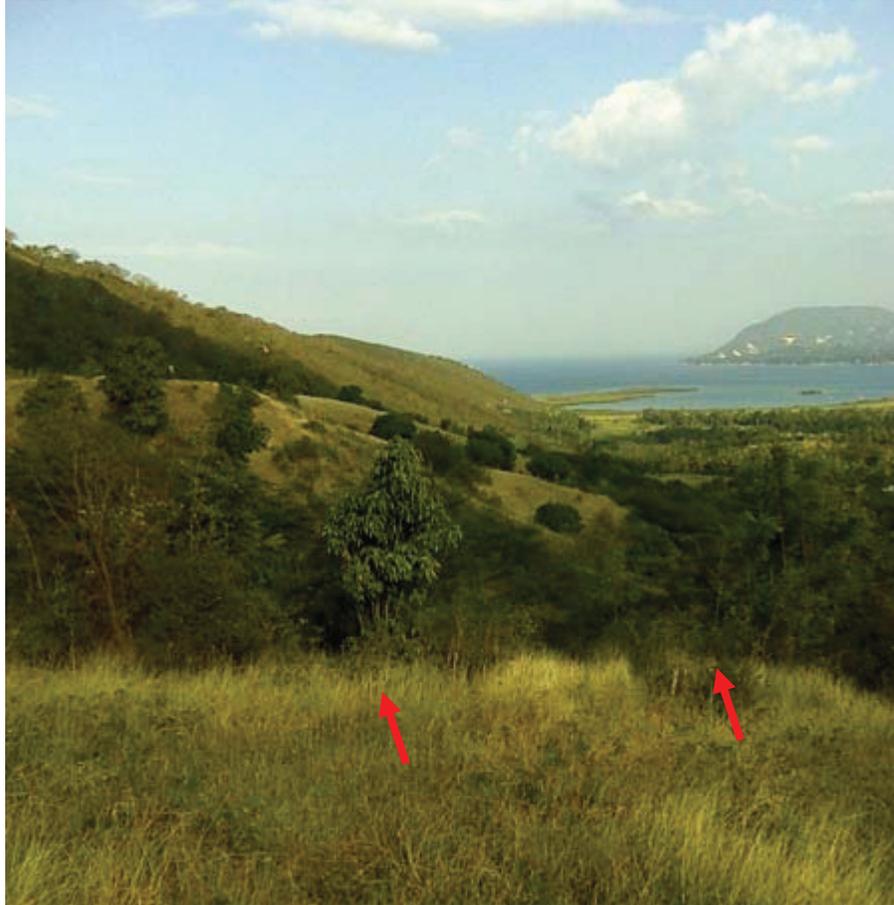
**Figure 4.9.** View east-northeast along fault west of Port Royal. Side-hill bench bounded by two fault traces at left and center of photo (above red arrows). No fractures or other evidence for fault rupture observed at this site (N18.440027, W72.923304).

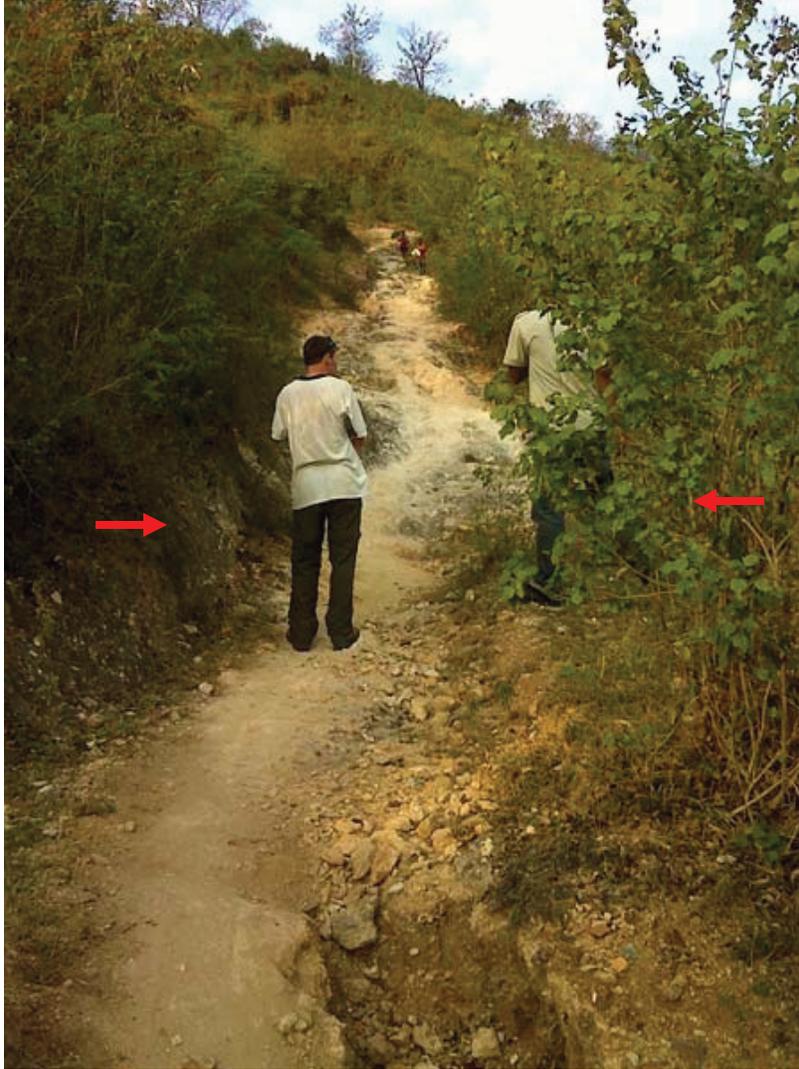
**Figure 4.11.** View north across fault at west of Port Royal. Fault passes perpendicular to track in middle of photograph at colluvium-bedrock contact (at red arrows upslope from team members). No fractures or other evidence for fault rupture observed at this site (N18.44150, W72.916389).

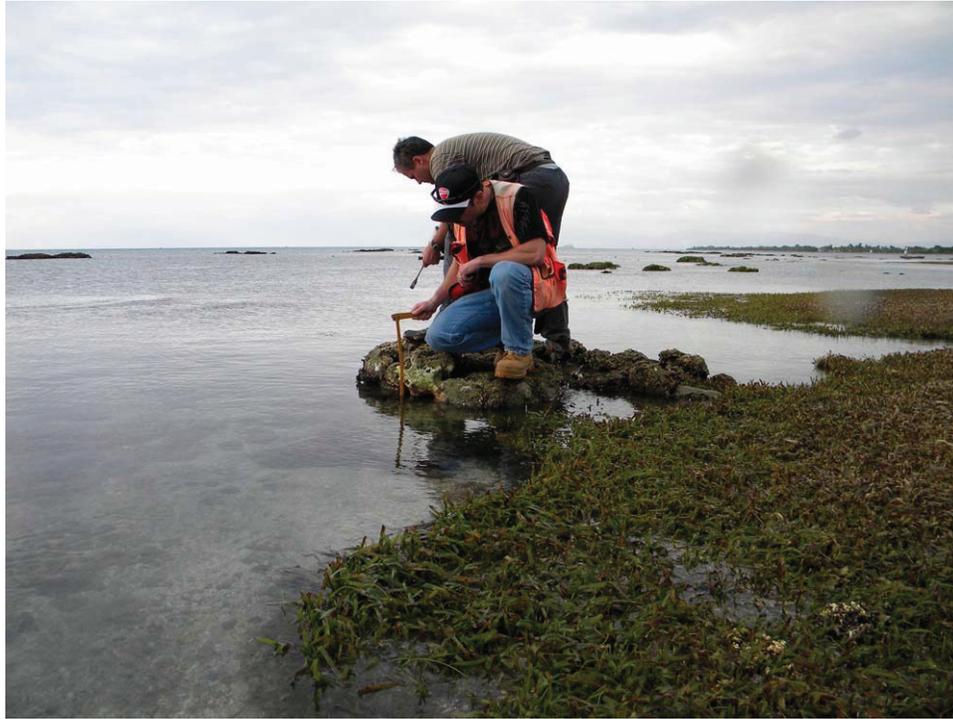
**Figure 4.17.** Exposed coral head at Ca Ira, Léogâne. Team members measuring uplift of coral head. (N18.525333, W72.652008)

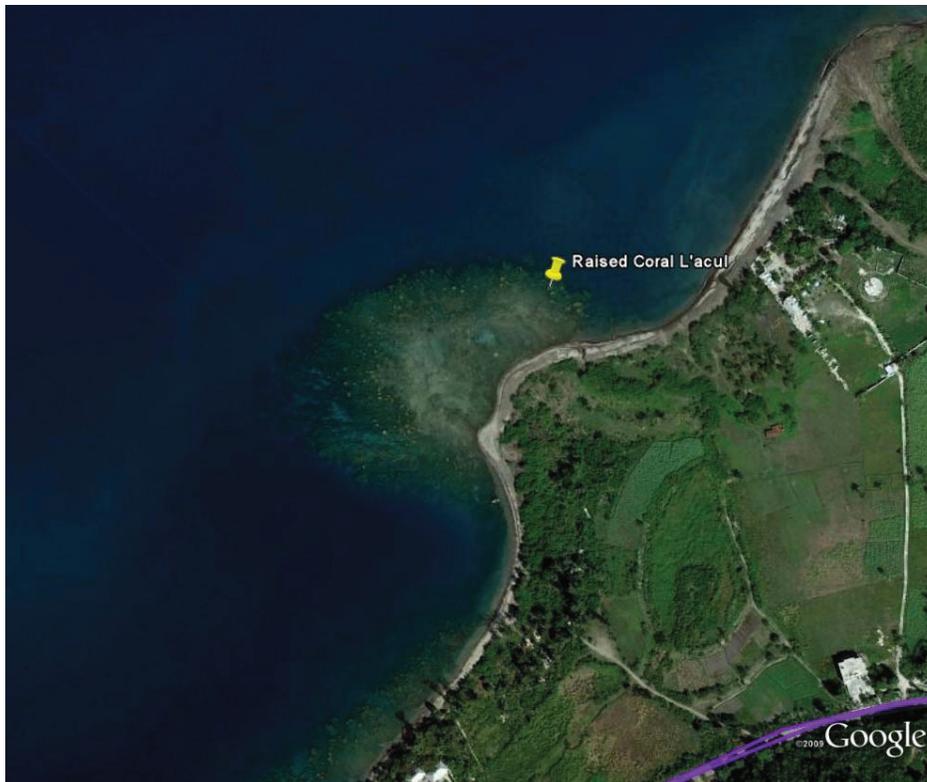
**Figure 4.18** Aerial view of coral uplift near L'acul.  
(See GEER Haiti Report.kmz for location)

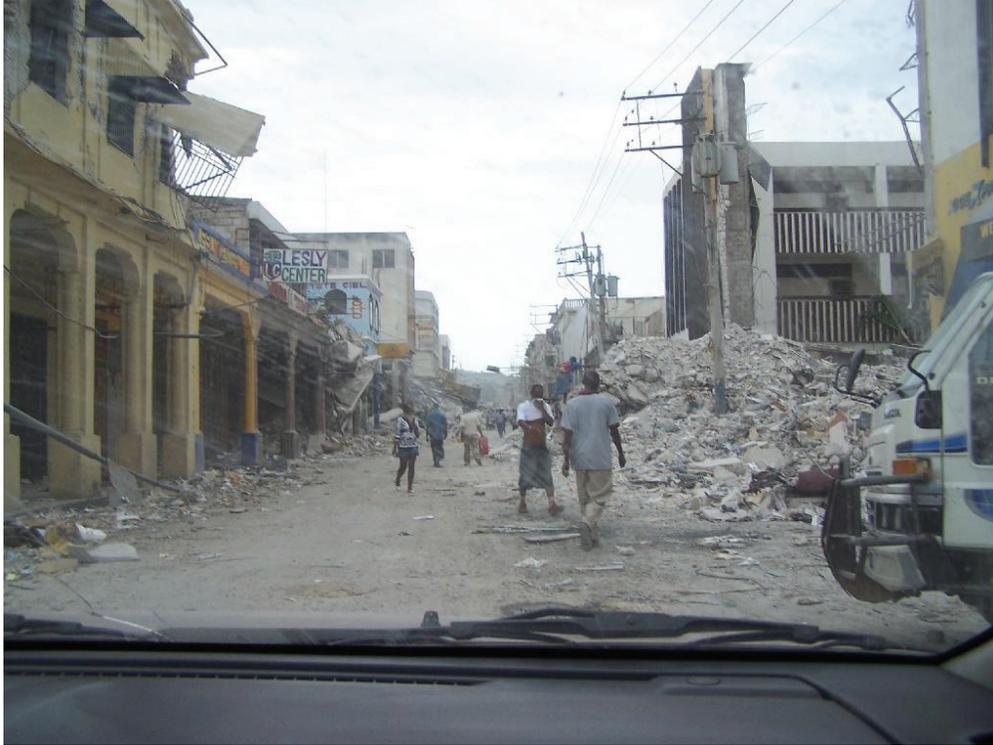
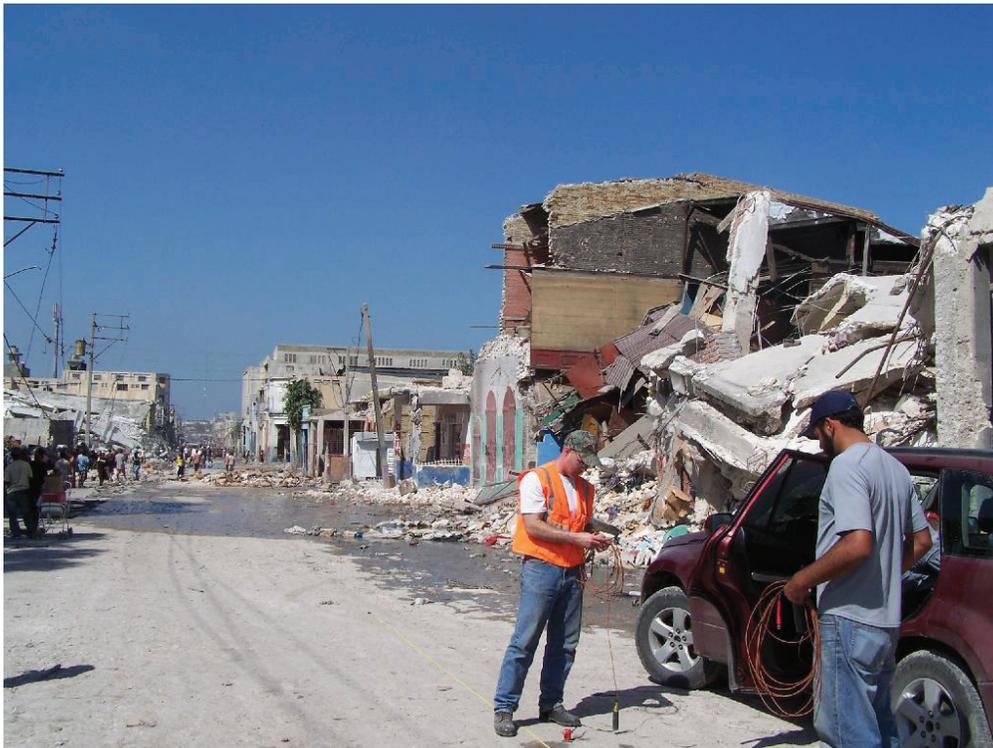
**Figure 5.8** Typical types of structures and damage found within the heavily damaged zone near SASW 8 (N18.550210°, W -72.339638°).

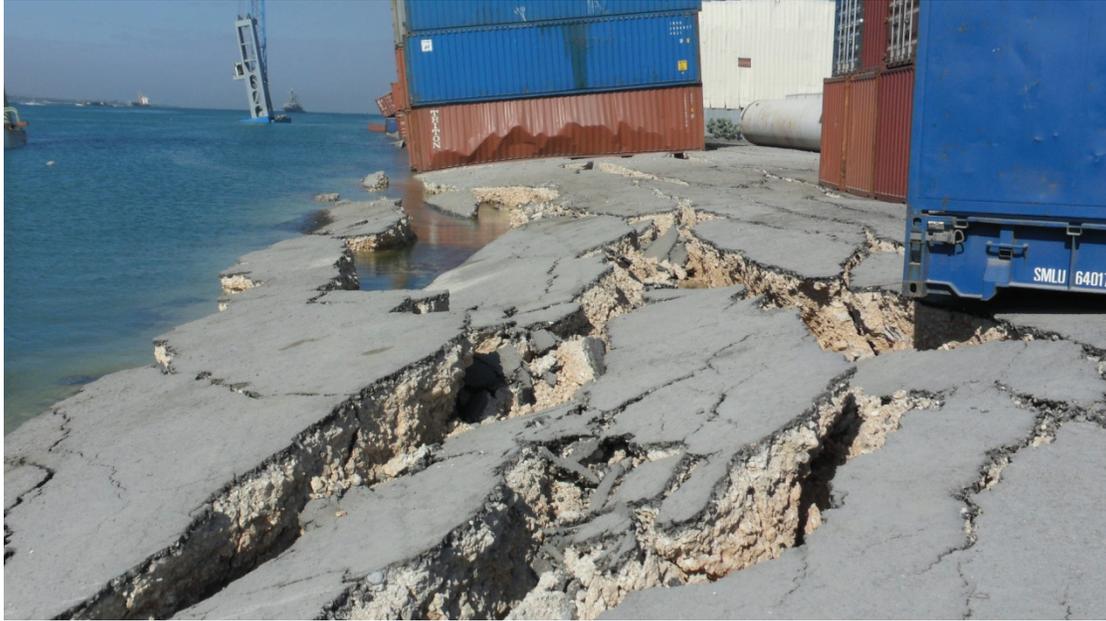
**Figure 6.6** Lateral spreading adjacent to the collapsed North wharf. Note the crane in the water in the background and the metal warehouses on the right. (N18.55622, W72.34787)

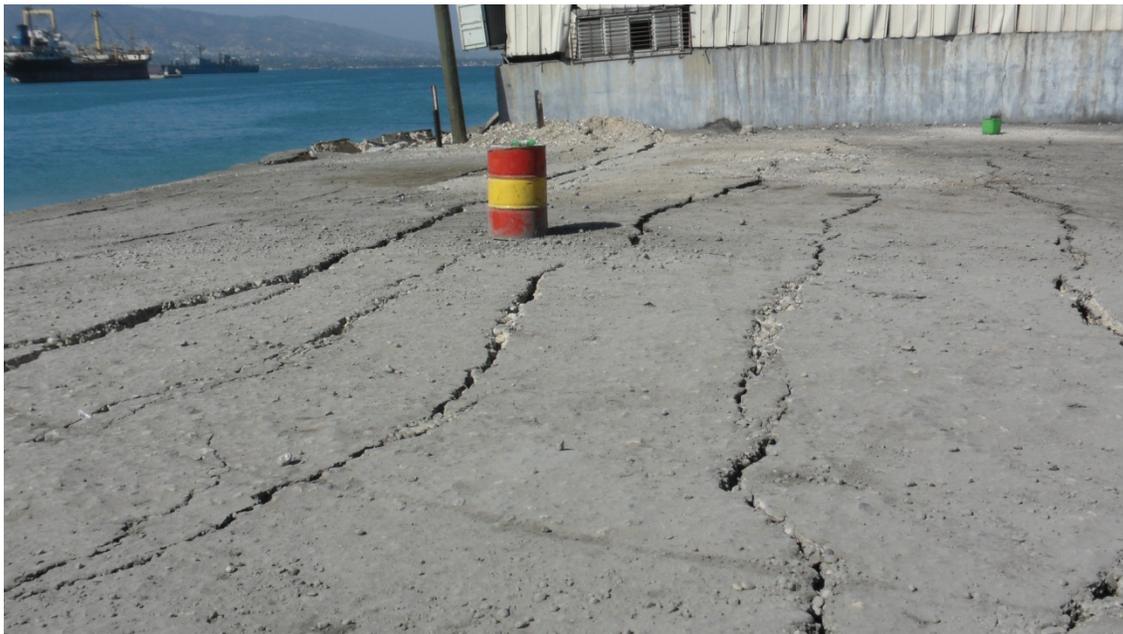
**Figure 6.7** Lateral spreading between the two metal warehouses, adjacent to the collapsed North wharf (left). A cumulative total of 89 cm of horizontal movement (determined by crack width) was measured in a zone extending inland approximately 30 m from the post-earthquake shoreline. Post-earthquake imagery indicates lateral spread cracking extended 50 m inland. (N18.556696, W72.34787)

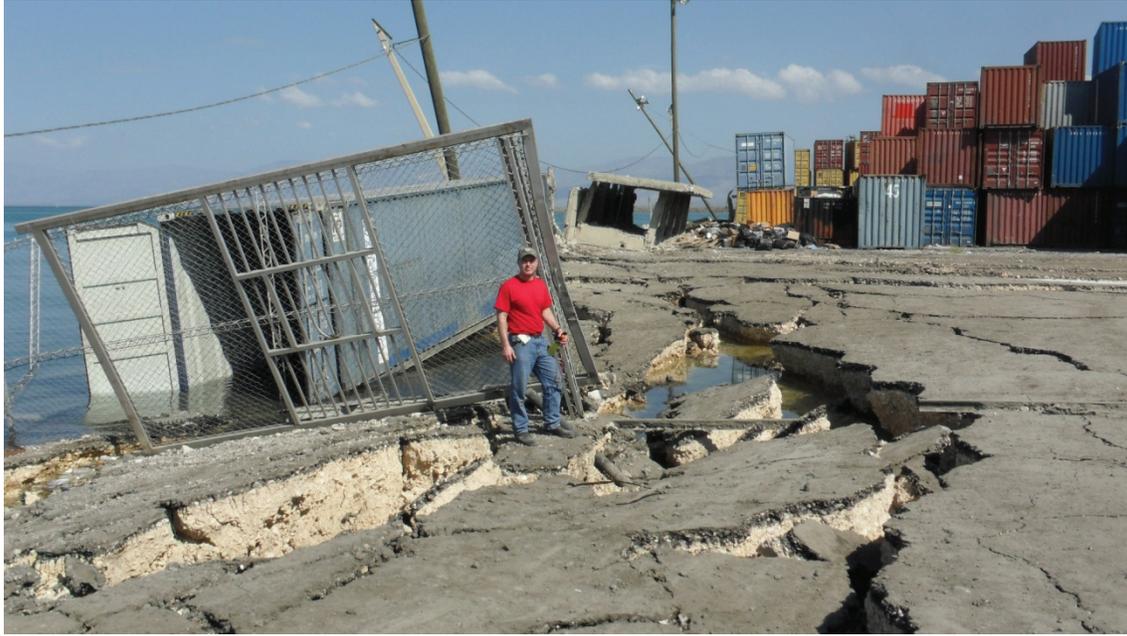
**Figure 6.8** Lateral spreading west of the two metal warehouses. Photo taken facing north with the metal warehouses to the right. (N18.557075, W72.352045)

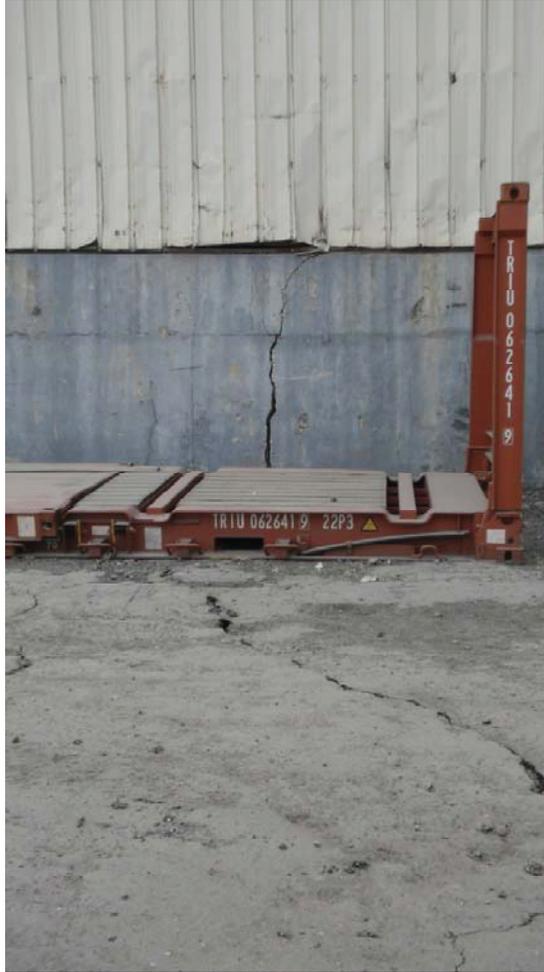
**Figure 6.11** Lateral spreading crack extending into the western foundation wall of the west warehouse. Photo taken facing east. (N18.55721, W72.35179)

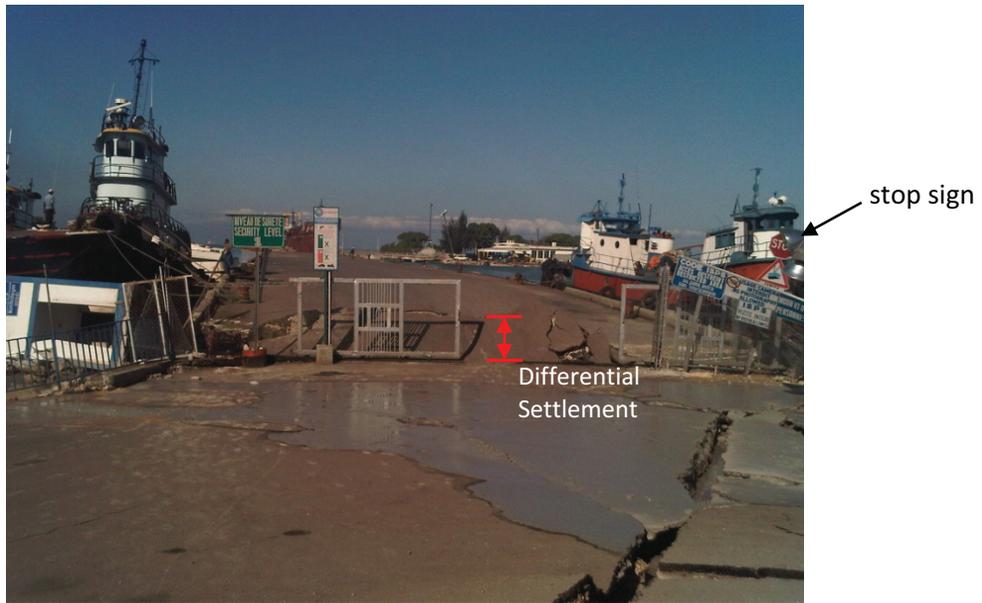
**Figure 6.15** Approach to the South Pier immediately after the earthquake (top photo: Source unknown; photo taken facing South-East) and after approximately 1 m of fill was placed (bottom photo: photo taken facing West). (N18.554028, W72.348658)

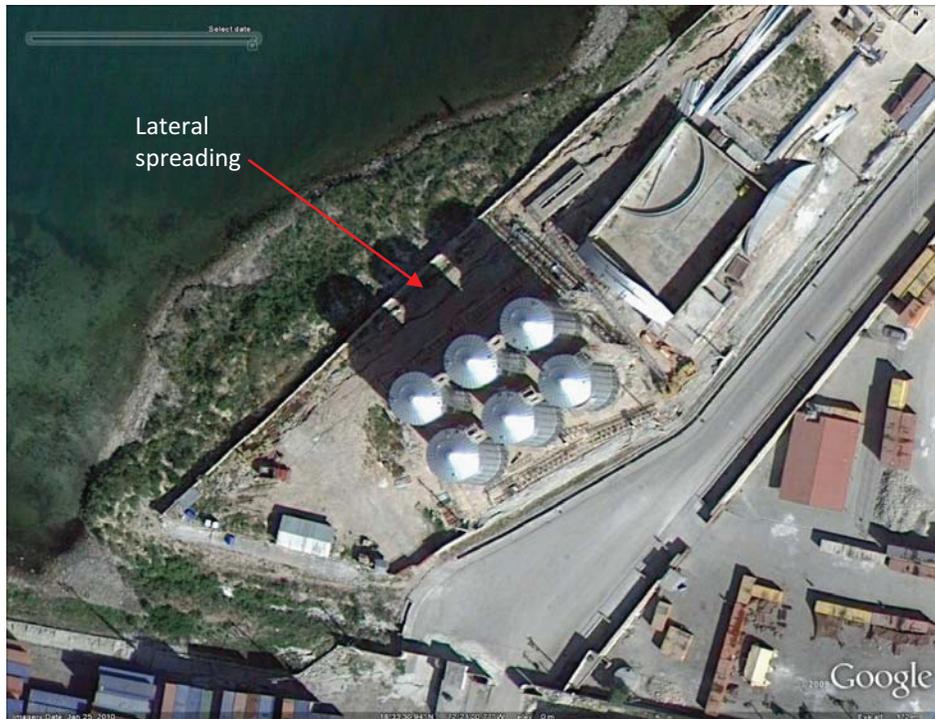
**Figure 6.18** Lateral spreading behind (westward side) steel grain hopper silos. However, the foundation system for the silos showed no visible signs of distress. Imagery courtesy of Google Earth.

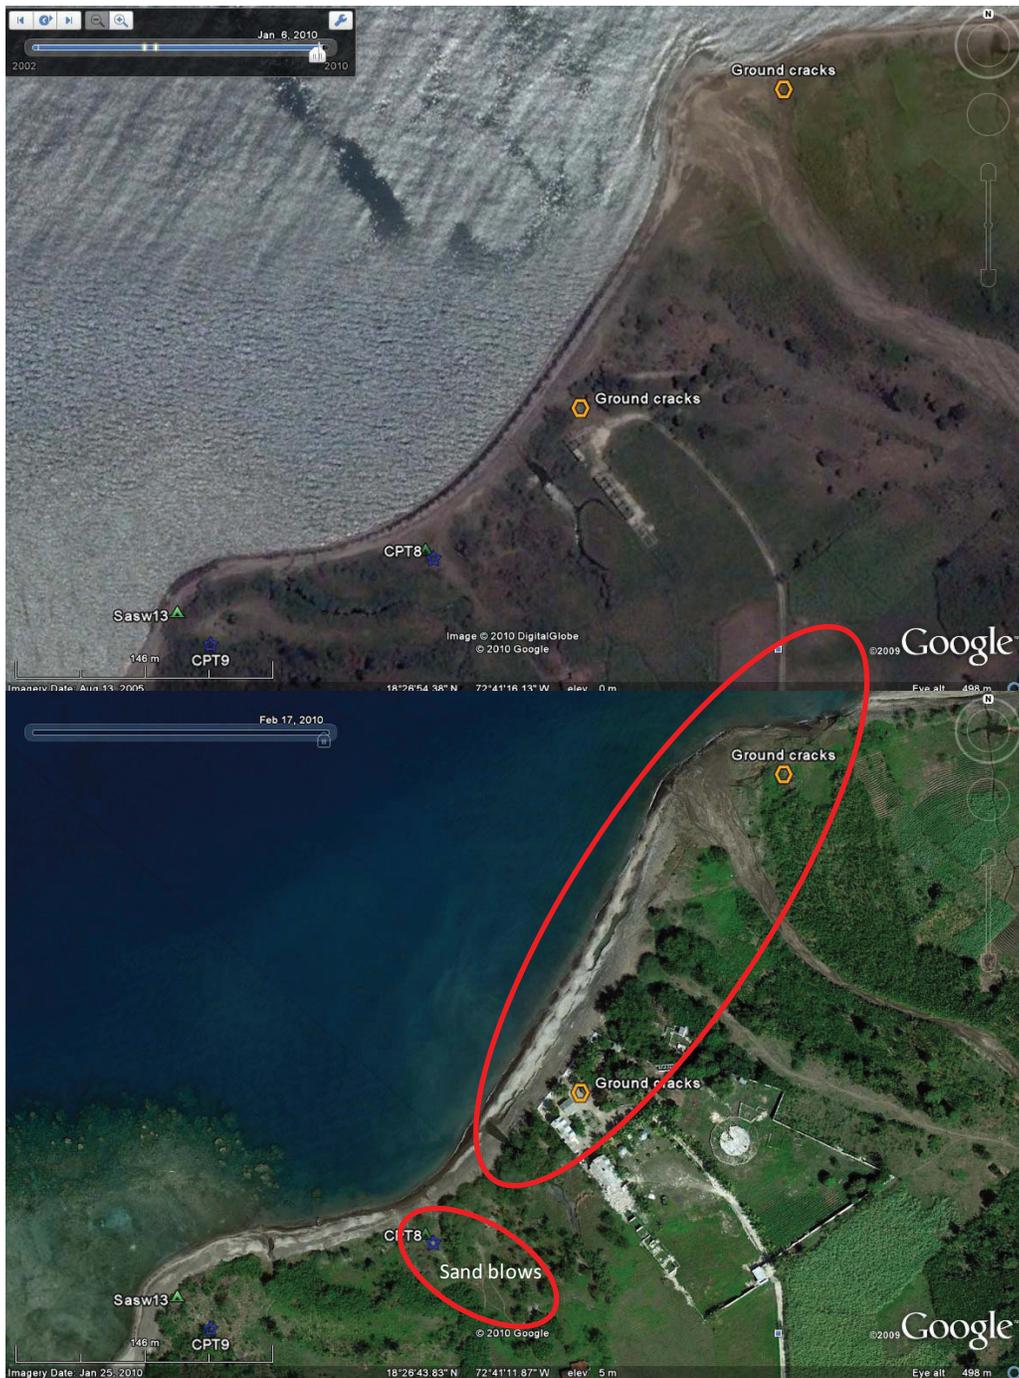
**Figure 7.3.** Pre- and post-earthquake images of coastline near village of L'Acuil. Note in the lower, post-earthquake image the significant cracking subparallel to the coast and the arcuate slump in the northern end of the failure. SASW and DCPT testing was performed near several large sand blows located near the south end of the failure zone, as well as farther south outside of the failed reach. Imagery courtesy of Google Earth. Approximate center of image at  $18^{\circ}26'51.17''\text{N}$ ,  $72^{\circ}41'11.06''\text{W}$ .

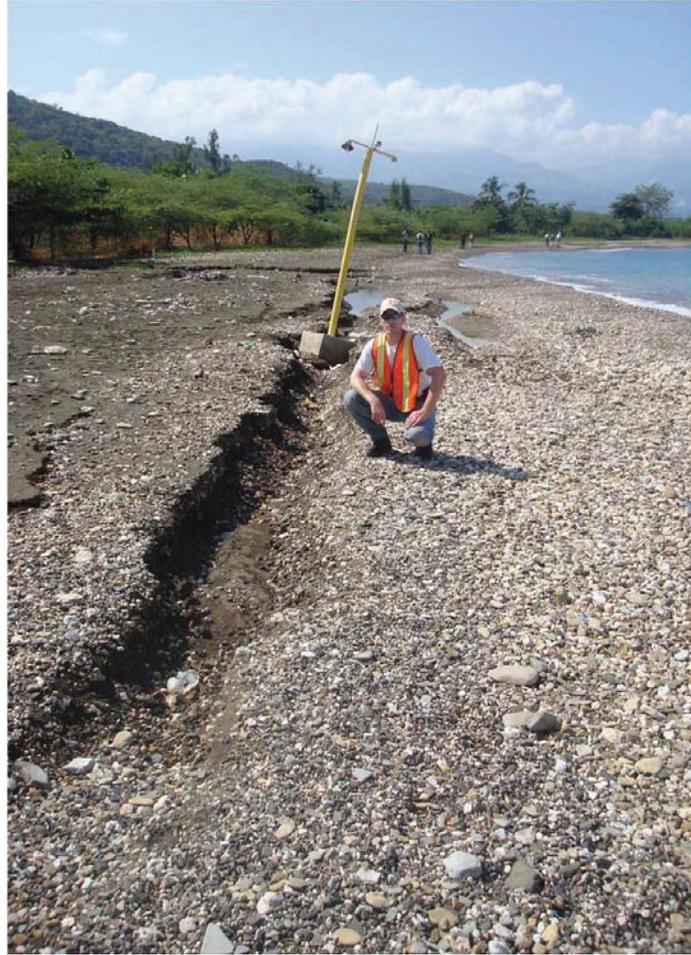
**Figure 7.4.** Cracking and lateral spread along coastline near village of L'Acul. (18°26'48.81"N, 72°41'11.92"W looking west).

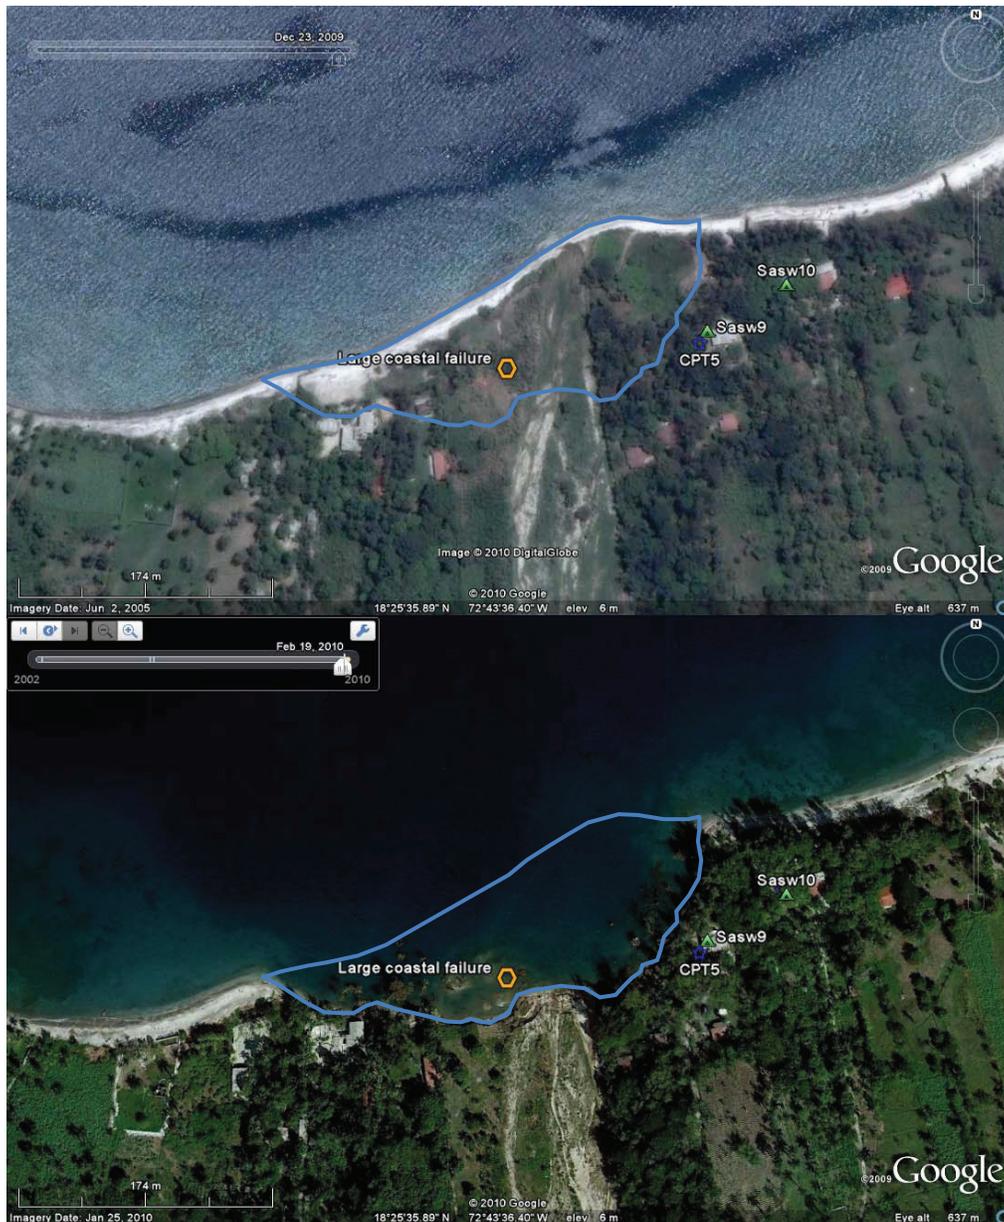
**Figure 7.8.** Pre- and post-earthquake images of coastline near village of Fouché. Note in the lower, post-earthquake image the significant loss of coast as outlined in blue. SASW-9 and DCPT-6 were performed near several moderate-sized sand blows located near the southeast end of the failure zone, while SASW-10 was performed outside of the failure zone. Imagery courtesy of Google Earth.

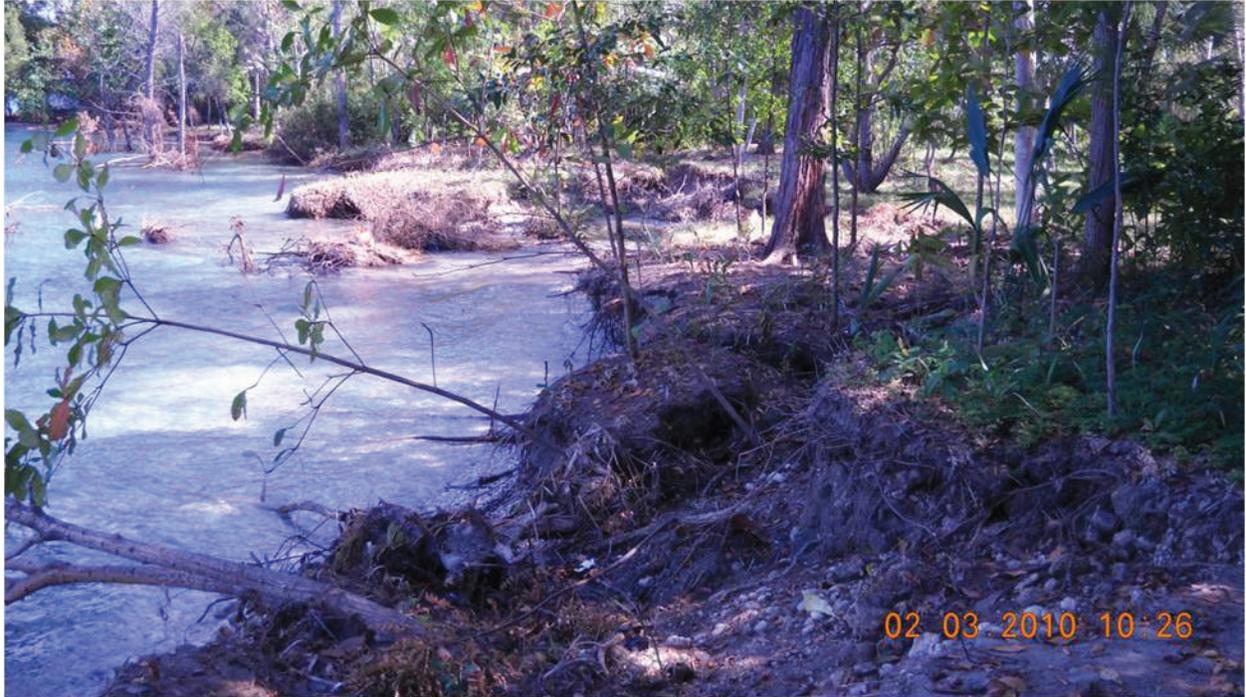
**Figure 7.9.** Scarp of coastal landslide near village of Fouche.  
( $18^{\circ}25'34.23''\text{N}$ ,  $72^{\circ}43'33.61''\text{W}$  looking northeastward)

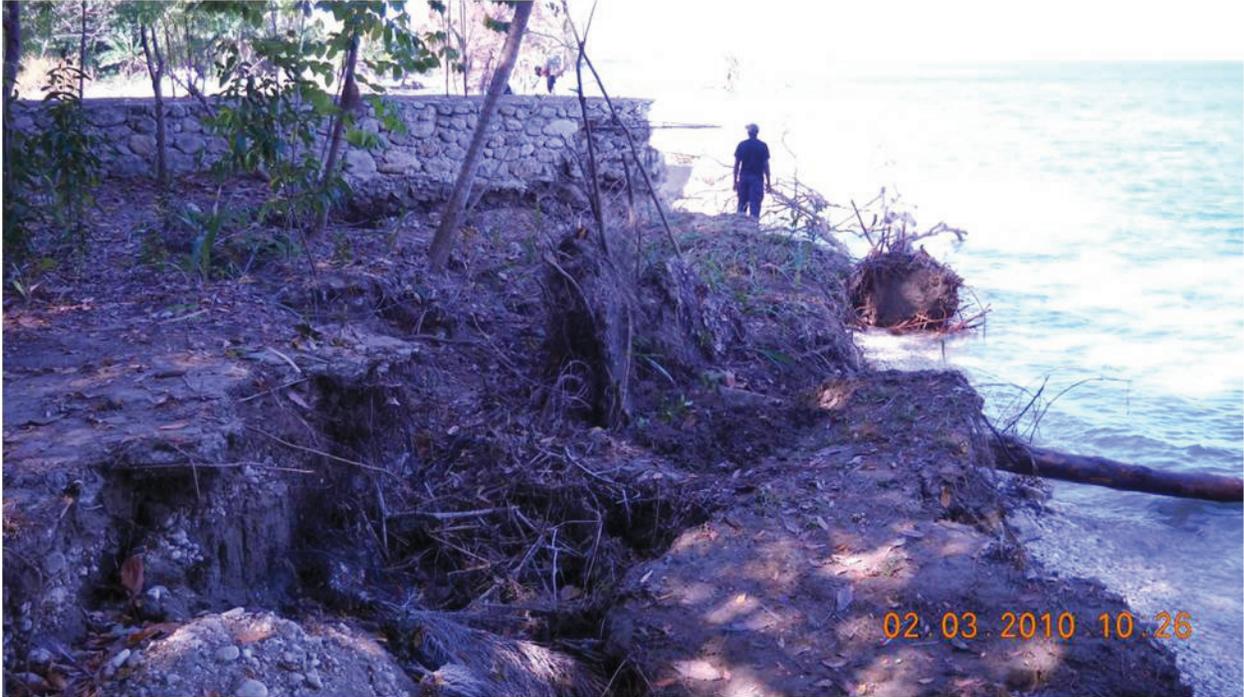
**Figure 7.11.** Damage to stone wall resulting from coastal failure and lateral spreading. (18°25'33.94"N, 72°43'34.27"W looking westward).

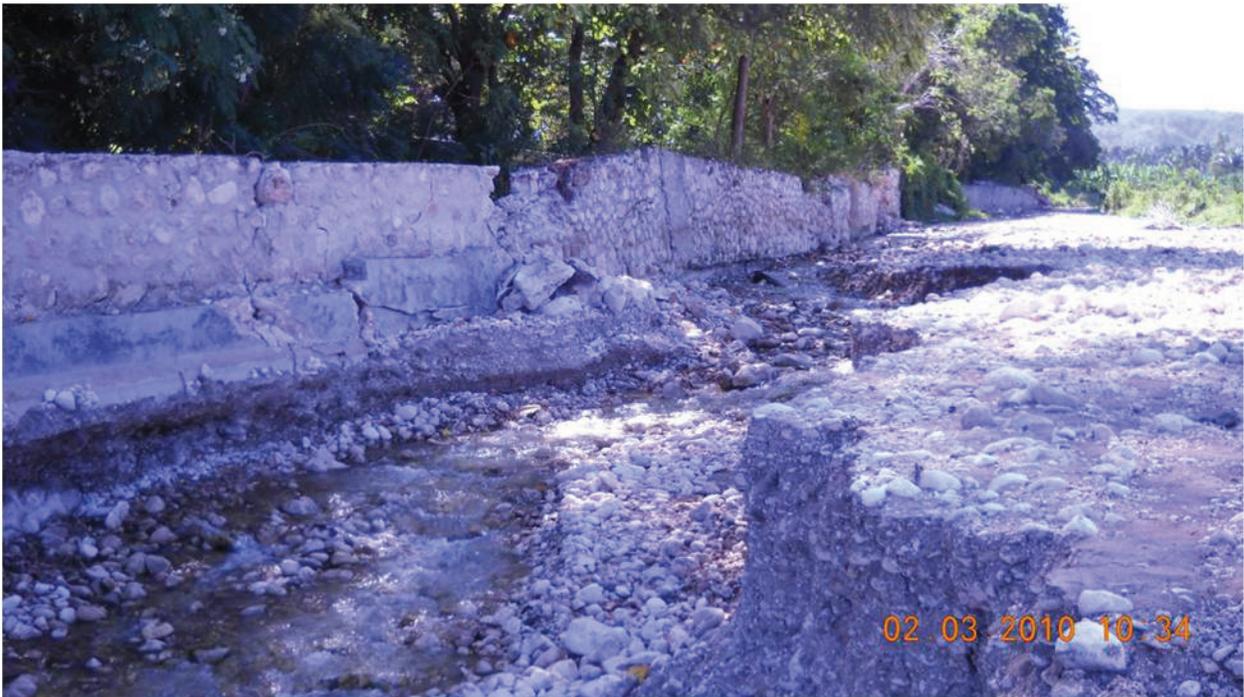
**Figure 7.12.** Damage to stone wall resulting from lateral spreading. Note the surficial cobbly material revealed by the failure scarp in the foreground. (18°25'33.31"N, 72°43'34.58"W looking southward away from coast).

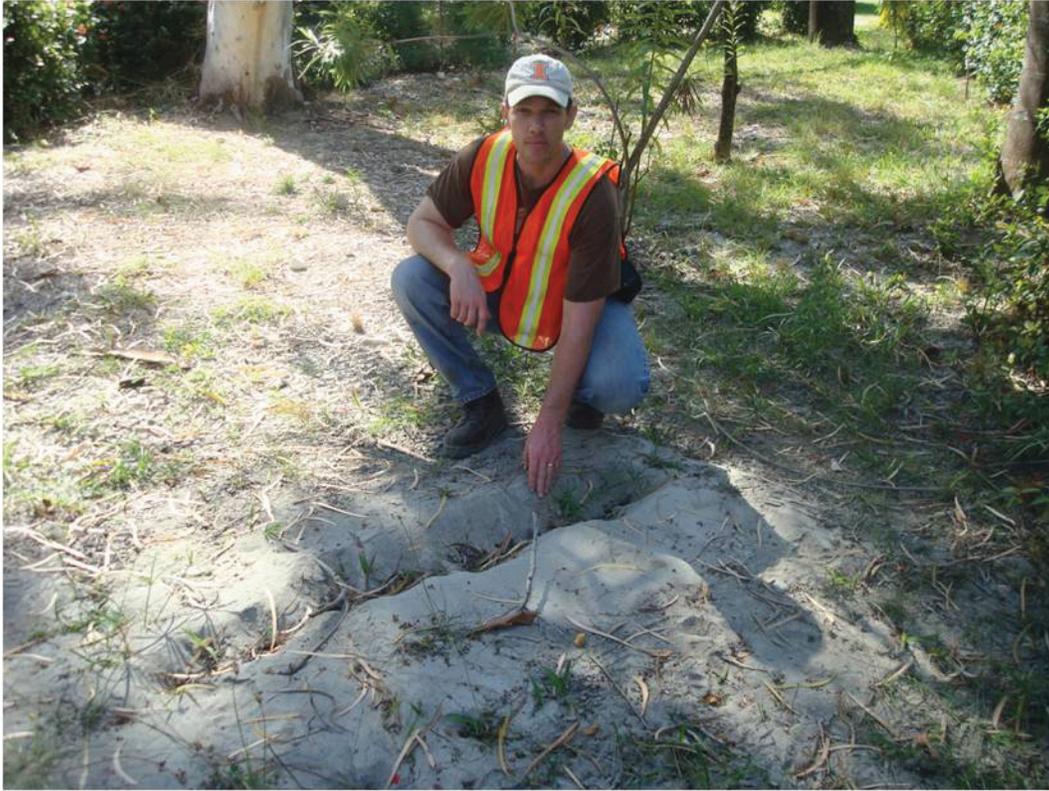
**Figure 7.13.** Sand blow and ejecta formed at coastal failure site near village of Fouche. Approximate image coordinates: 18°25'35.08"N, 72°43'31.70"W.

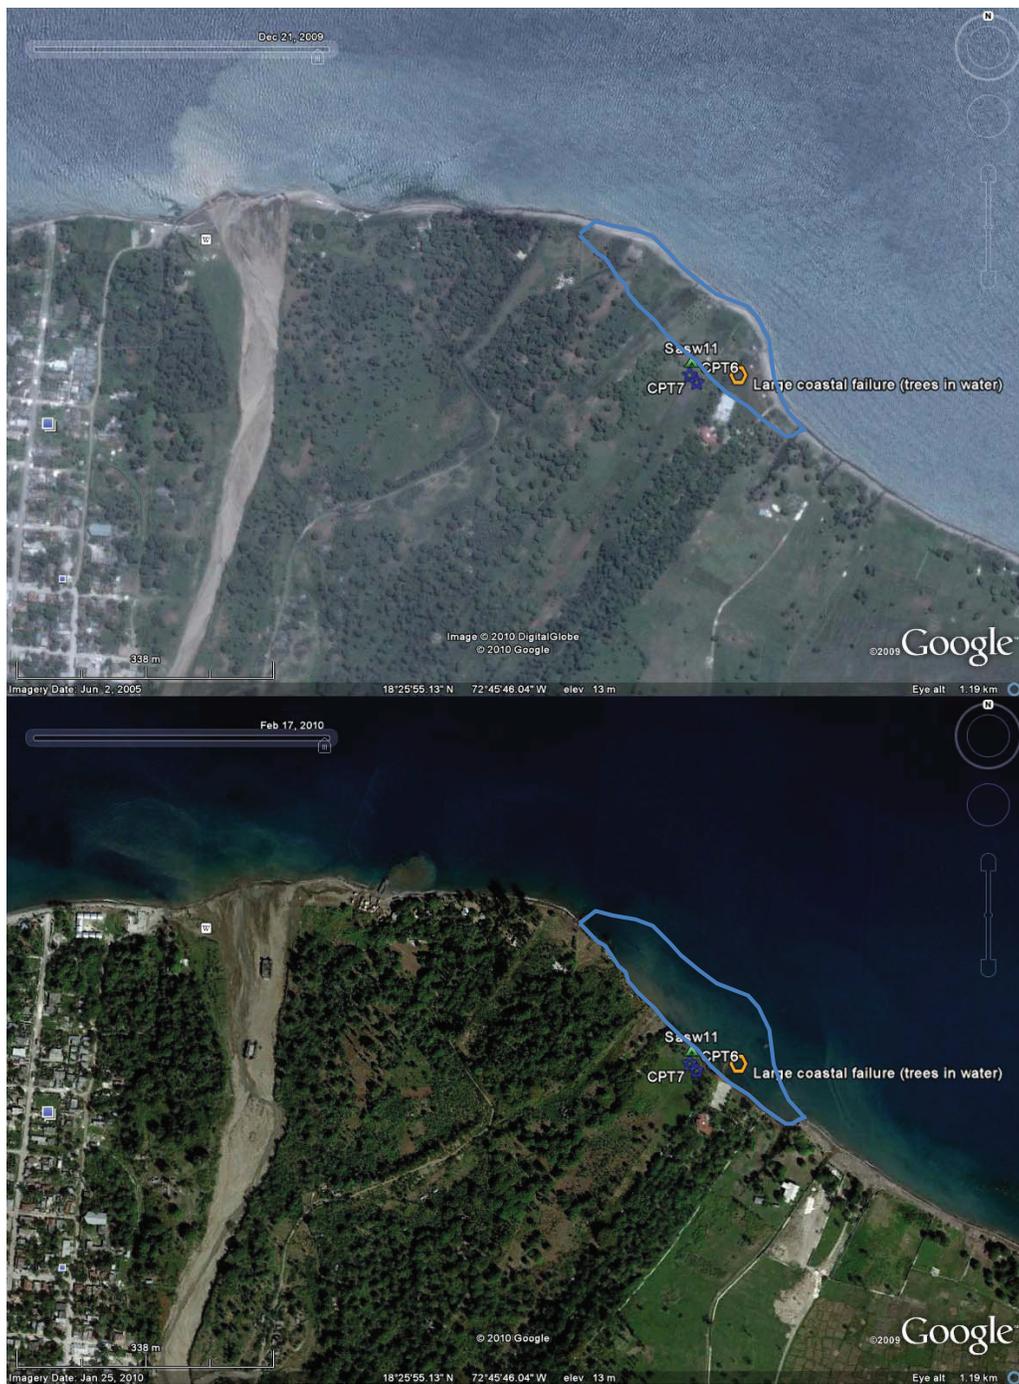
**Figure 7.16.** Pre- and post-earthquake images of coastline near village of Grand Goâve. Note in the lower, post-earthquake image the significant loss of coast as outlined in blue. SASW-11, DCPT-7, and DCPT-8 were performed just inland of the backscarp of the failed zone. Imagery courtesy of Google Earth.

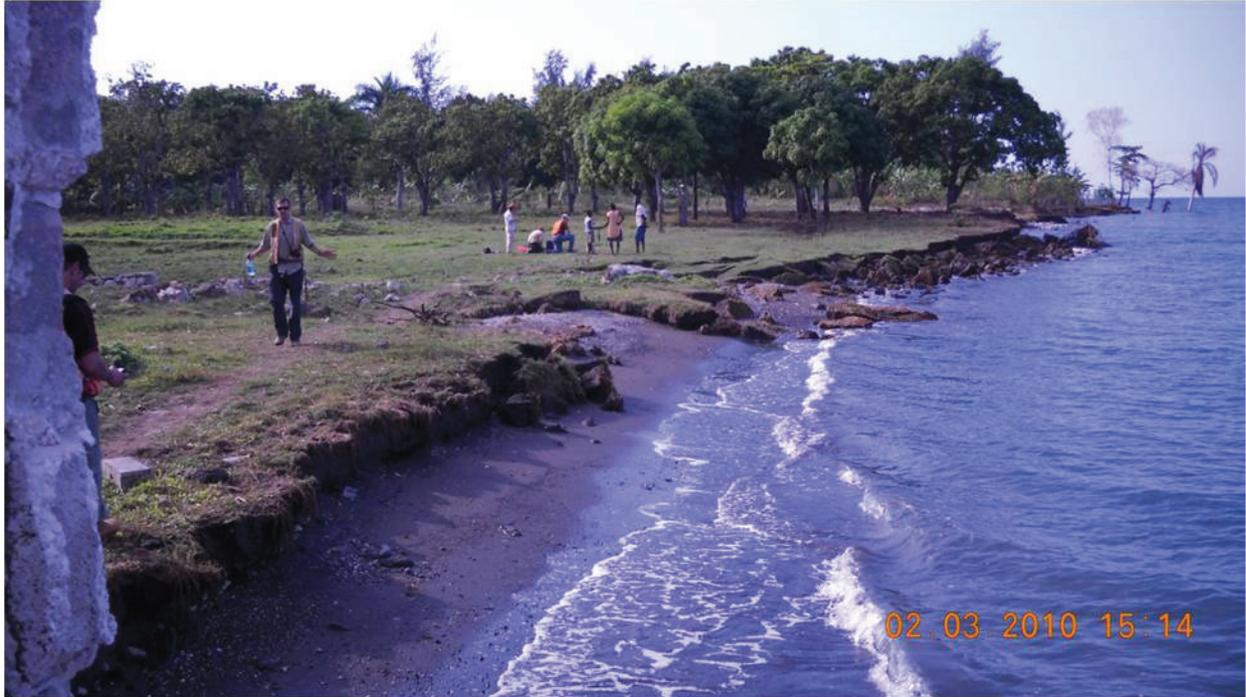
**Figure 7.17.** Scarp formed along northern portion of coastal failure near village of Grand Goave. ( $18^{\circ}25'53.82''\text{N}$ ,  $72^{\circ}45'37.16''\text{W}$  looking northwest).

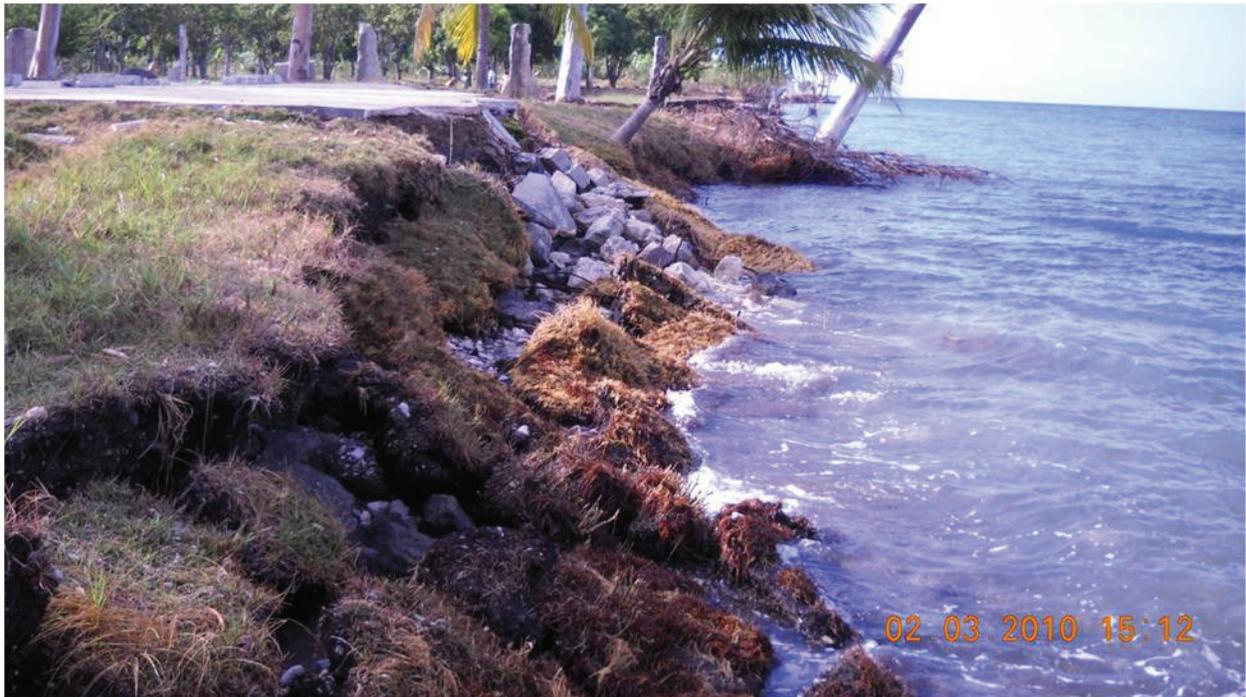
**Figure 7.18.** Scarp formed along southern portion of coastal failure near village of Grand Goave. ( $18^{\circ}25'52.91''\text{N}$ ,  $72^{\circ}45'35.92''\text{W}$  looking northwest)

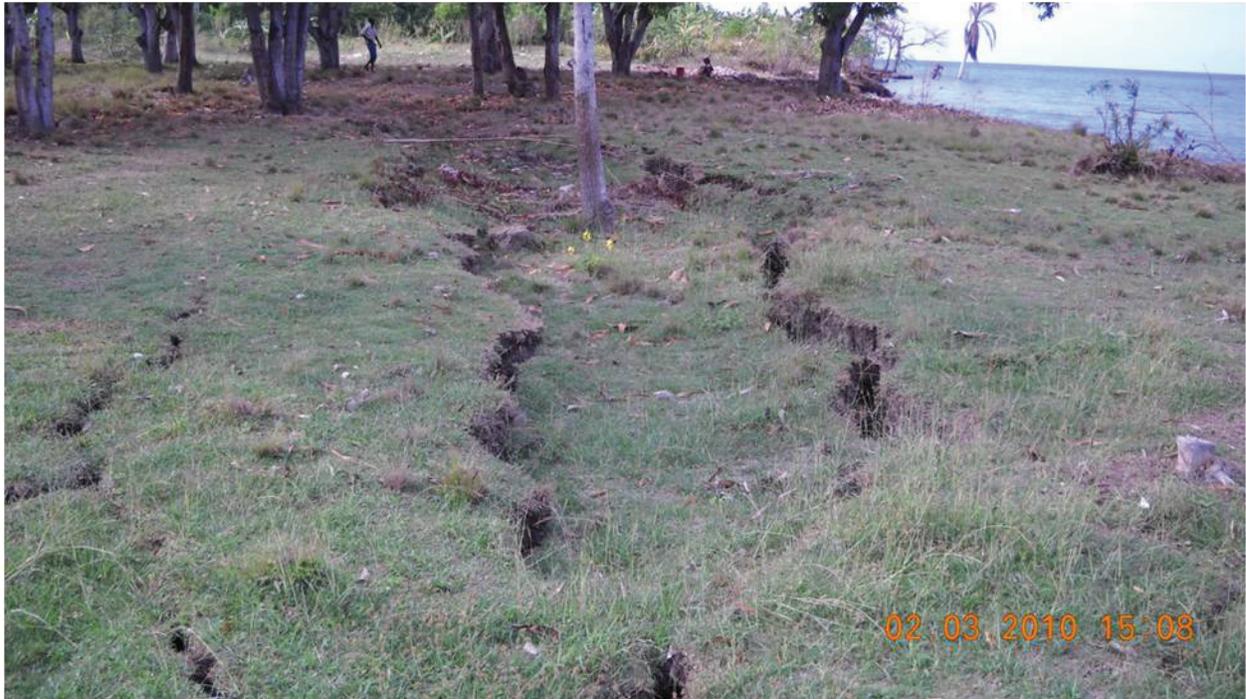
**Figure 7.19.** Graben formation subparallel to coastline at coastal failure near village of Grand Goâve. ( $18^{\circ}25'54.43''\text{N}$ ,  $72^{\circ}45'37.99''\text{W}$  looking northwest).

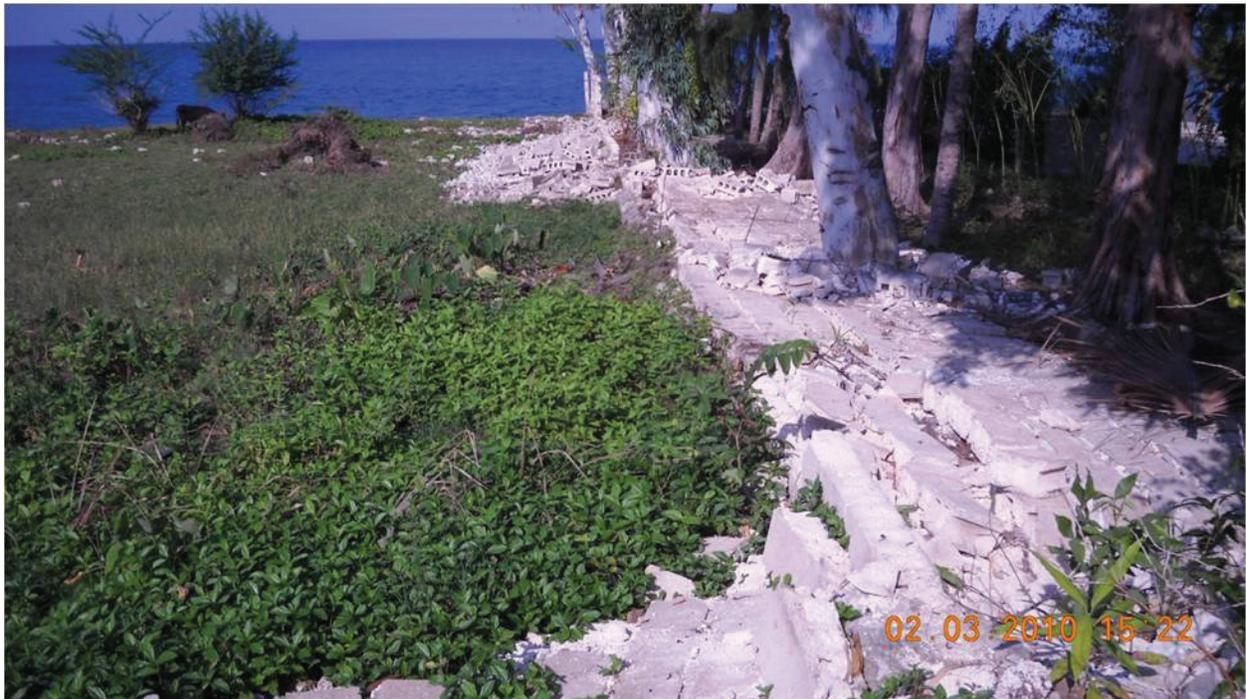
**Figure 7.20.** Damage to unreinforced block wall running perpendicular to coast near village of Grand Goâve. ( $18^{\circ}25'51.84''\text{N}$ ,  $72^{\circ}45'38.06''\text{W}$  looking northeast).
