# GEOTECHNICAL ENGINEERING RECONNAISSANCE OF THE 2010 HAITI EARTHQUAKE

Version 1: February 22, 2010

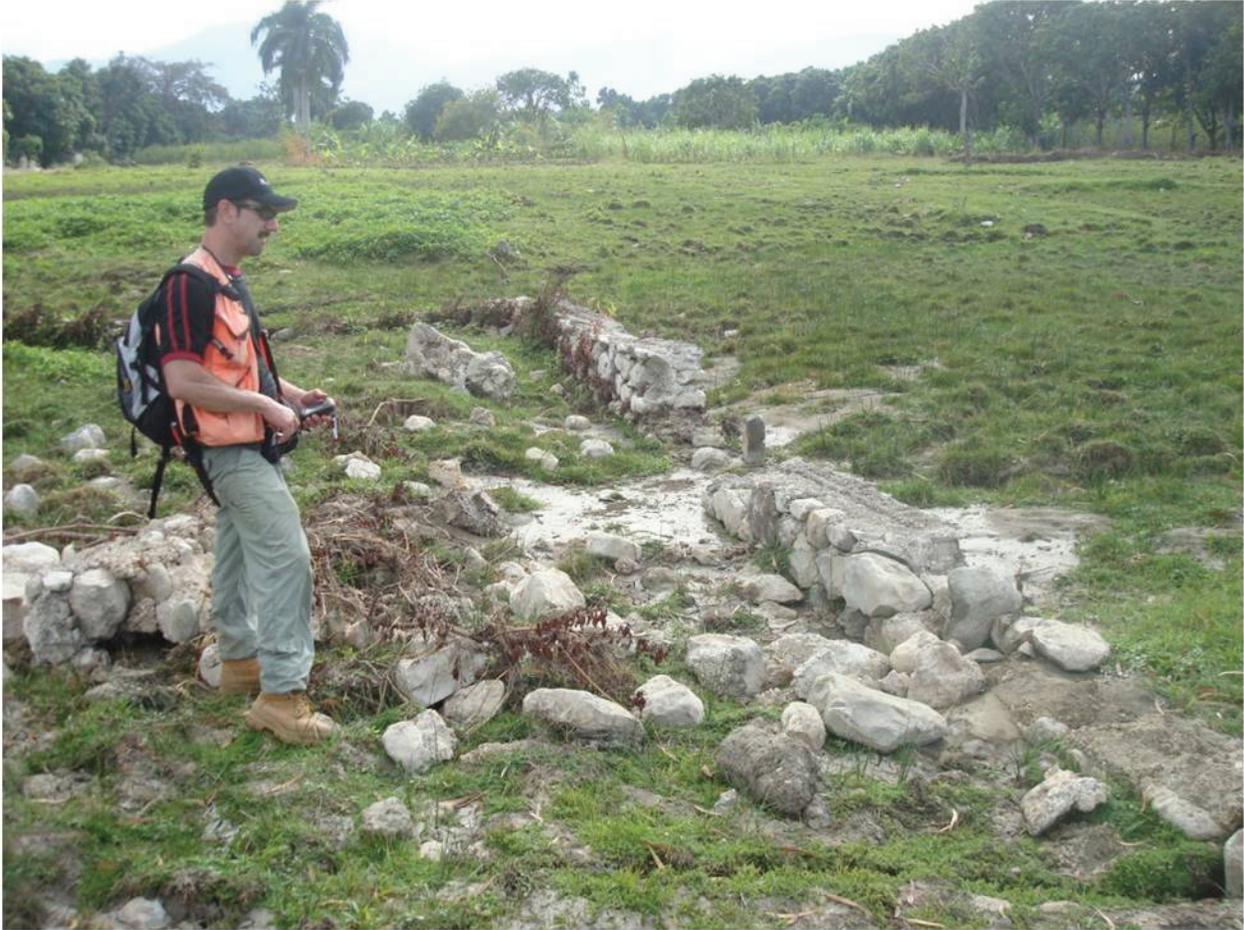
**Figure 7.21.** Sand blow formation along inland extent of coastal failure near village of Grand Goâve. ( $18^{\circ}25'53.73''\text{N}$ ,  $72^{\circ}45'37.65''\text{W}$ )

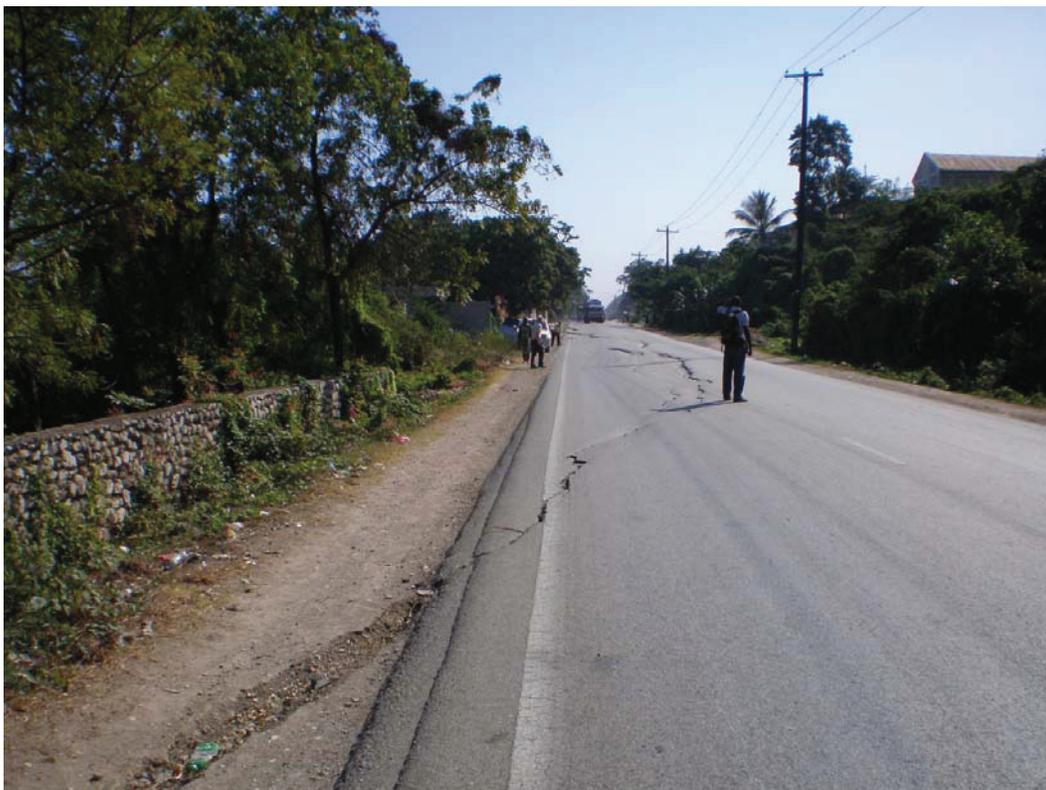
**Figure 8.4** Typical arcuate road cracks at road failure site RCA west of Carrefour.

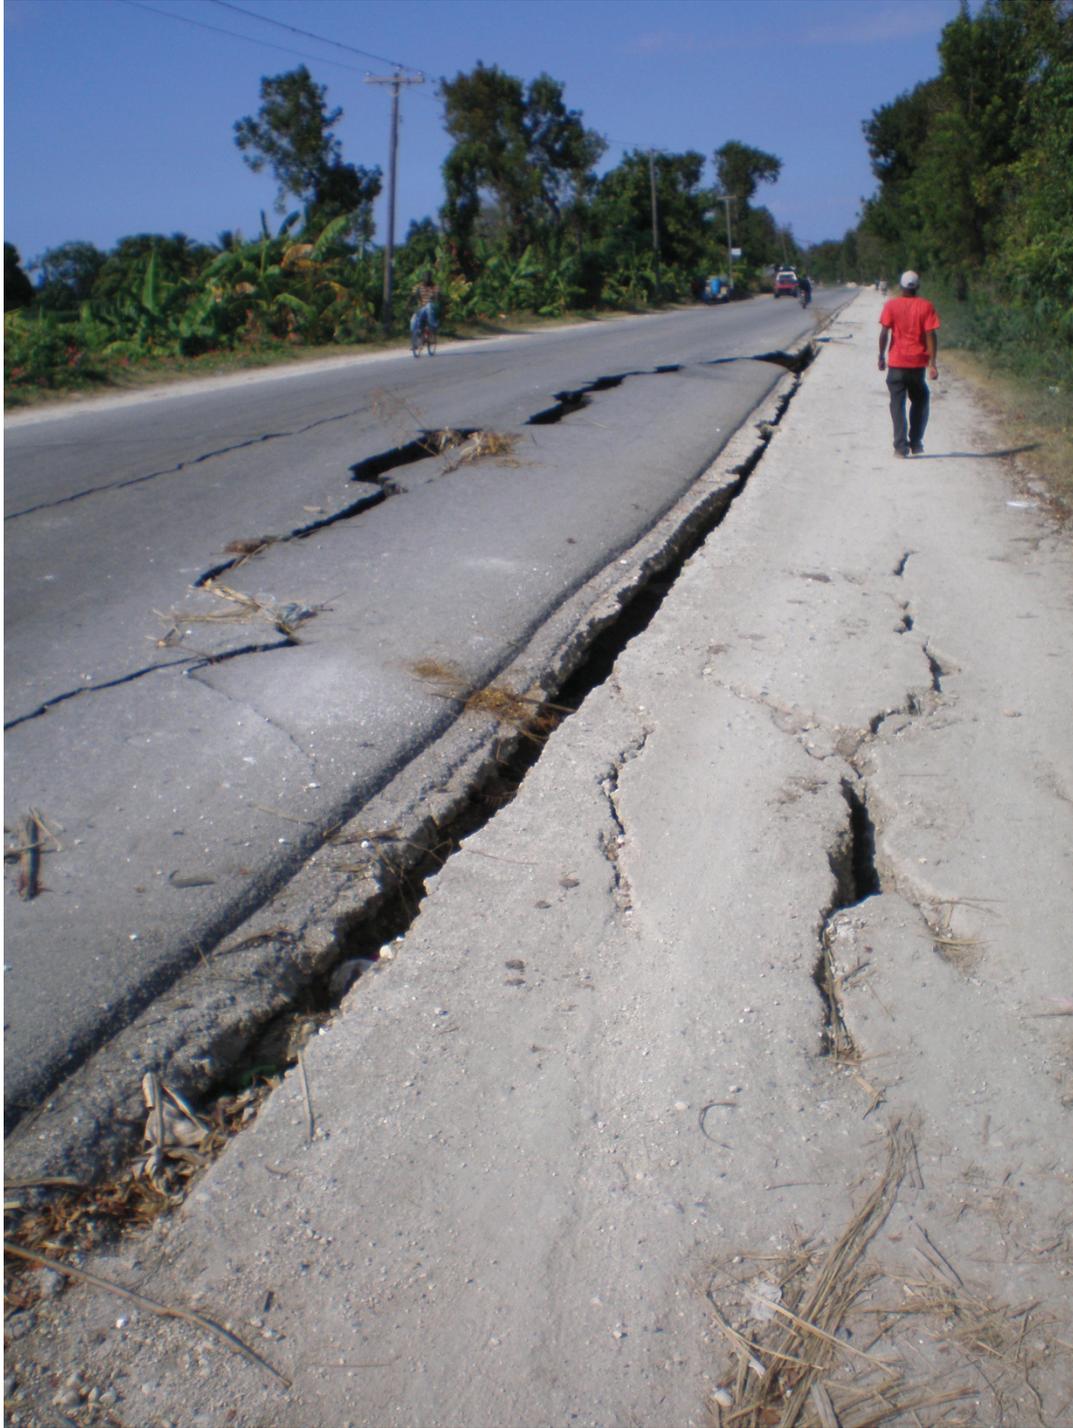
**Figure 8.5** Cracks induced by fill slope slumping at road damage site BOXCLVTA.

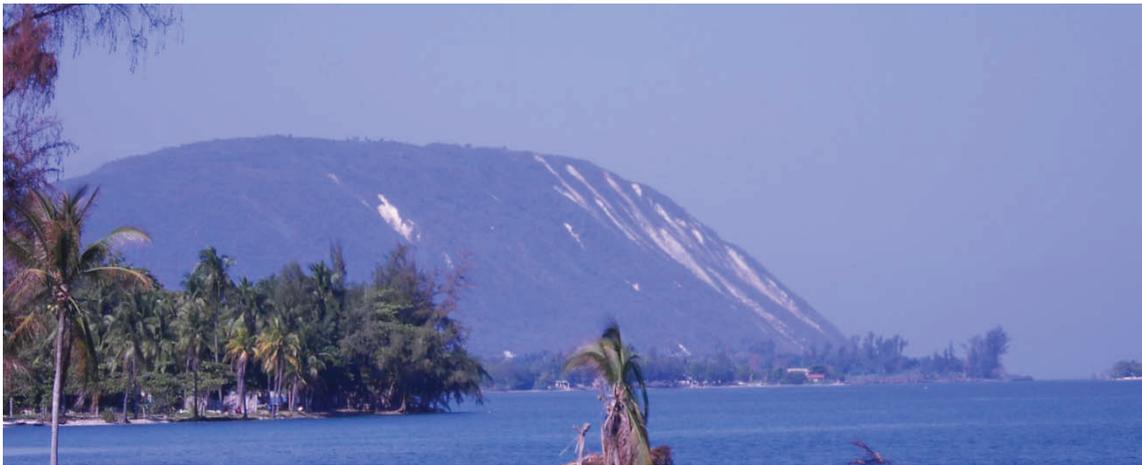
**Figure 9.3** Landslide scars near Provence in distance. ( $18.426166^{\circ}\text{N}$ ,  $72.725825^{\circ}\text{E}$ ).

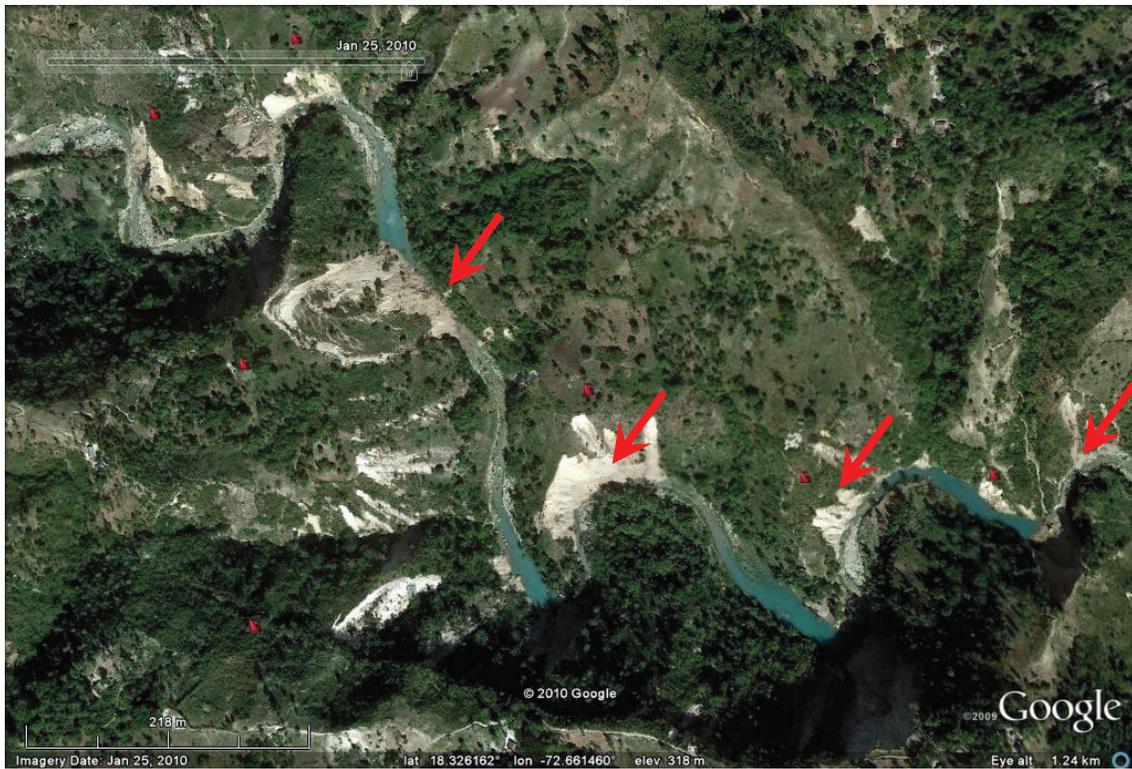
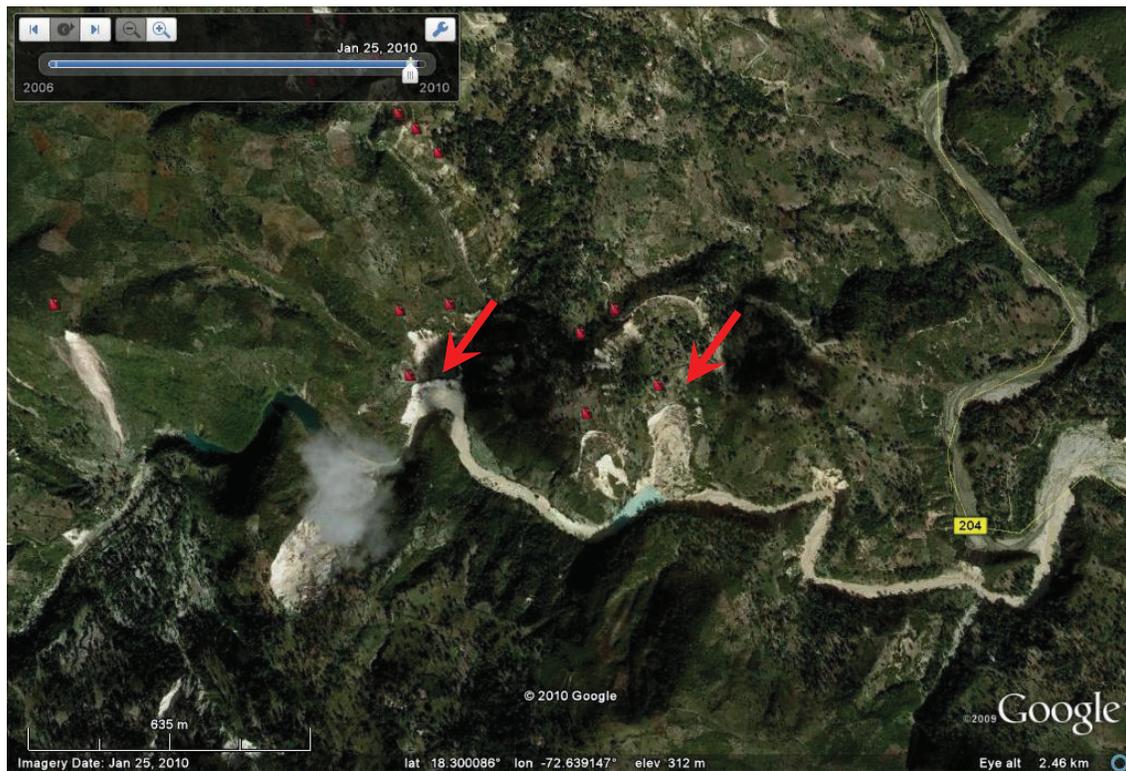
**Figure 9.4** Landslide dams (red arrows) and retained lakes west of Route 204 and approximately 15 km northwest of Jacmel (top: N18.326162, W72.66146, bottom: N18.300086, W72.639147).
