# GEOTECHNICAL ENGINEERING RECONNAISSANCE OF THE 2010 HAITI EARTHQUAKE

Version 1: February 22, 2010

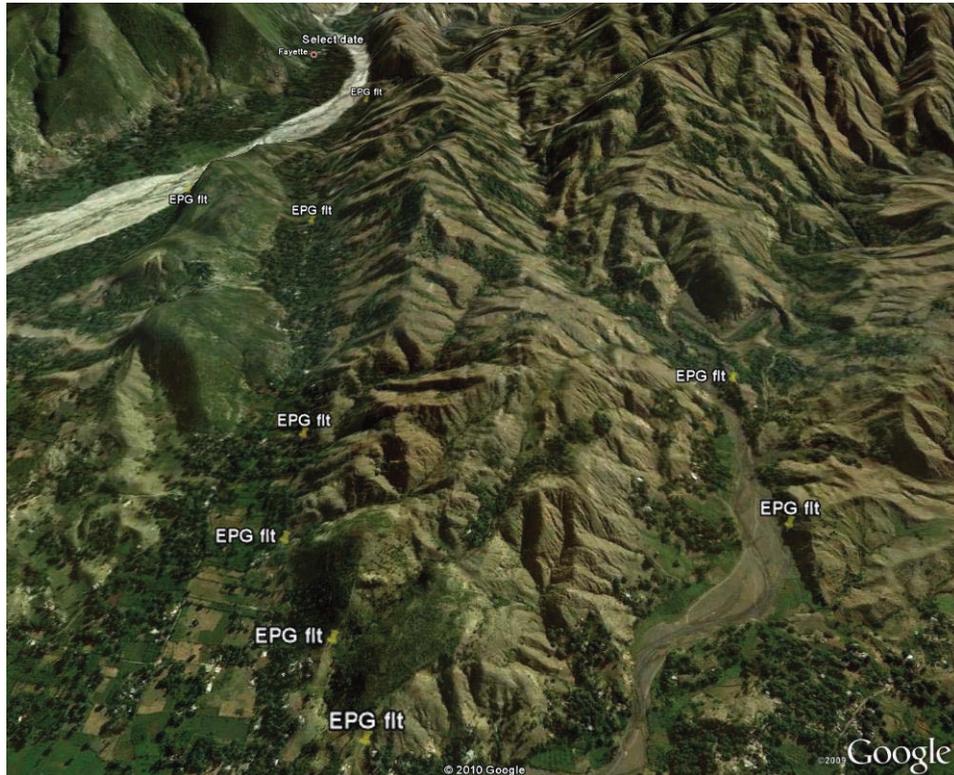
**Figure 4.1.** View east towards Fayette and Leogane along parallel east-northeast trending traces of Enriquillo Plantain Garden fault. Fault trace marked by push-pins labeled “EPG flt”. Fault trace at right (left offset of river along prominent north-facing scarps) apparently steps north to linear valley of Momance River at top left of picture.

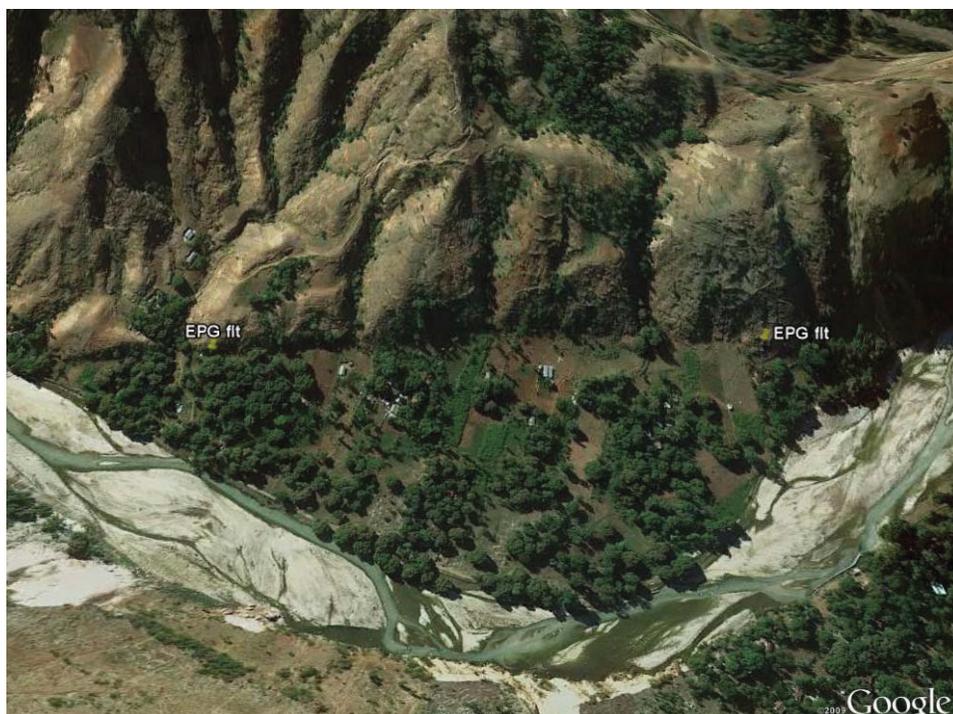
**Figure 4.2.** View south of prominent fault scarp crossing fluvial terrace on Momance River east of Fayette. Fault trace marked by push-pins labeled “EPG flt”.

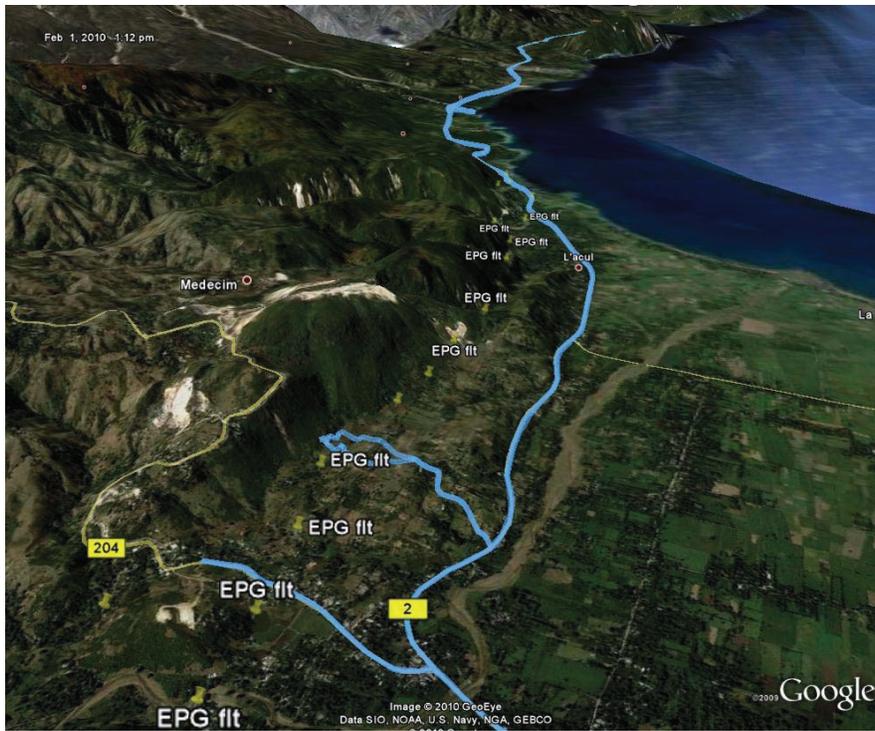
Dr. Mann and Dr. Koehler identified several locations near Dufort where the location of the EPG fault was well constrained and accessible, and the combined team visited these sites on February 1. These sites are located along Road 204 (Jacamel Road) and west of Road 204 (Figure 4.3). Road 204 passes south from the intersection with Road 2 across the plain and up the slope of the east-west trending mountain range. The EPG fault lies along the base of the range, at a prominent break-in-slope from the plains to the lower part of the range. The team confirmed that Road 204 is not displaced where it crosses the fault and range front. A distinct linear valley and shutter ridge occur at the base of the hills about 0.75 km west of Road 204, providing a well-constrained location of the active trace of the EPG fault. The team inspected the fault over a distance of several hundred meters across the small valley, along several transects extending across the shutter ridge and through the valley bottom to bedrock areas exposed on the hillslope above the valley. The fault is constrained to lie at the prominent break-in-slope at the base of the hill or within a few tens of meters east in the valley bottom (Figure 4.4). South of this valley, the EPGFZ is marked by the prominent break-in-slope and a series of side-hill benches (Figure 4.5). The team observed minor cracking in the valley floor at one location, and a linear north-facing scarp at the base of the hillslope. It was concluded that the minor cracking in the valley floor likely represented effects of shrink-swelling in the soil and that the north-facing scarp was the result of hoeing/tilling for agricultural purposes (Figure 4.6). Therefore, the team concluded that the fault did not rupture at the ground surface through the small valley.

**Figure 4.3.** View southwest along EPG fault west of Dufort. Reconnaissance track marked in blue shows location of fault traverses on and west of Road 204. Fault trace marked by push-pins labeled “EPG flt”.

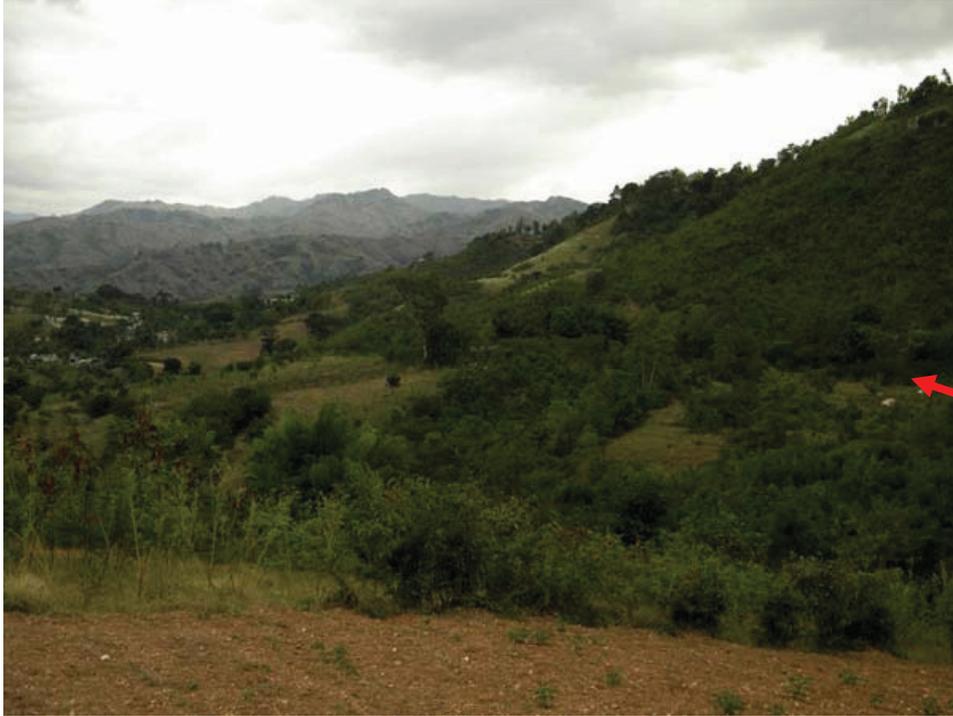
**Figure 4.5.** View east along trace of EPG fault from hill above linear valley west of Road 204 (along red arrow) (N18.445819, W72.6431718).

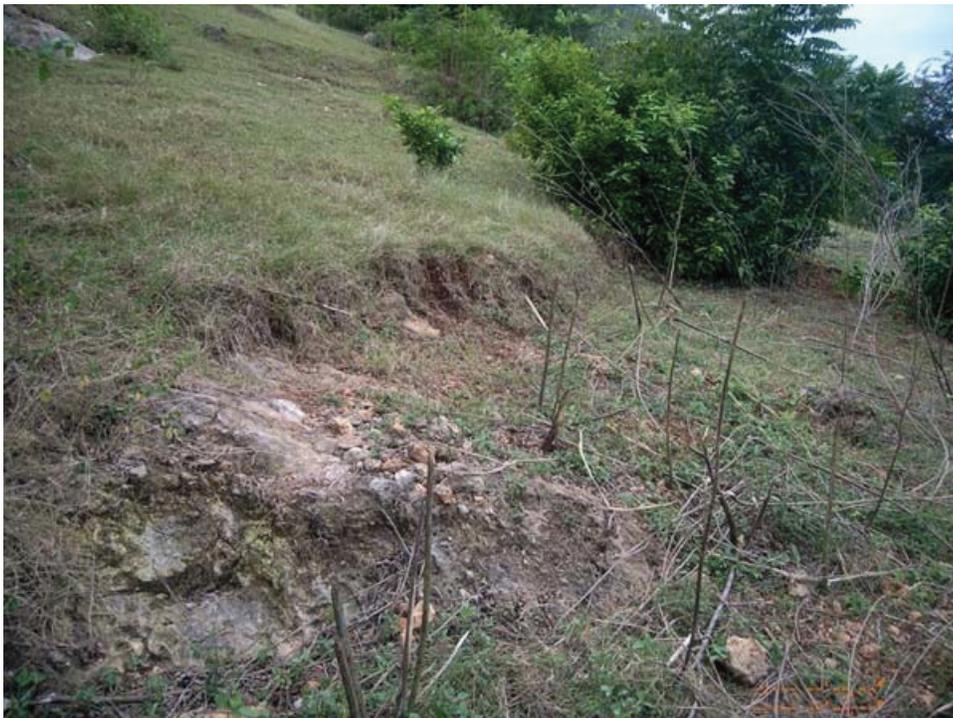
**Figure 4.6.** View west along agricultural scarp in linear fault valley west of Road 204 (N18.444527, W72.643777).

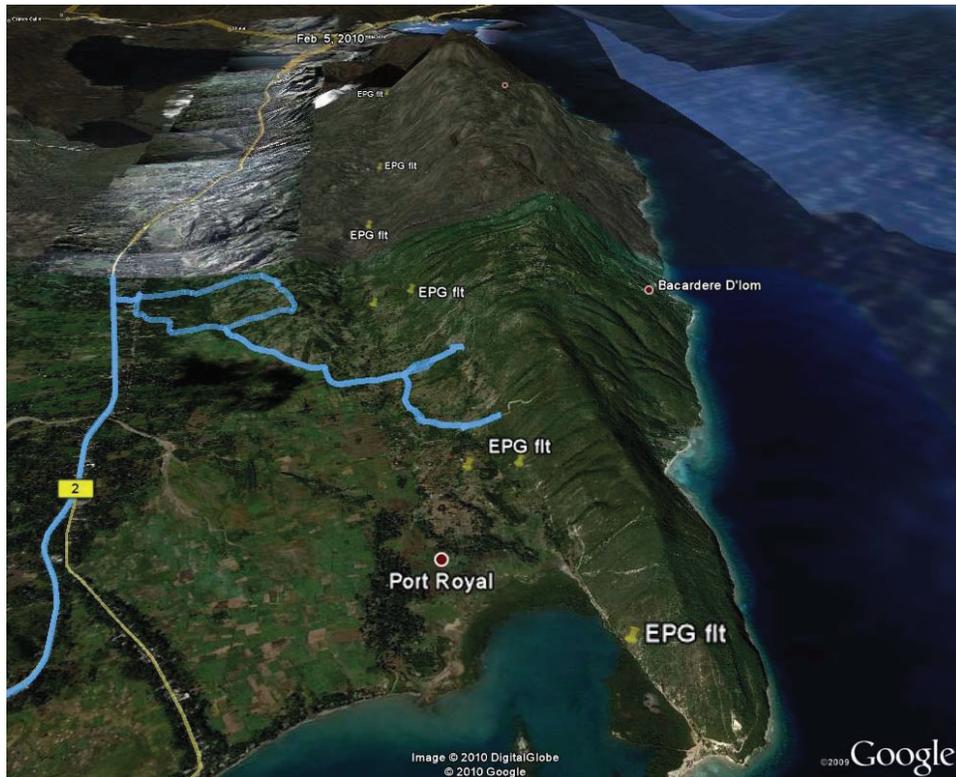
was observed at the bedrock-colluvial contact (a northern fault trace) or along the base of the side-hill benches and alignment with diverted drainages (a southern fault trace). When asked whether and where they had observed any ground cracking, several local residents described ground failures due to landsliding on slopes on the opposite side of the valley, and one location of ground cracking on the coast east of Port Royal. We were not able to travel to the coast to evaluate the ground cracks because of impending darkness, but based on the description of the cracks as being near the water, and due to the prevalence of lateral spreading along the coast, it is likely that these fractures were due to ground failure rather than fault rupture. Thus, based on our observations and the information from the local residents, the team concludes that the EPGFZ did not rupture at the surface where it extends onshore from Petit Goâve Bay.

**Figure 4.8.** View west of prominent parallel west-southwest trending fault traces along south-facing slope of hills west of Petit Goâve Bay and Port Royal. Reconnaissance track marked in blue shows location of fault traverses west of Port Royal. Fault trace marked by push-pins labeled “EPG flt”.

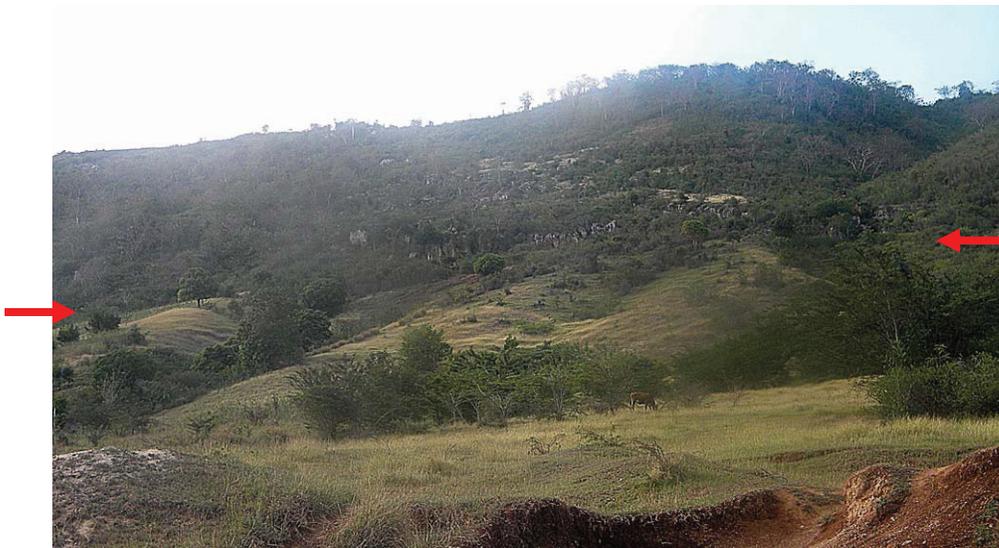
**Figure 4.10.** View north across fault (at upper break in slope) west of Port Royal. Side-hill bench and blocked drainages at center of photograph (between red arrows) (N18.439666, W72.916444).

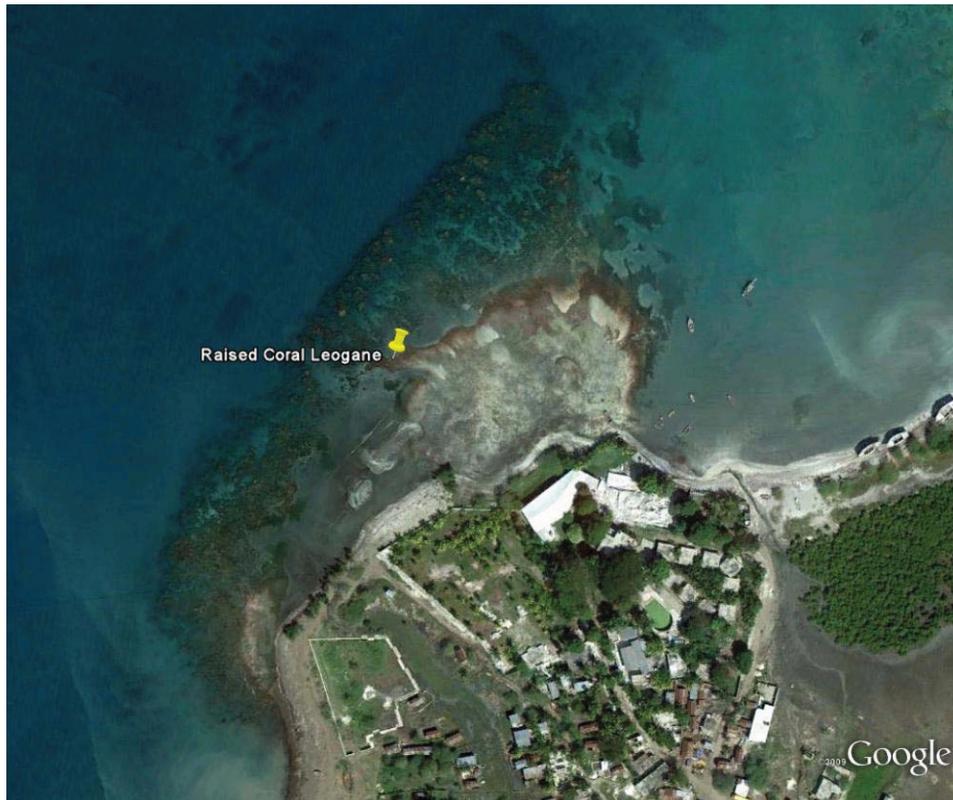
Interpretation of aerial imagery and reports from Haitians in the coastal area of Léogâne indicated that several areas along the coast were uplifted as a result of the 12 January earthquake. The GEER team traveled to the Ca Ira area west of Léogâne on 1 February to observe one area where coastal uplift had been observed. At this site, the team observed an area of exposed coral and subtidal Turtle grass extending for more than 100 m seaward from the shoreline (Figure 4.12). Key observations from this area are as follows.

**Figure 4.12** Aerial view of coastal uplift in Ca Ira, near Legwane.  
(See GEER Haiti Report.kmz for location)

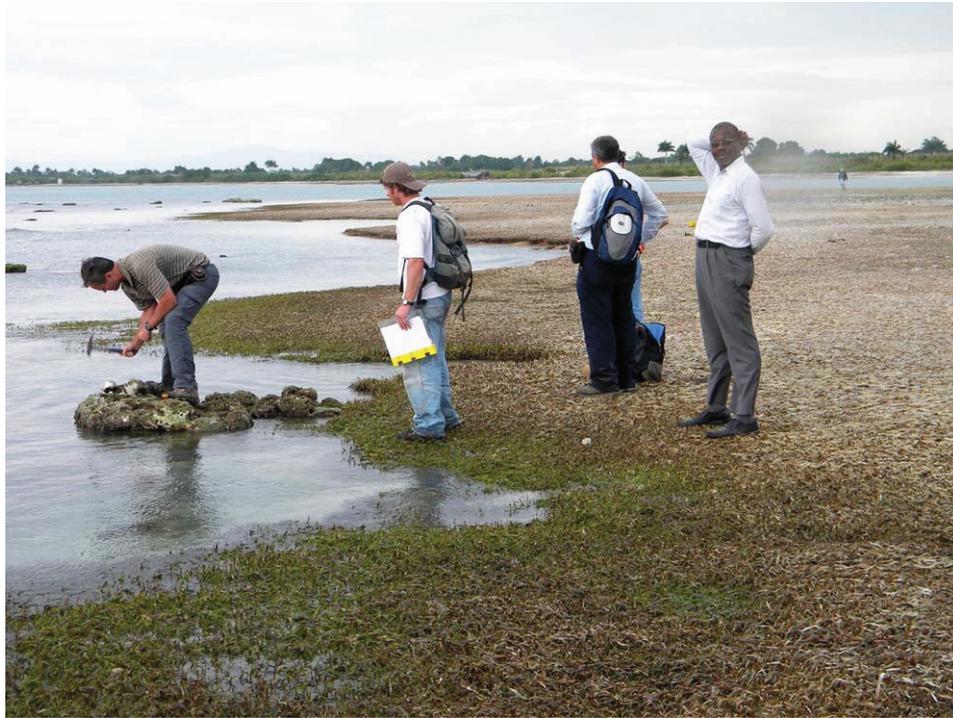
Turtle grass is a subtidal plant, and apparently does not grow in areas exposed at low tide. As observed during our reconnaissance, an extensive area of this grass was exposed above the water level (which was at or close to low tide during our reconnaissance). Much of the exposed grass was brown and appeared to be dying as a result of exposure to air/direct sunlight (Figure 4.13). The length of the grasses was about 10 cm, possibly indicating the minimum submergence depth at low tide prior to the 12 January earthquake.

**Figure 4.13.** Reconnaissance team inspecting exposed grass and coral at Ca Ira, Léogâne. An extensive area of mud flats, grasses, and coral was exposed at low tide. (18.525333°N, 72.652008°W).

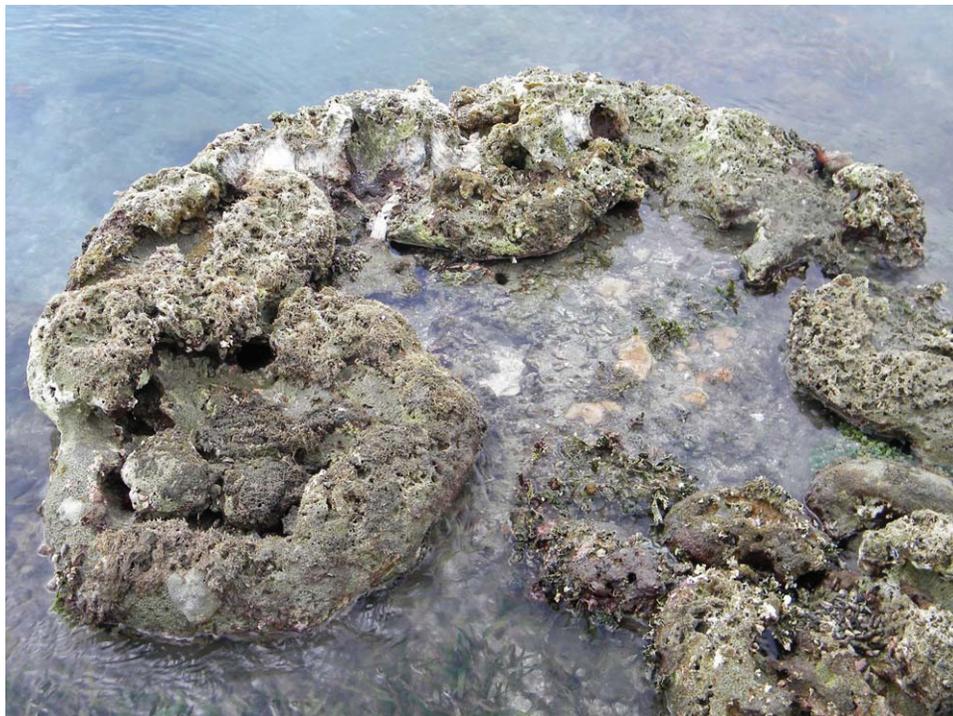
The coral reef exposed at low tide consisted of largely dead coral heads (Figure 4.14), with small areas of new living coral at the top of the heads (Figure 4.15). The outer coral head is dead, which appears to indicate that uplift occurred previously at this site, followed by submergence and growth of new coral. The minimum subtidal depth at which coral grows is dependent on the specific coral species and other factors, but may be on the order of several tens of centimeters.

**Figure 4.14** Coral head (~1.0 m diameter) with living coral at center exposed at low tide at Ca Ira, Léogâne (N18.525333, W72.652008).

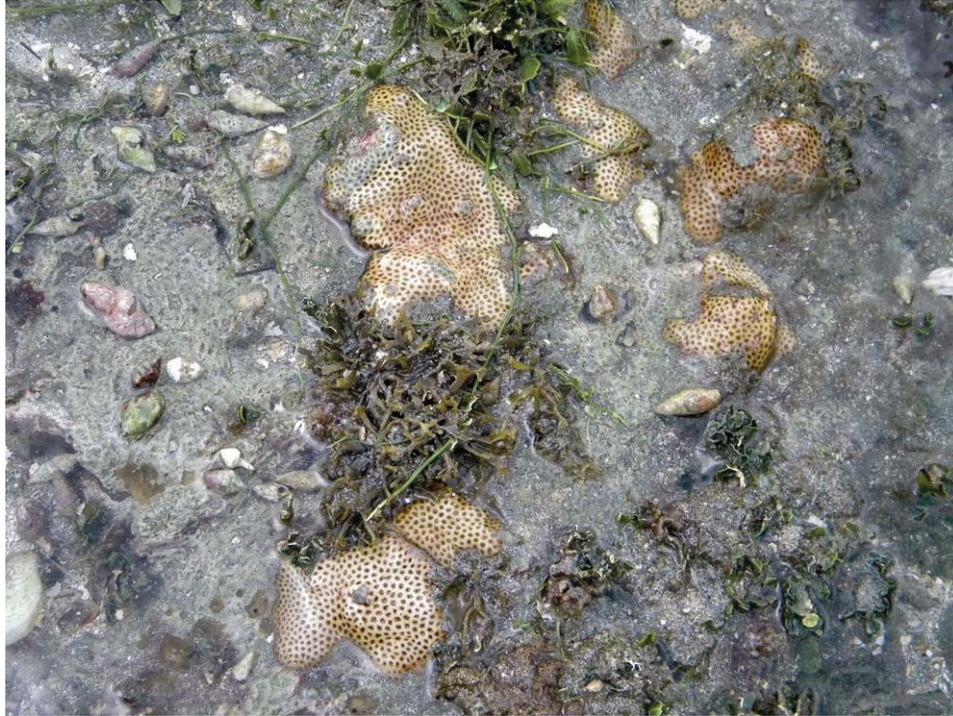
**Figure 4.15** Living coral in coral head exposed at low tide at Ca Ira, Léogâne. (N18.525333, W72.652008)

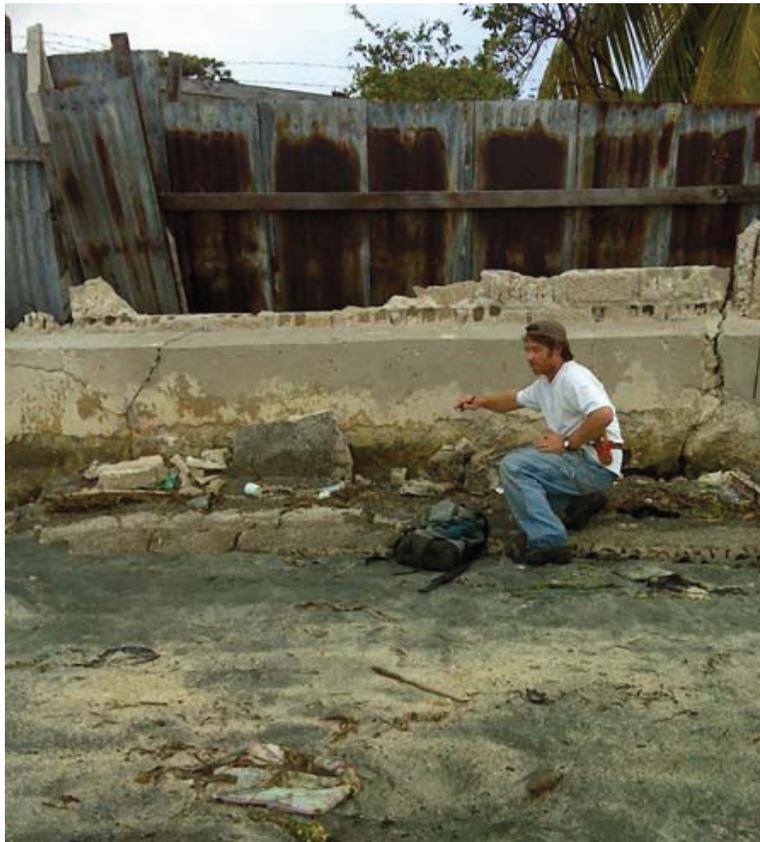
Local villagers indicated that the grasses and mud flats were not exposed at low tides prior to the 12 January earthquake, and that the high tides no longer extended to the sea wall as indicated by the water marks on these walls (Figure 4.16). The current tide chart for Port-au-Prince indicates the tidal range typically is about 0.4 to 0.6 m.

The estimated uplift resulting from 12 January earthquake is on the order of 50 centimeters based on elevational differences between pre-event high tide marks on a seawall (interpretation by Rich Briggs), tidal records for the date and time of the field visit, elevation of current high tide debris strandline, presence of living coral exposed in the coral head above the water (Figure 4.17), the height (length) of the exposed grasses, and reports on water level/tidal changes by local villagers.

**Figure 4.16.** Water mark for high tides on sea wall at Ca Ira, Léogâne. Residents indicate high tides no longer extend up the wall to the former high tide level (N18.524924, W72.650871)

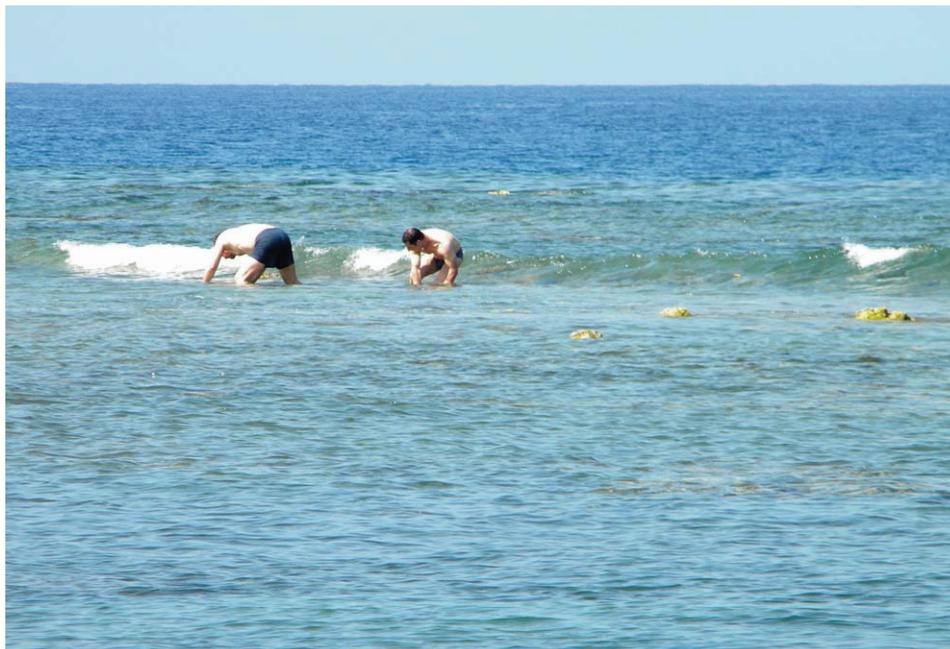
**Figure 4.19** GEER team members inspecting uplifted coral reef near L'acul Coral heads are exposed above water at right, approximately one hour prior to high tide. (N18.446463, W72.688354).

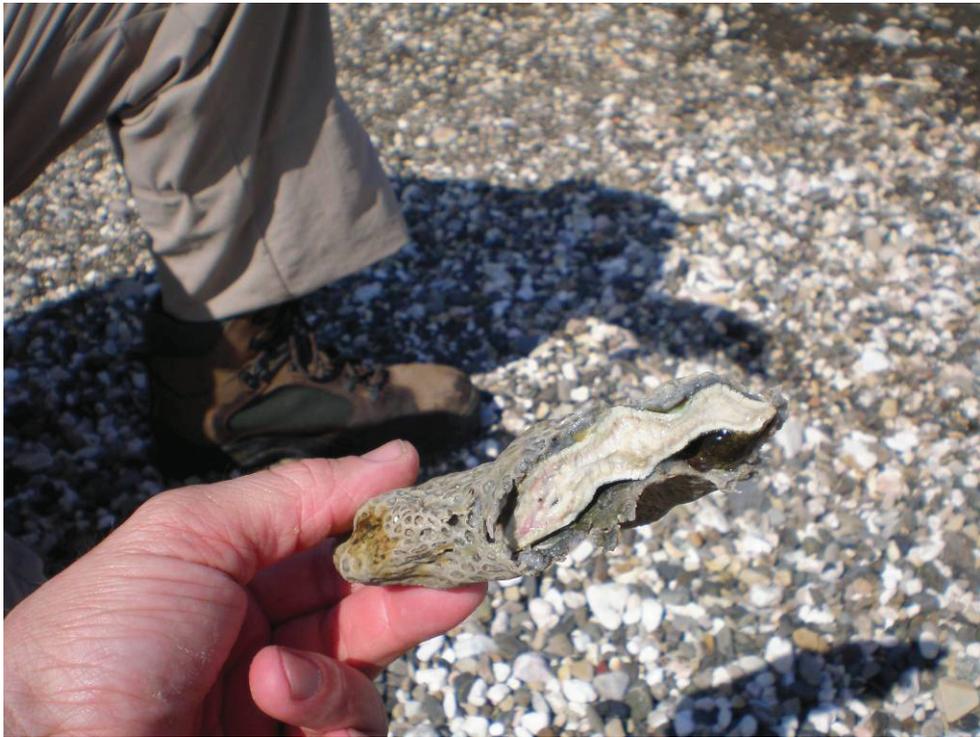
**Figure 4.20** Fleshy living, or recently living, coral collected from the top of a coral spire projecting about 3 to 5 cm above water level at the time of the GEER field visit. (N18.446463, W72.688354)

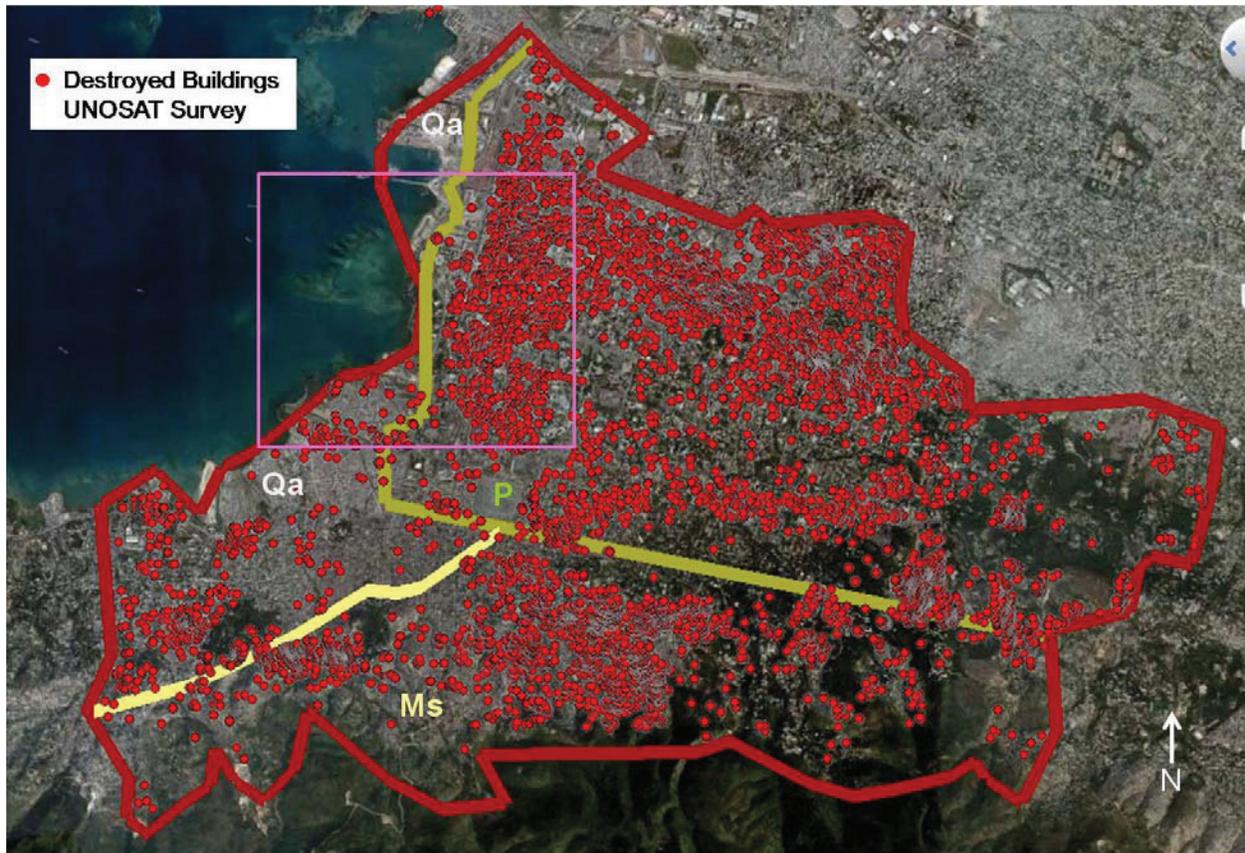
Figure 5.6 shows the buildings categorized as Destroyed in the UNOSAT survey relative to the Quaternary (Qa), Pliocene (P) and Miocene (Ms) deposits discussed in Section 5.2. It is evident from this broad view that many buildings were destroyed in each of these three deposits (however, recall that the geologic boundaries are somewhat uncertain). However, the picture is skewed somewhat because only the Destroyed buildings are shown (approximately 10,000 points). When one zooms in on the damage, certain patterns begin to emerge. The following discussion will focus on the area boxed in pink in Figure 5.6.

**Figure 5.6** Buildings classified as Destroyed in the UNOSAT survey relative to the three geologic units (Quaternary = Qa, Pliocene = P and Miocene = Ms) underlying the survey area. Note that the destroyed buildings shown in this figure only represent about 10% of the more than 90,000 total buildings categorized in the UNOSAT survey (refer to the text for more detail).

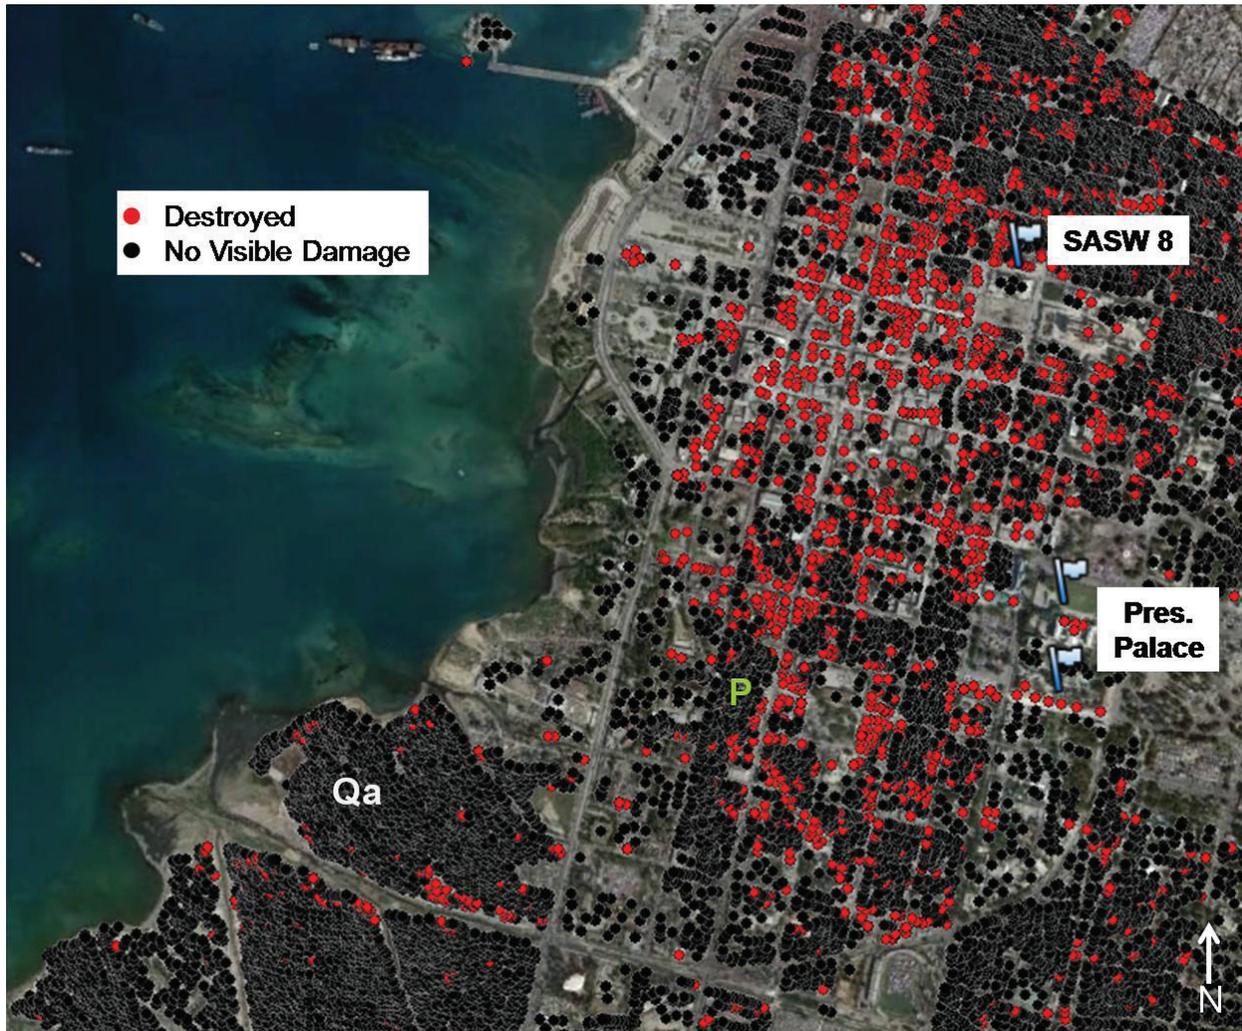
One intensely damaged zone noticed on the GEER reconnaissance was an area located due west and north of the Presidential Palace. This area is boxed in pink in Figure 5.6 and shown in Figure 5.7 along with the buildings that were categorized as either Destroyed (red dots) or No Visible Damage (black dots) in the UNOSAT survey. Also shown are three flag markers where Spectral Analysis of Surface Waves (SASW) testing was performed to investigate the near-surface soil layering and stiffness in the area. It is clear that nearly every building on some of these blocks was completely destroyed (particularly just west and south of SASW 8). However, it is also clear that other areas nearby (e.g. the extreme left-hand bottom corner of Figure 5.7) had very few destroyed buildings. Interestingly, according to the published geologic map, the heavily damaged area lies on Pliocene deposits, while the lightly damaged area lies on younger (presumably softer) Quaternary deposits. However, the revised interpretation of the Quaternary/Pliocene contact (see Section 5.2) would place both of these areas within Quaternary alluvium. One reason for these differences in damage may be building type. Most of the buildings in the heavily damaged zone were larger, multi-story, reinforced concrete structures, while most of the buildings in the lightly damaged area were smaller, densely packed Shanty's with tin roofs (note the difference in density of black dots in the two areas). Several pictures of the type of structures and damage encountered in the heavily damaged zone near SASW 8 are shown in Figure 5.8.

**Figure 5.7** Buildings classified as No Visible Damage and Destroyed in the UNOSAT survey for the boxed area specified in Figure 5.6. Notice the heavily damaged zone lying on P deposits to the north and west of the Presidential Palace and the lightly damaged zone lying on Qa deposits in the lower left-hand corner. Most of the buildings in the heavily damaged zone were larger, multi-story, reinforced concrete structures, while most of the buildings in the lightly damaged area were smaller, densely spaced Shanty's with tin roofs (refer to the text for more detail).

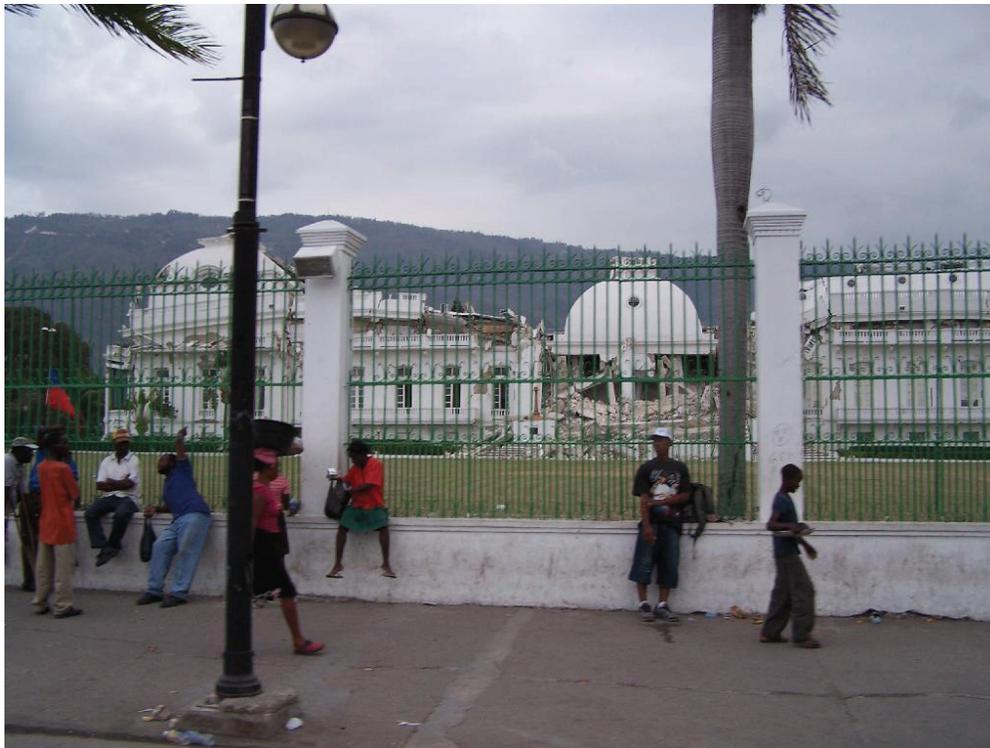
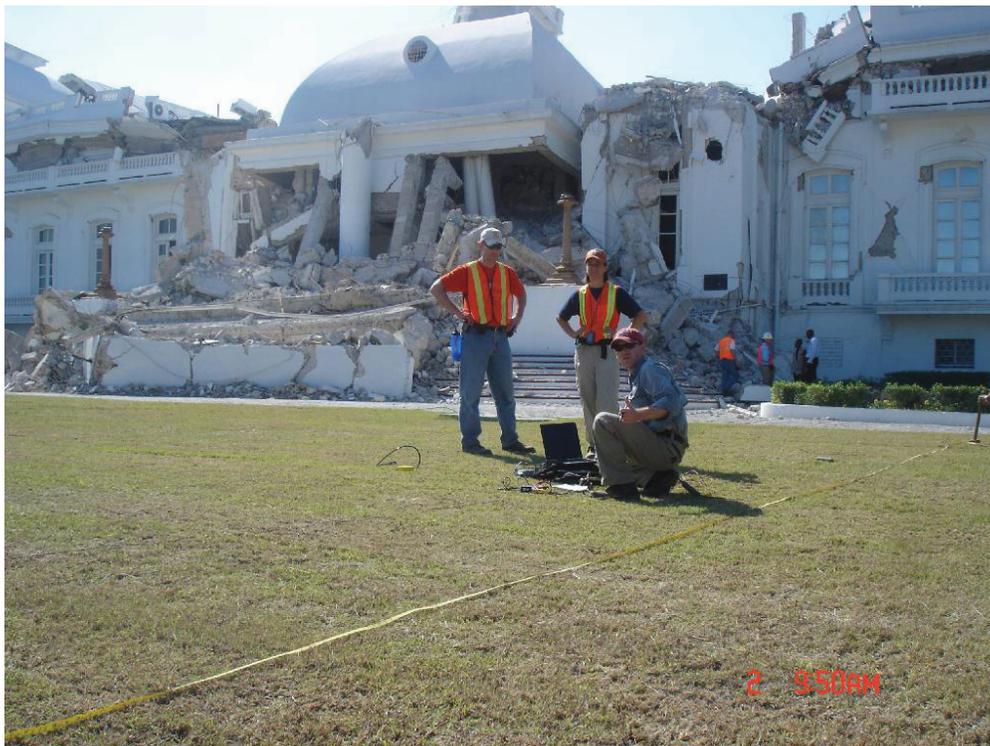
The Presidential Palace also lies on the eastern edge of this heavily damaged zone. The damage to the Presidential Palace (Figure 5.9) was documented by many news crews covering the aftermath of the earthquake due to its symbolism for the widespread, devastating destruction throughout the city. The GEER team conducted two SASW tests (SASW 6 and SASW 7) and one H/V Spectral Ratio test on the grounds of the Presidential Palace. These results have not been fully processed yet, but will be made available as soon as they are complete.

**Figure 5.9** The Presidential Palace lies within the heavily damaged zone noted above. Two SASW tests and one H/V Spectral Ratio test were conducted here (N 18.543633°, W - 72.338905°).

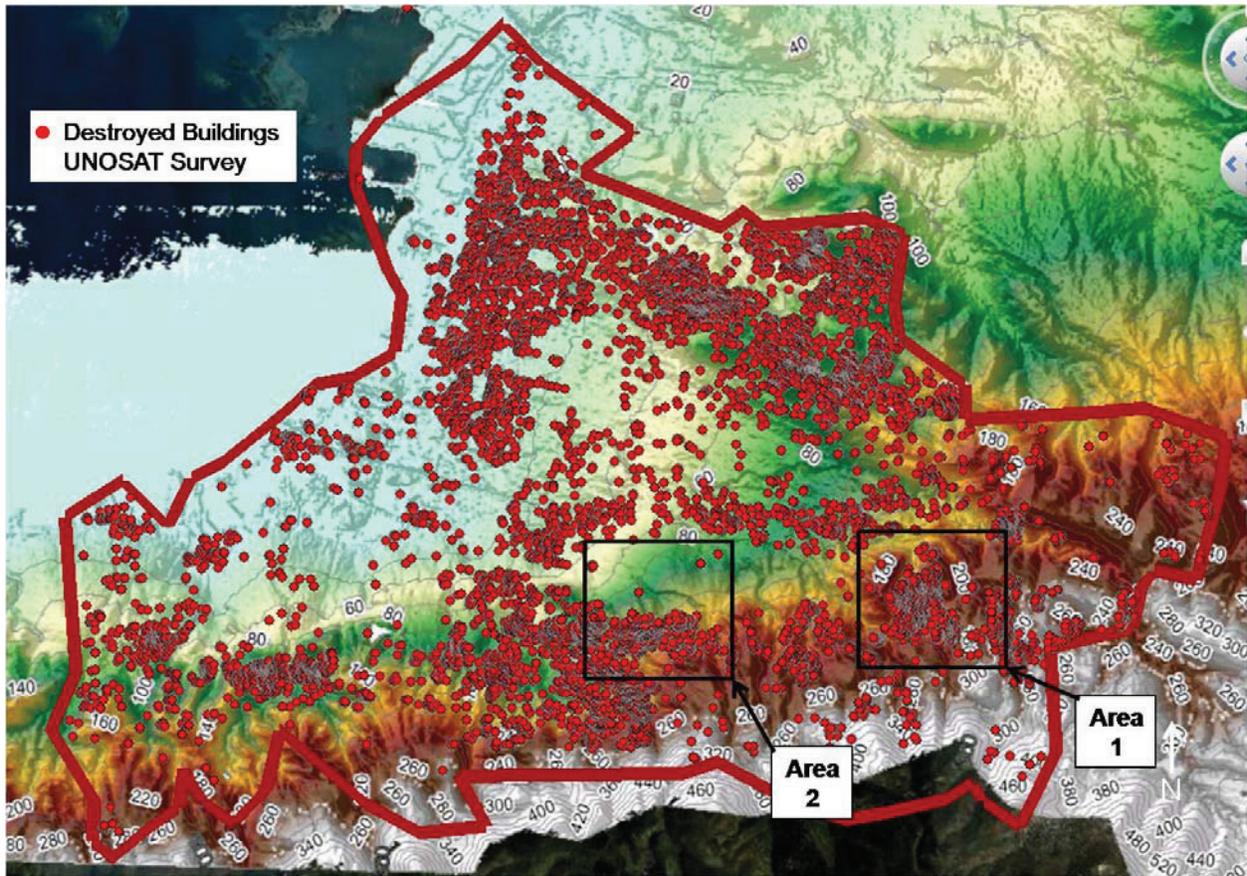
Figure 5.10 shows the buildings categorized as Destroyed in the UNOSAT survey relative to a color-shaded topographic map of the Port-au-Prince area. These 20-m, color-shaded contours were generated by personnel from CAST using LiDAR data processed by Chris Crosby at OpenTopography ([http://opentopo.sdsc.edu/files/Haiti/WorldBank\\_Haiti\\_lidar\\_hs\\_v1.kmz](http://opentopo.sdsc.edu/files/Haiti/WorldBank_Haiti_lidar_hs_v1.kmz)). As was the case with the varied geologic deposits shown in Figure 5.6, it is evident that many buildings were destroyed in all types of topography. However, when one zooms in on the damage, certain patterns begin to emerge. The following discussion will focus on the two areas labeled in Figure 5.10.

**Figure 5.10** Buildings classified as Destroyed in the UNOSAT survey relative to topography in the Port-au-Prince area. Note that the destroyed buildings shown in this figure only represent about 10% of the more than 90,000 total buildings categorized in the UNOSAT survey (refer to the text for more detail).

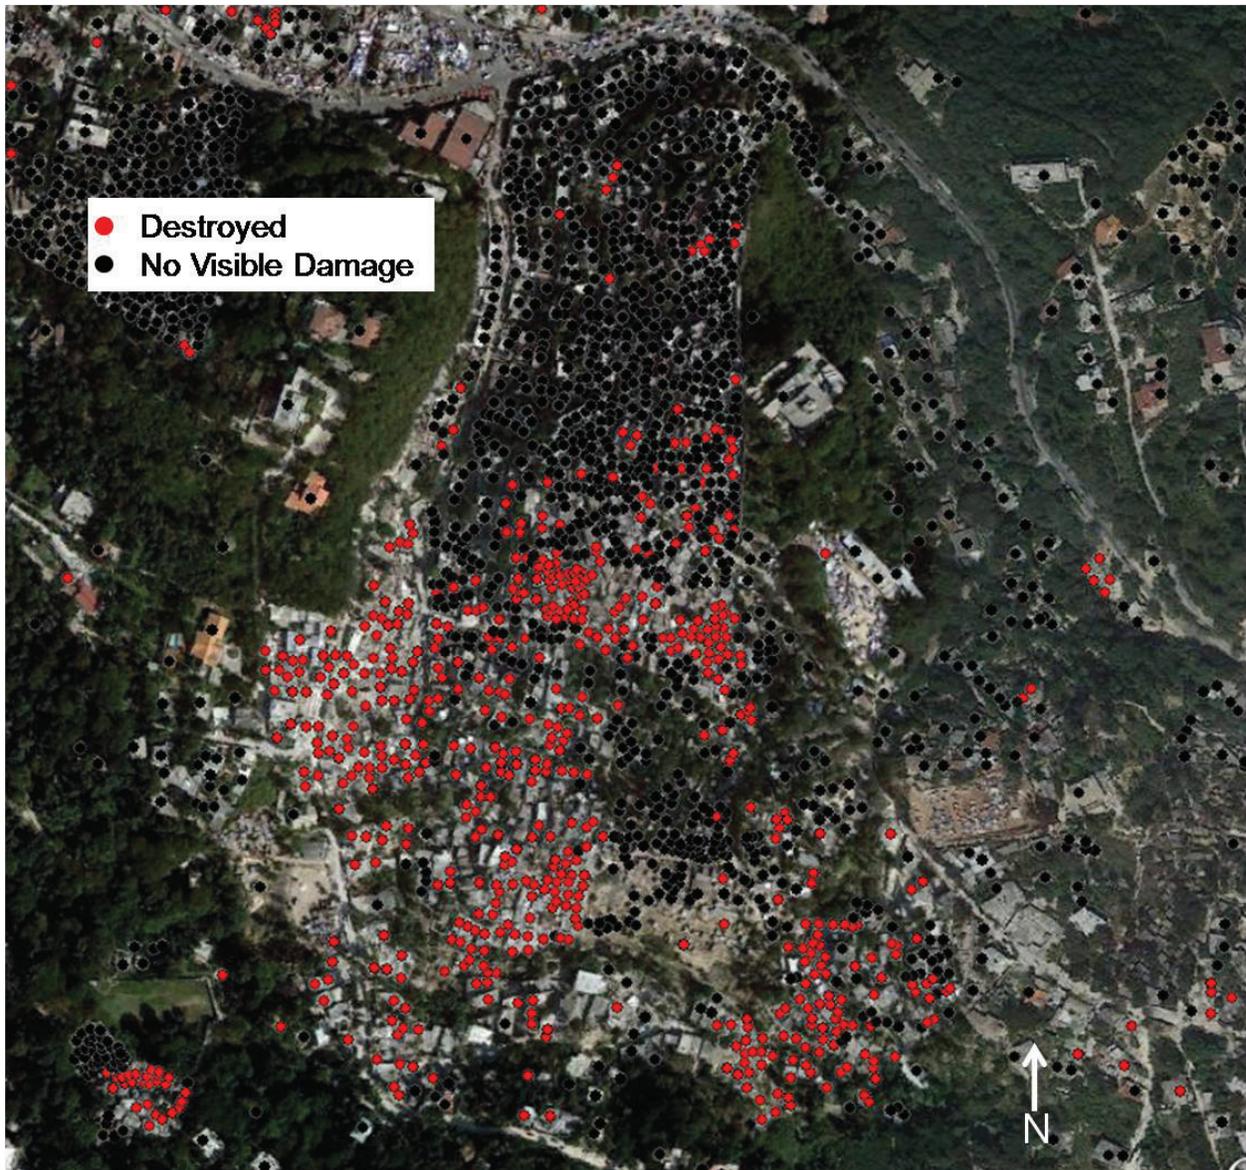
One interesting area lying on steep topography is shown in Figure 5.11 along with the buildings that were categorized as either Destroyed (red dots) or No Visible Damage (black dots) in the UNOSAT survey. This zone is labeled as Area 1 in Figure 5.10. There is almost a distinct line that could be drawn from east-to-west that separates heavy damage to the south from almost no visible damage to the north. When one zooms in on this area there appears to be no significant difference in the type of structures. All of them appear to be densely packed Shanty-type buildings. It is possible that the steepness of the slope affected this pattern, but no conclusive evidence is known at this time.

**Figure 5.11** Buildings classified as No Visible Damage and Destroyed in the UNOSAT survey for the boxed area labeled as Area 1 in Figure 5.10. Notice the clear north-south separation between no visible damage and destroyed buildings that bisects the ridgeline east-to-west. All of these buildings appear to be Shanty-type structures with similar construction (refer to the text for more detail).

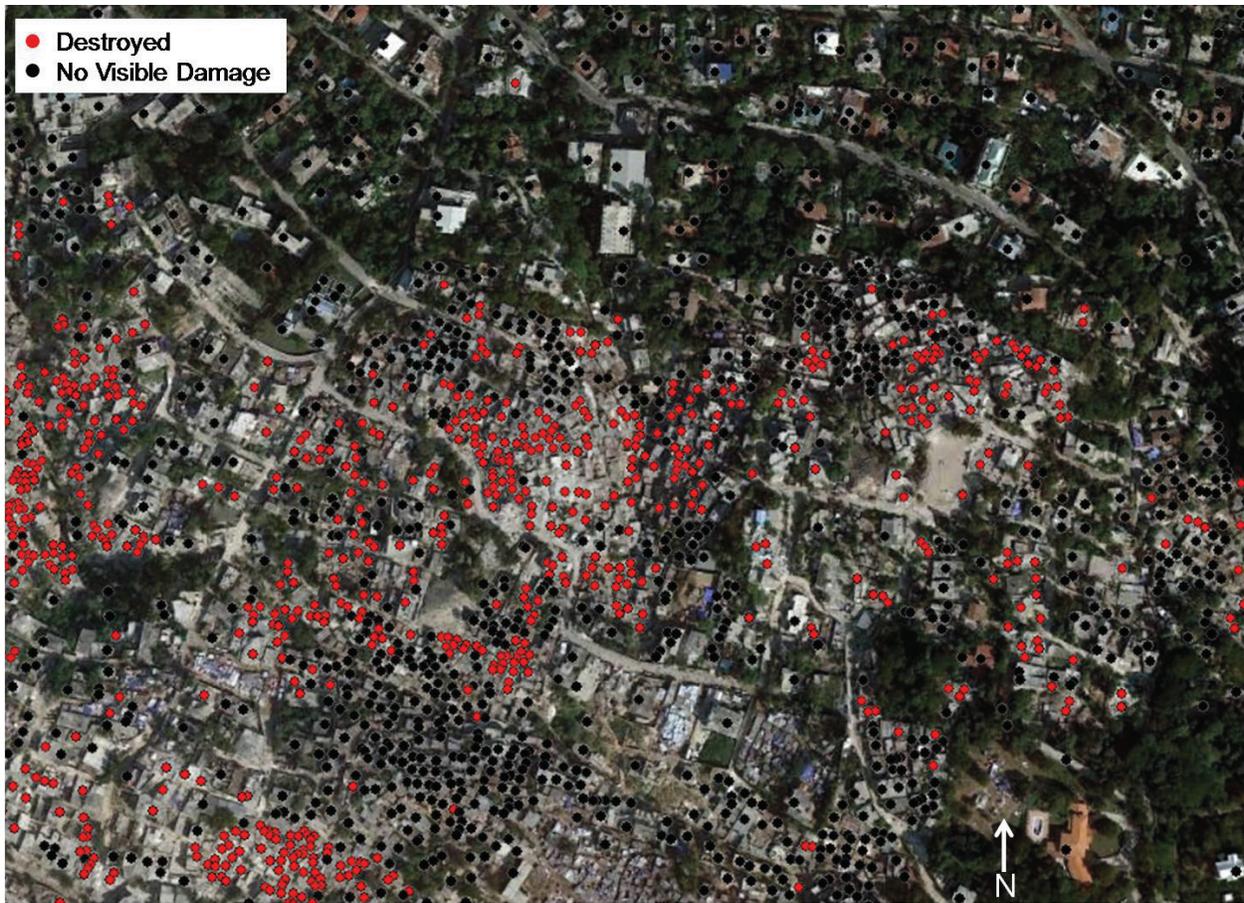
Another interesting area lying on a transition from moderate to steep topography is shown in Figure 5.12. This zone is labeled as Area 2 in Figure 5.10. Once again, there is almost a distinct line that can be drawn from east-to-west that separates heavy damage to the south from no visible damage to the north. However, in this case there is both a distinct difference in the type of structure (and likely quality of construction) and type of topography. The structures to the north are larger buildings that appear to be nice homes (some with swimming pools). They are also constructed on more gradual topography. Very few of these homes were damaged. The structures to the south are Shanty-type structures, and the ones that are damaged most severely are located near the top of the hillsides/ridges. This could be evidence of ridge-top focusing of seismic energy. Conversely, the line of Shanty's where no visible damage is noted (bottom center of Figure 5.12) are constructed in a valley.

**Figure 5.12:** Buildings classified as No Visible Damage and Destroyed in the UNOSAT survey for the boxed area labeled as “Area for Fig. 10” in Figure 3.8. Notice the clear north-south separation between no visible damage and destroyed buildings that bisects this area from east-to-west. The undamaged buildings to the north are larger homes that appear to be well constructed. Furthermore, they also sit on more moderate topography. The destroyed buildings appear to be Shanty-type structures that sit near the top of the hillsides/ridges (refer to the text for more detail).
