# GEOTECHNICAL ENGINEERING RECONNAISSANCE OF THE 2010 HAITI EARTHQUAKE

Version 1: February 22, 2010

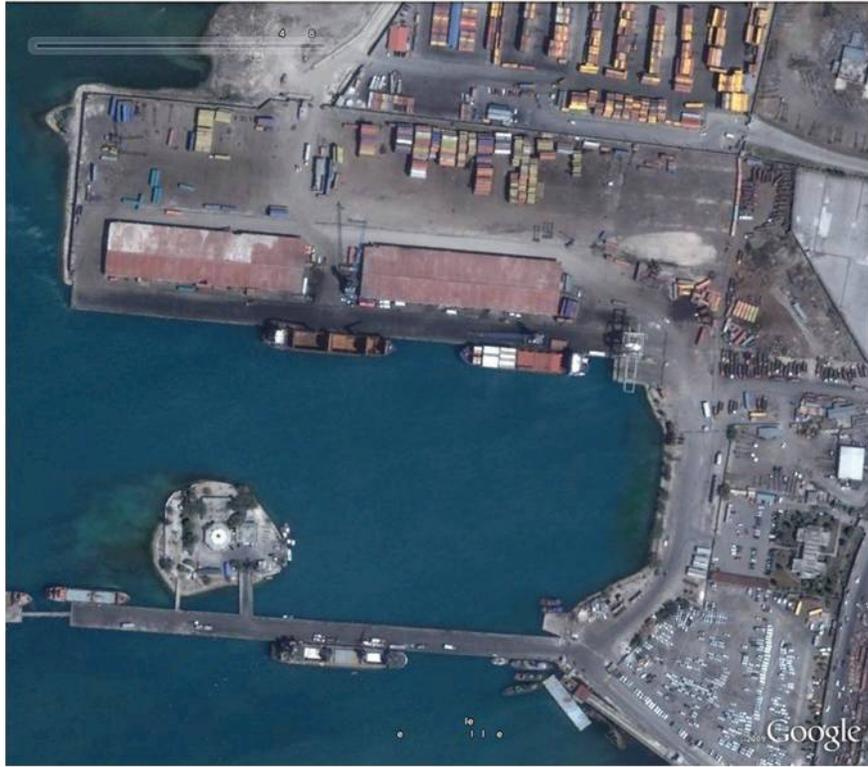
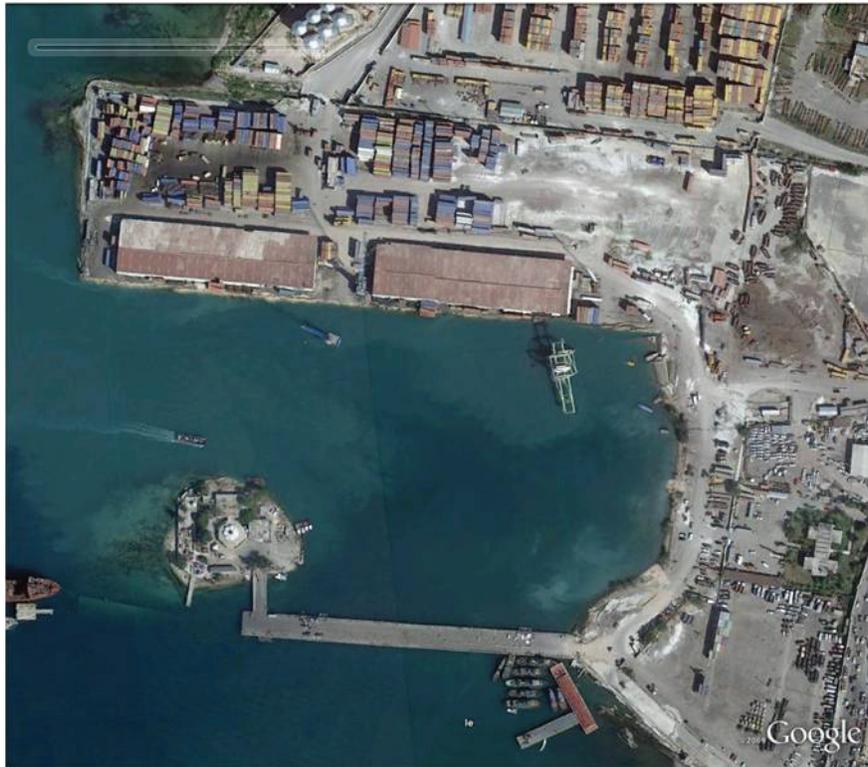
Pre- and post-earthquake aerial images of the port are shown in Figure 6.2, and these images clearly show evidence of liquefaction and lateral spreading, failure of the North Wharf, and collapse of portions of the South Pier. The photo of the port shown in Figure 6.3 (unknown photographer) is circa 1962, and shows one long pier that extends from the main coastal road. This pier is located along the southern margin of the current port (Figure 6.4), which suggests that the present port facility is constructed on fill, likely un-engineered and of unknown origin. Also, from field reconnaissance, it is clear that the fill material extends to the North (to the left and out of view of the photo shown in Figure 6.3), demarcated by dashed lines in Figure 6.4. The port suffered extensive damage during the earthquake (Figure 6.5), inhibiting the delivery of relief supplies to areas affected by the earthquake. Light-colored areas on the ground surface in Figure 6.4 are sand boils/ejecta and can be seen in the eastern half of the container storage yard and behind and between the two warehouses. The locations where large lateral spreading fissures were observed are also shown in Figure 6.5.

**Figure 6.2** Pre- and post-earthquake satellite/aerial imagery (top and bottom, respectively) of the port at Port-au-Prince, Haiti (N18.555058°, W72.351144°). Imagery courtesy of Google Earth.

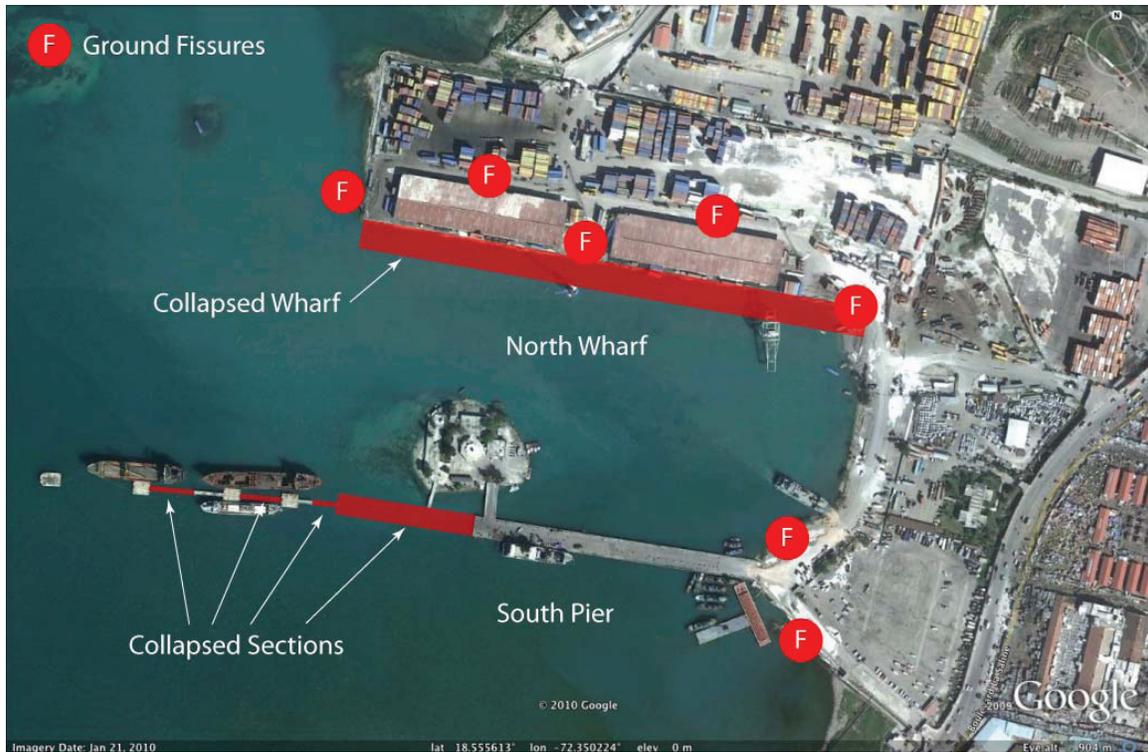
**Figure 6.5** Annotated aerial image of Port de Port-au-Prince showing locations of damage due to the earthquake. Imagery courtesy of Google Earth. (N18.555058°, W72.351144°)

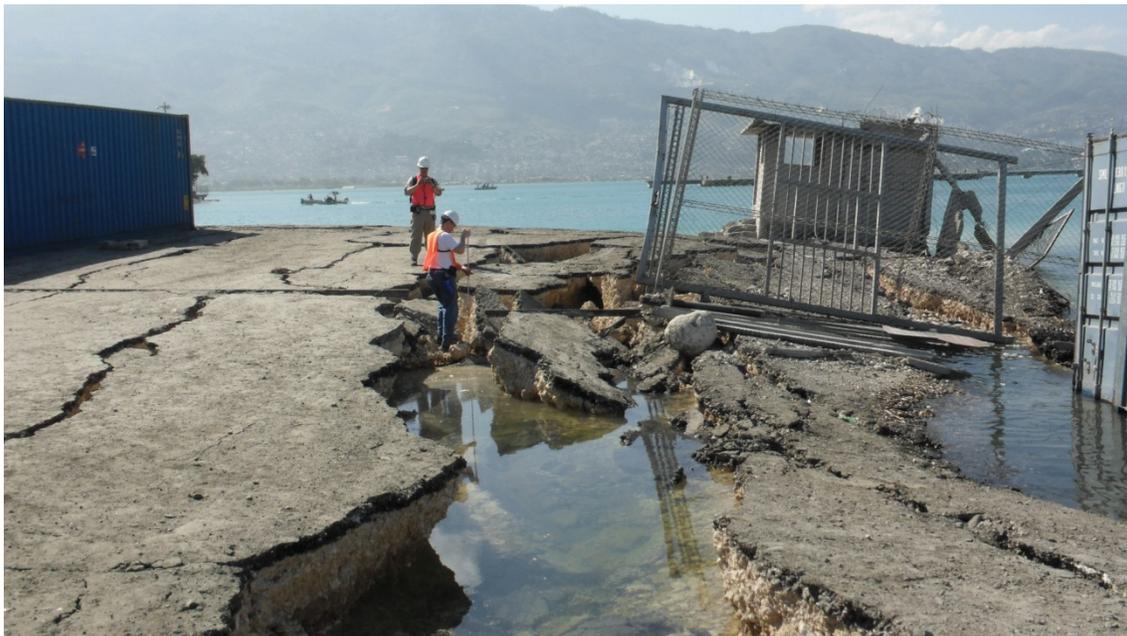
**Figure 6.9** Lateral spreading west of the two metal warehouses. Photo taken facing south with the metal warehouses to the left. (N18.557075, W72.352045)

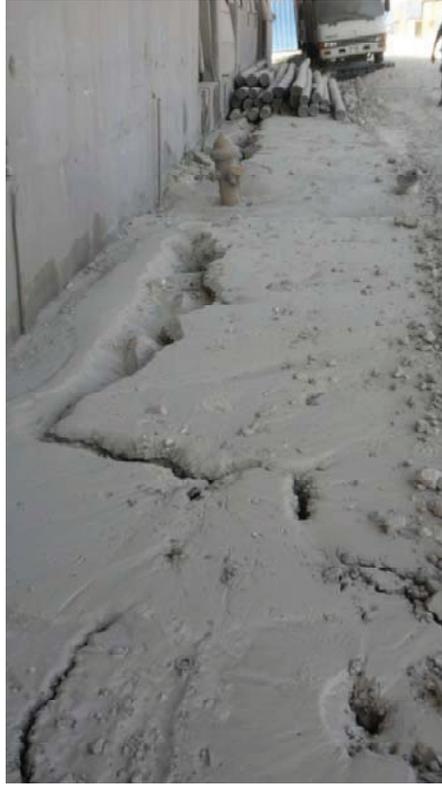
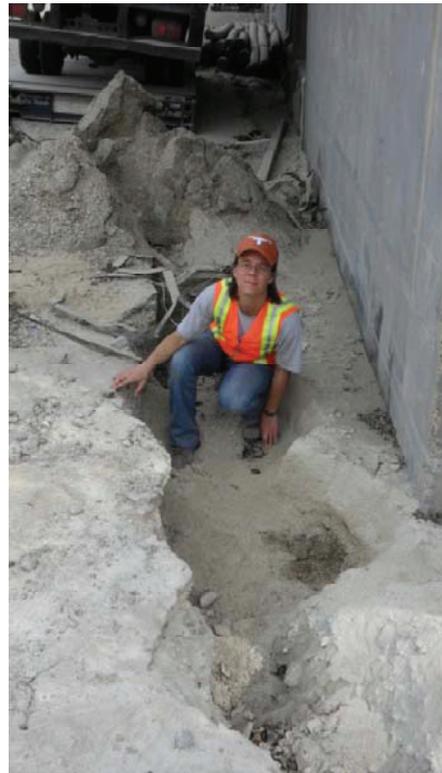
**Figure 6.10** Liquefaction and lateral spreading adjacent to the north side of the metal warehouses. Photo on top taken facing west, photo on bottom taken facing east. (N18.556961, W72.349751)

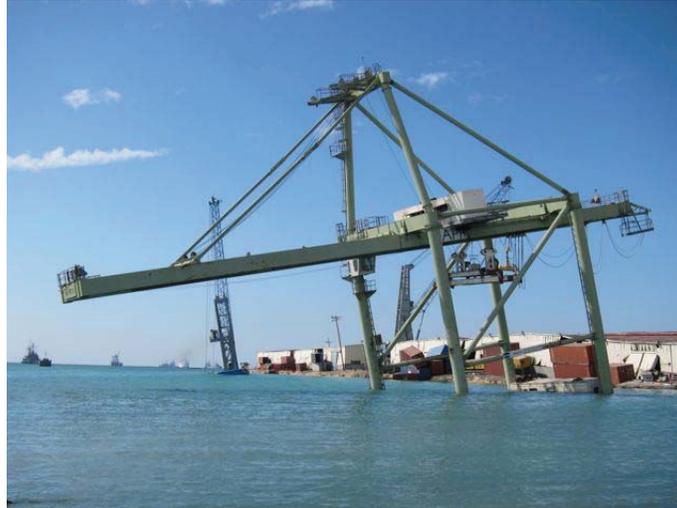
Two of the three cranes were apparently on the North Wharf at the time of the earthquake and are now partially submerged. Figure 6.12 shows the A-frame container crane in the foreground and a submerged mobile crane in the background. There was no obvious structural damage to the container crane. Interestingly, a photo taken by an unknown photographer (apparently aboard a ship docked at the eastern end of the wharf) immediately after the earthquake (Figure 6.13) shows that the landside legs of the A-frame crane were still above water, with the crane in its most eastwardly position. However, a U.S. Coast Guard photo taken during an overflight of the port at mid-day on January 13, 2010 shows the crane in the same position as in Figure 6.12 (i.e., moved westward about 60 m from its position in Figure 6.13) and with the base of the crane fully submerged. Also, the January 13 photo shows that additional subsidence occurred at the eastern end of North Wharf (i.e., the location of the crane in Figure 6.12). The National Earthquake Information Center reports no fewer than 45 aftershocks ranging from  $M_w$  4.0 to 6.0 following the main shock until 1:54 pm EST on January 13, 2010. This raises the likelihood that a portion of the observed permanent displacements caused by liquefaction occurred as a result of aftershocks. The second mobile crane was parked between the two warehouses and appears to be undamaged.

**Figure 6.12** Submerged 15-m gauge container crane (foreground) and mobile crane (background). Photo taken facing west. (N18.55598, W72.348564)

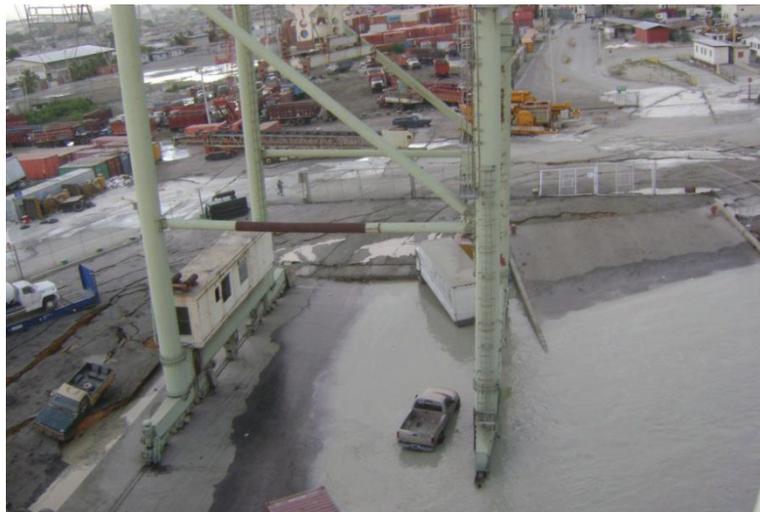
**Figure 6.13** Photo taken immediately after the earthquake with the crane in its most eastward position and with the landside legs of the crane above water. Photo taken facing east. Source: unknown (N 18.556056, W72.347981)

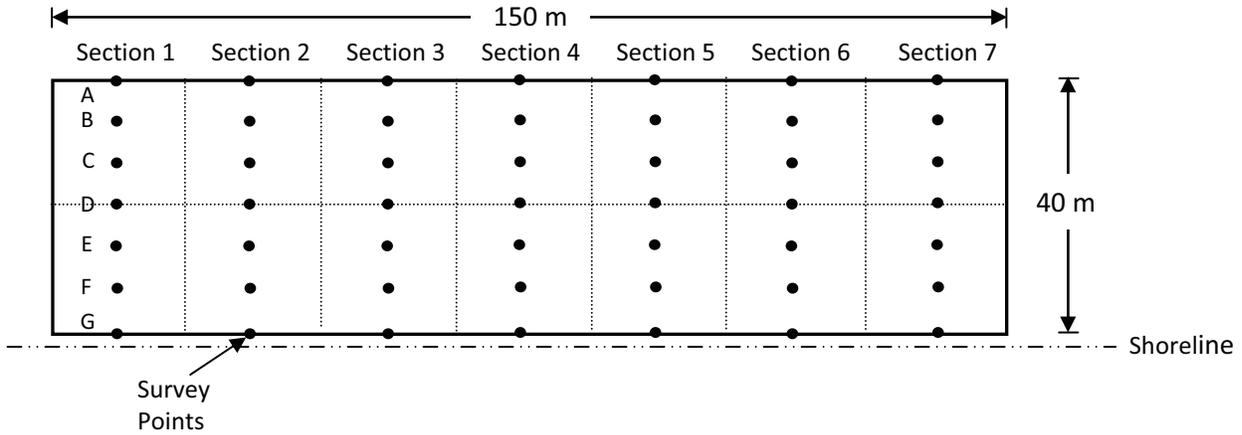
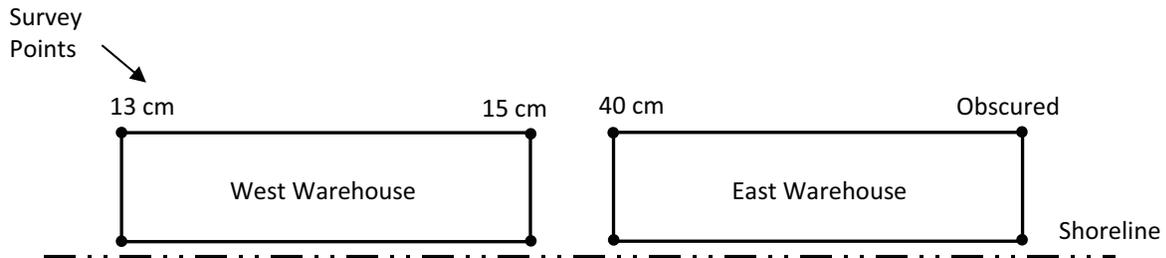
The warehouses suffered severe damage as a result of the lateral spreading and settlement, and will likely have to be torn down. As shown in Figure 6.11, lateral spreading cracks running in the East-West direction cut through each warehouse foundation wall. A detailed survey of the relative elevations and lateral movements of the west warehouse slab is shown in Figure 6.14. The interior slab consisted of 14 separate slabs, two abreast and seven long. Due to lateral spreading, the south wall (adjacent to the shoreline) moved approximately 0.7 to 1.4 m laterally towards the shoreline (i.e., the width of the warehouses increased). The relative elevations across the slab are more difficult to interpret because it was clear that the slab was constructed with a significant slope and/or curvature towards the seaward edge. Without knowledge of the relative elevation differences before the earthquake, these movements cannot be converted to relative settlements due to liquefaction. Nonetheless, the relative elevations across the interior were variable, with the some areas almost 1 m lower than others. It appeared that the

warehouses were founded on strip footings around their perimeters, which settled significantly. Settlements measured at the inland corners of the warehouses are also shown in Figure 6.14. The west warehouse appears to have settled approximately 15 cm relative to the ground surface, while the east warehouse settled more than 40 cm

**Figure 6.14** Results of a detailed survey of the relative settlements of the west warehouse slab, and the total settlements at the inland corners of the warehouses

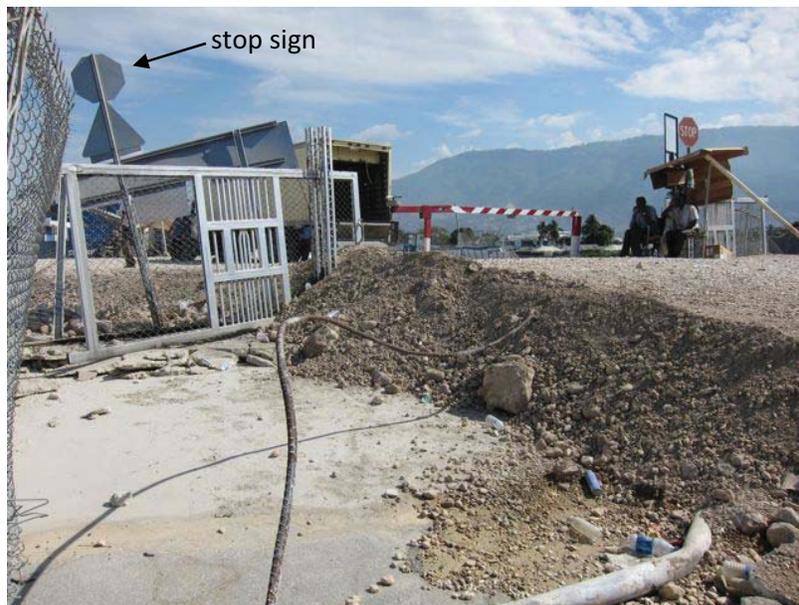
In addition to the damage to the piles supporting the South Pier, the abutment also experienced liquefaction-induced lateral and vertical displacements. Approximately 1 m of fill was required to re-level the approach to the pier as shown in Figure 6.15. Also, the piles supporting the small pedestrian bridge connecting the South Pier to the island could be readily observed. Figure 6.16 shows the damage to these piles, including the extensive damage to the landward row of piles.

**Figure 6.15** Approach to the South Pier immediately after the earthquake (top photo: Source unknown; photo taken facing South-East) and after approximately 1 m of fill was placed (bottom photo: photo taken facing West). (N18.554028, W72.348658)

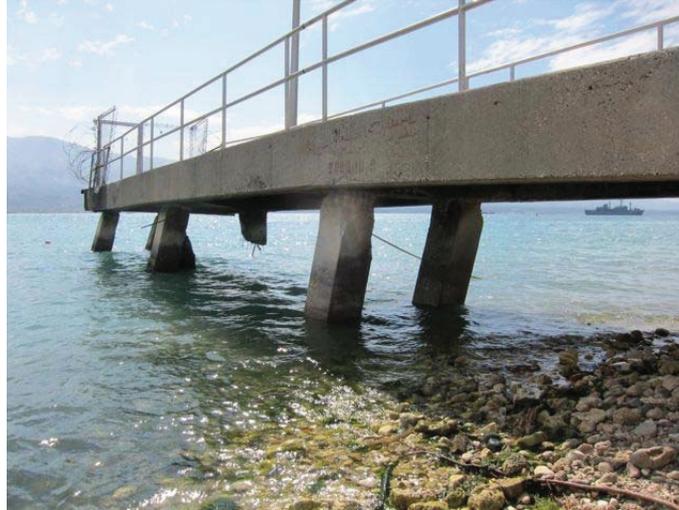
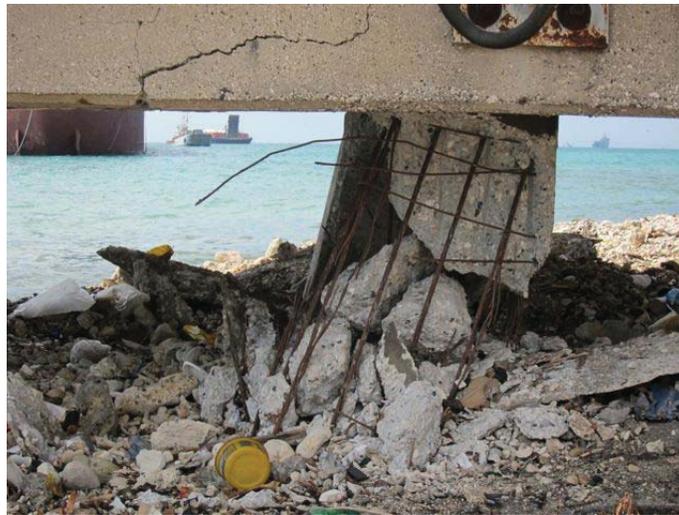
**Figure 6.16:** (top) Damage to piles supporting the pedestrian bridge connecting the South Pier to the island (photo taken facing South) and (bottom) extensive damage to the landward row of piles (photo taken facing West) (N18.554628, W72.351492)

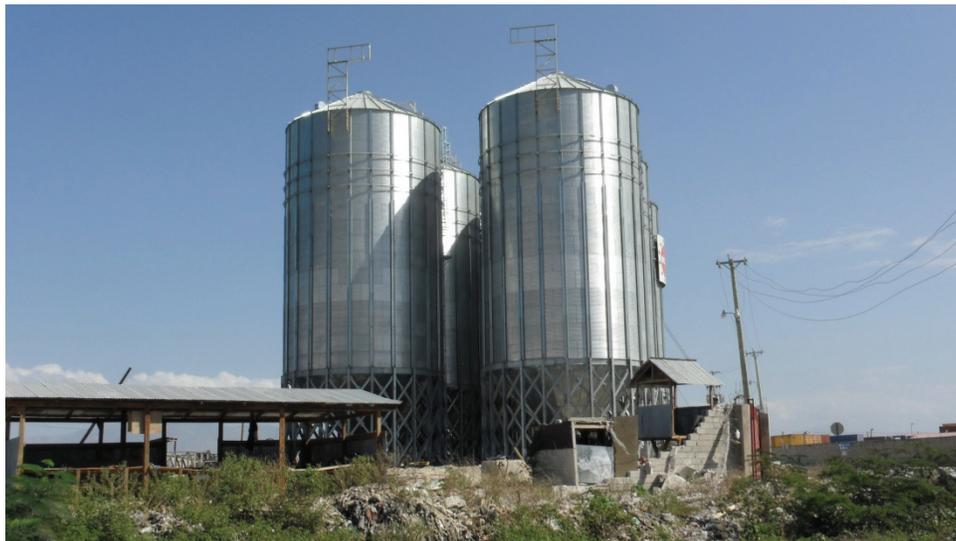
**Figure 6.19** Post-earthquake photo of steel grain hopper silos (photo taken facing North). The silos showed no visible signs of distress. (N18.558431, W72.350350)

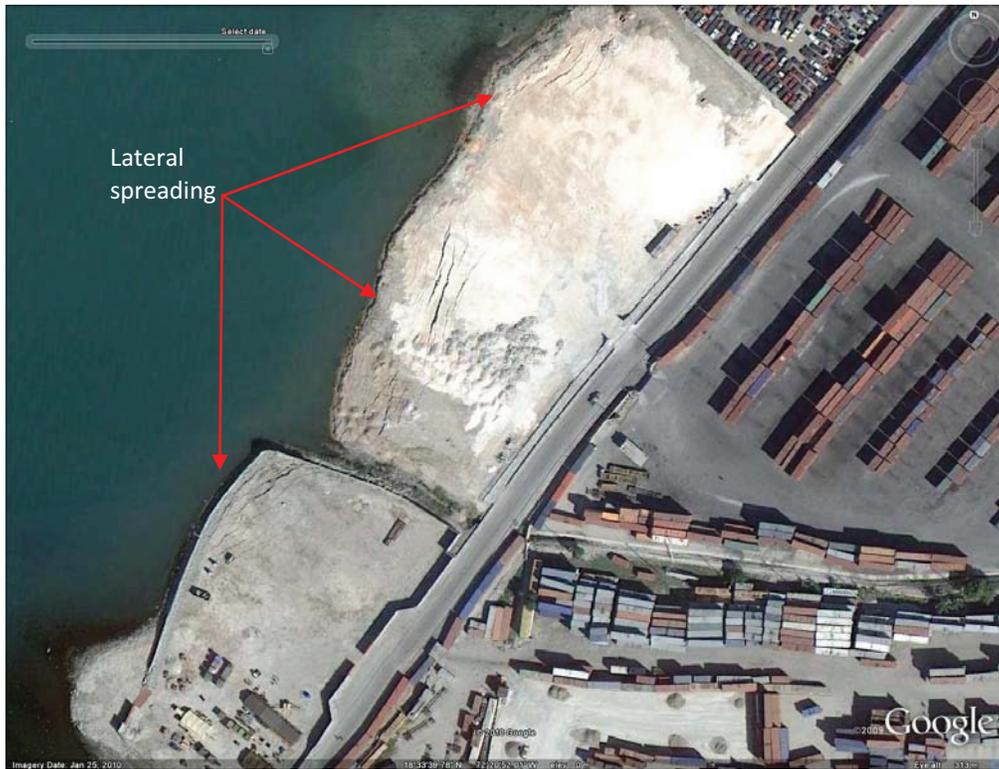
**Figure 6.20** Lateral spreading in the storage yards in the northern part of the port facility. Imagery courtesy of Google Earth. ( $18^{\circ}33'40.23''\text{N}$   $72^{\circ}20'52.33''\text{W}$ )

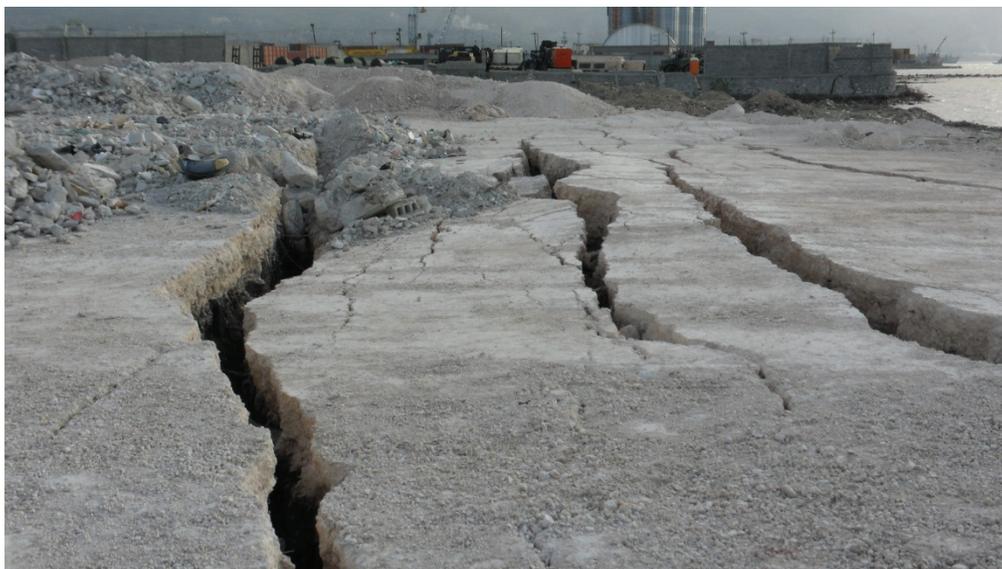
**Figure 6.21** Lateral spreading in the storage yards in the northern part of the port facility. Photo taken facing South. ( $18^{\circ}33'41.39''\text{N}$   $72^{\circ}20'52.51''\text{W}$ )

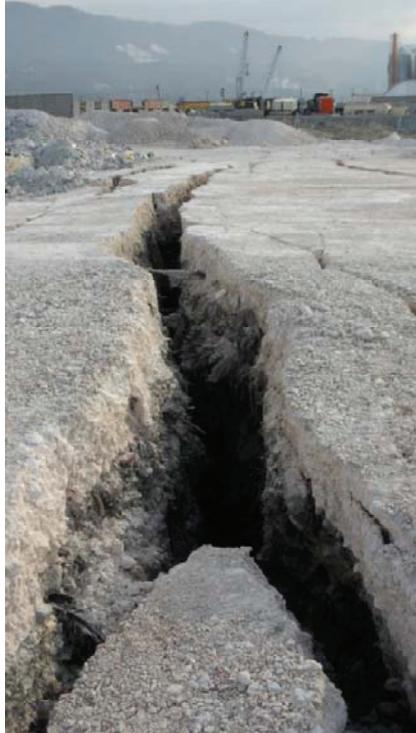
**Figure 6.22** Lateral spreading in the storage yards in the northern part of the port facility. Photo taken facing South. (18°33'41.76"N 72°20'52.25"W)

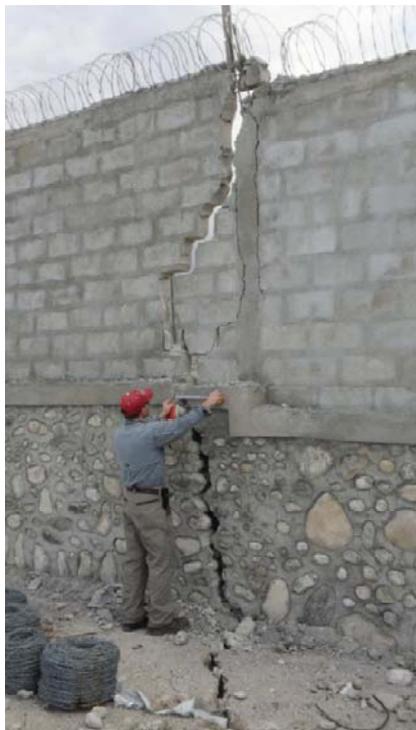
**Figure 6.23** Lateral spreading in the storage yards in the northern part of the port facility. Lateral spread crack passes through a stone/masonry wall. Photo taken facing South. (Approximate long. and lat. of photo: 18°33'35.15"N 72°20'56.18"W)

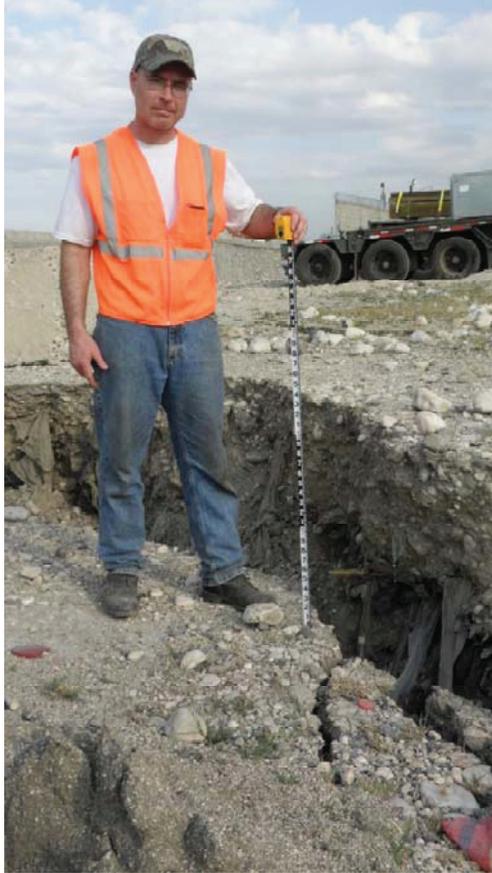
**Figure 6.24** Lateral spreading in the storage yards in the northern part of the port facility. A unique feature of this lateral spread is that the fill is garbage. However, it is believed that the liquefaction of the sand below garbage is the cause of the lateral spreading. Photo taken facing North-East. (Approximate long. and lat. of photo: 18°33'38.93"N 72°20'54.89"W)

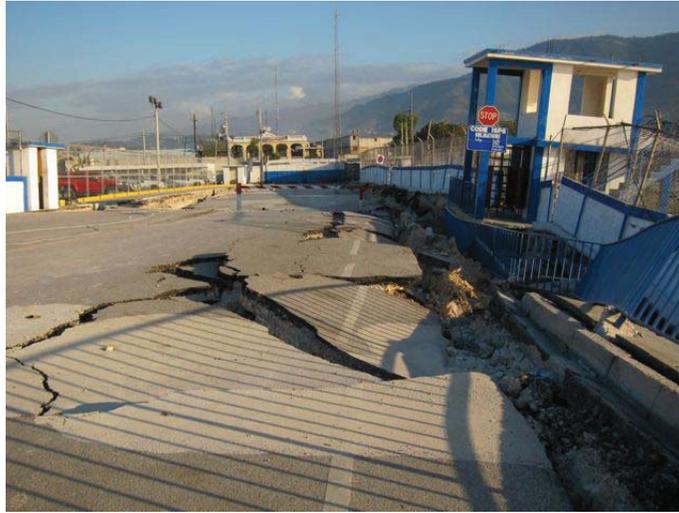
Finally, one of the main entrance roads to the port was heavily damaged by liquefaction-induced lateral spreading, as shown in Figure 6.25.

**Figure 6.25:** Damage to entrance road caused by lateral spreading. Photo taken facing South-East. (Approximate long. and lat. of photo: 18°33'11.61"N 72°20'52.50"W)

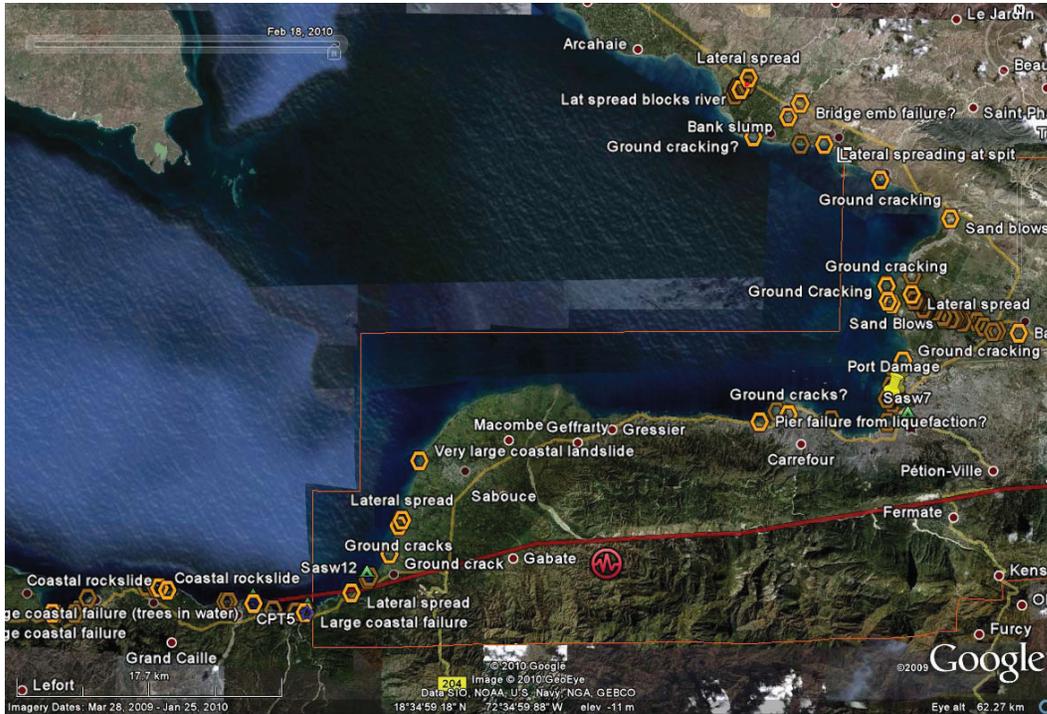
Prior to arrival in Haiti, GEER team members identified numerous potential liquefaction-induced failures near the coastline, as shown in Figure 7.1. Potential liquefaction-induced failures were identified up to 38 km from the epicenter and up to 26 km from the fault trace. These data plot well within the boundaries for most distal liquefaction sites proposed by Ambraseys (1988) using worldwide data (Figure 7.2). As discussed by Olson et al. (2005), this suggests that the natural coastal and alluvial soils near Port-au-Prince Bay are only moderately susceptible to liquefaction, although liquefiable Quaternary sediments were generally noted only within short distances from the coast. Additionally, without any strong motion recordings from this event, the level and duration of shaking is unknown. The slip inversions for the event (see Section 2.0 Seismological Aspects) indicate that most of the earthquake energy was released in 6 to 8 seconds, which is relatively short for a M 7 earthquake. This short duration of shaking would have limited the number of cycles of loading and minimized the zones that experienced liquefaction.

**Figure 7.1.** Potential liquefaction, lateral spreading, and coastal failure sites identified from post-earthquake aerial photography (sites identified as open hexagons). Imagery courtesy of Google Earth.

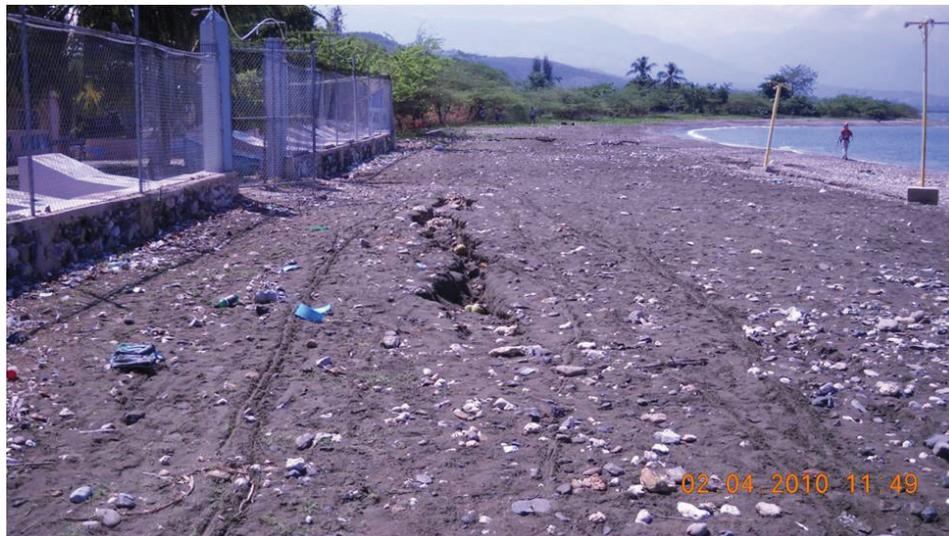
**Figure 7.5.** Ground cracking along coastline near village of L'Acul. (18°26'48.83"N, 72°41'11.39"W looking west).

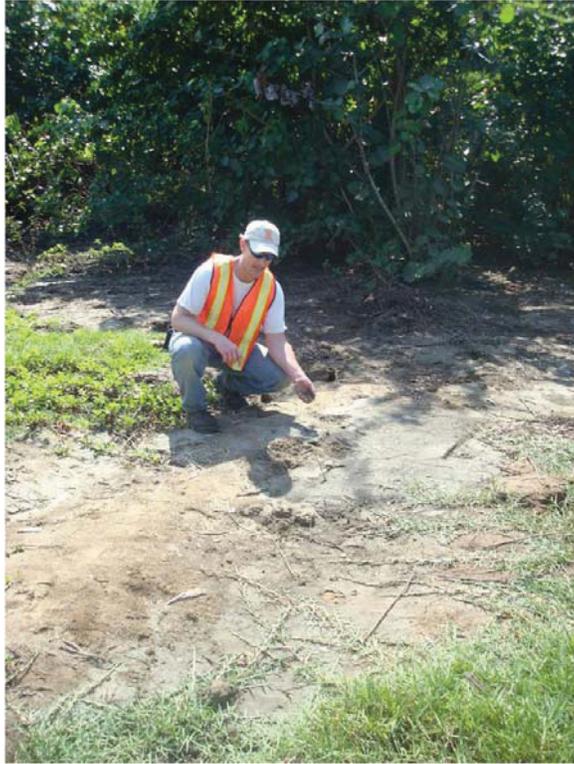
**Figure 7.6.** Sand blow formation to the south of the main cracks along coast near village of L'Acuil. ( $18^{\circ}26'44.27''N$ ,  $72^{\circ}41'12.05''W$  looking south).

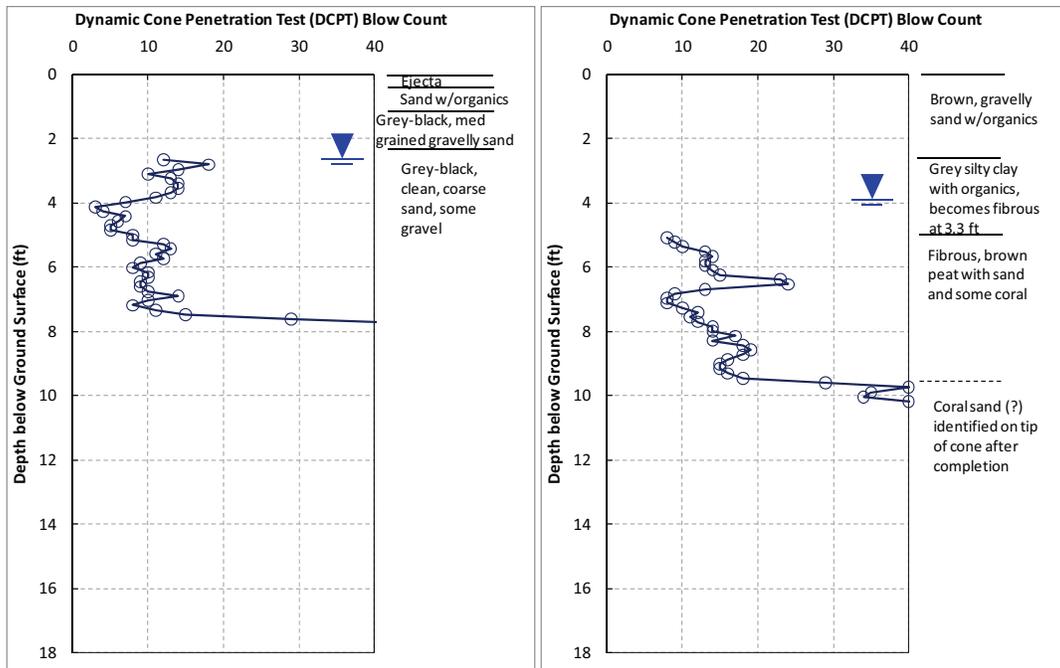
During reconnaissance efforts, the team conducted two dynamic cone penetration tests (DCPT) and two spectral analysis of seismic waves (SASW) lines at the site, one set near the sand blows at the southern end of the failed zone and one set outside of the failed zone to the south (Figure 7.3). Figure 7.7 presents the results of the DCPTs. As illustrated in Figure 7.7, the stratigraphy changes dramatically between the failed and non-failed zones, with loose sands being encountered near-surface within the failed zone and clays and peats being encountered near-surface outside of the failed zone. The fine-grained stratigraphy is expected because of its significant distance from the active mouth of the stream to the north. The results from SASW testing are still being processed and will be included in future versions of this report.

Based on the subparallel cracking, the formation of sand blows, and the results of the in-situ tests, the team attributed this failure to liquefaction and lateral spreading. Liquefaction likely occurred within the loose to medium dense sands below the watertable between depths of about 0.75 m and 2.3 m (2.5 to 7.5 ft). Below 2.3 m in the failed zone, the DCPT encountered much denser sands. The extent of the failure to the south was limited by the presence of fine-grained soils and peat overlying the denser marine sands.

**Figure 7.7.** Results of DCPTs performed near coastline near village of L'Acuil. Sounding on left performed at south end of failed zone (DCPT-8), and sounding on right performed outside of failed zone (DCPT-9).

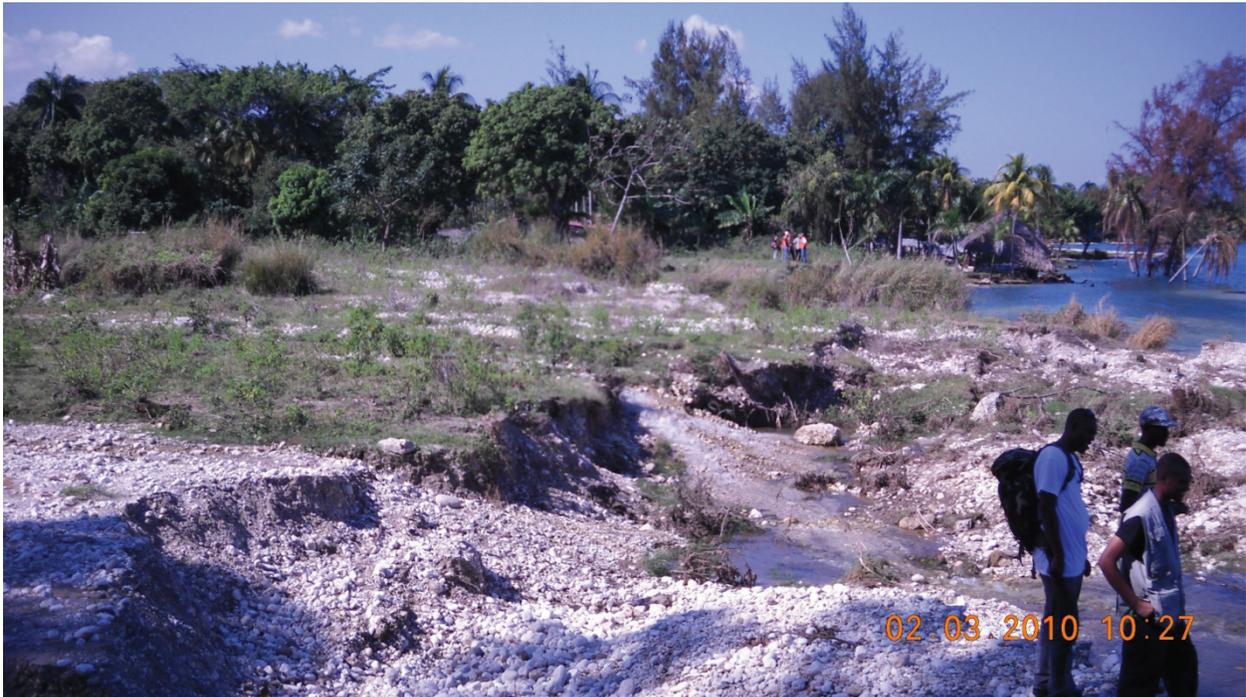
**Figure 7.10.** Scarp of coastal landslide near village of Fouche.  
( $18^{\circ}25'34.01''\text{N}$ ,  $72^{\circ}43'34.60''\text{W}$  looking westward).

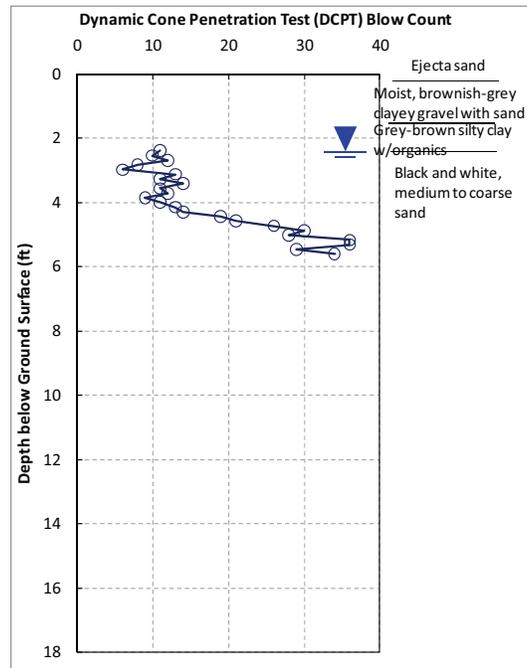
During the reconnaissance efforts, the team conducted one DCPT and one SASW line near several sand blows at the eastern end of the failed zone (Figure 7.8 and Figure 7.14), and one SASW line outside of the failed zone to the east (Figure 7.8). A second DCPT was attempted in this non-failed area but a thick layer of fill precluded augering beyond a few inches. Figure 7.15 presents the results of the DCPT in the failed zone. As illustrated in Figure 7.15, loose sand was encountered at a depth of about 0.7 m (2.5 ft), underlying a low permeability cap layer consisting of clayey sand and silty clay. The sands became medium-dense to dense at a depth of about 1.6 m (5.5 ft). The results from SASW testing are still being processed and will be included in future versions of this report.

Based on the arcuate scarp, graben formation, sand blows development, and the results of the in-situ tests, the team attributed this failure to liquefaction and lateral spreading of the loose to medium dense sands below a depth of 0.7 m (2.5 ft). Headscarps and slump block scarps were up to 1.5 m high in the central parts of the failure, suggesting that failure extends perhaps 1.5 to 2 m below the original ground surface. Liquefaction likely extended to a depth of 1.6 m and may have occurred at greater depth, but penetration with the DCPT was limited in these denser sands. Similar to the coastal failure near the village of L'acul, this failure appears to coincide directly with the presence of the braided stream dumping loose sand into the sea, rather than in the marine sands present along the coast.

**Figure 7.15.** Results of DCPT-5 testing at coastal failure site near village of Fouche.

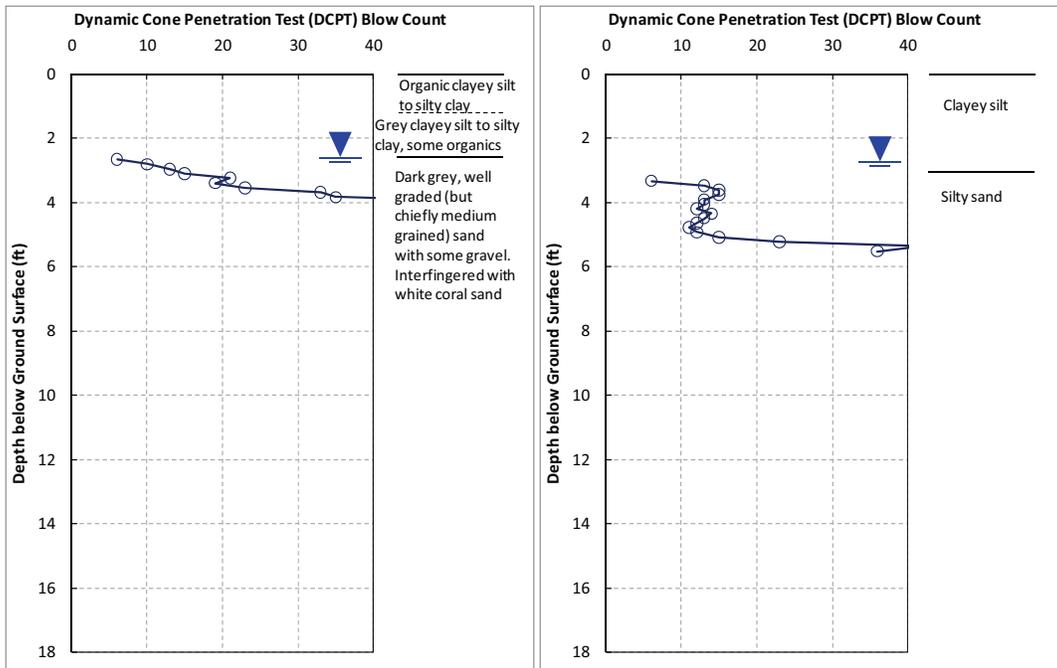
During reconnaissance, the team performed two DCPT and one SASW line near several sand blows at the inward end of the failed zone (Figure 7.16 and Figure 7.22). Figure 7.23 presents the results of the DCPT. As illustrated in Figure 7.23, loose sand to silty sand was encountered at a depth of about 0.8 to 0.9 m (2.6 to 3.0 ft), underlying a low permeability cap layer consisting of clayey silt. The sands became medium-dense to dense at a depth of about 1.1 to 1.6 m (3.6 to 5.3 ft). The results from SASW testing are still being processed and will be included in future versions of this report.

Based on the arcuate scarp, graben formation, sand blows development, and the results of the in-situ tests, the team attributed this failure to liquefaction and lateral spreading of the loose to medium dense sands and silty sands below a depth of 0.9 m. Liquefaction likely extended to a depth of 1.6 m and may have occurred at greater depth, but penetration with the DCPT was limited in these denser sands. Similar to the coastal failures near the villages of L’acul and Fouche, this failure occurred adjacent to a braided stream dumping loose sand into the bay (probably in a former channel of the stream), rather than in the marine sands present along the coast.

**Figure 7.23.** Results of DCPT-6 (at left) and DCPT-7 (at right) performed at coastal failure near village of Grand Goâve.

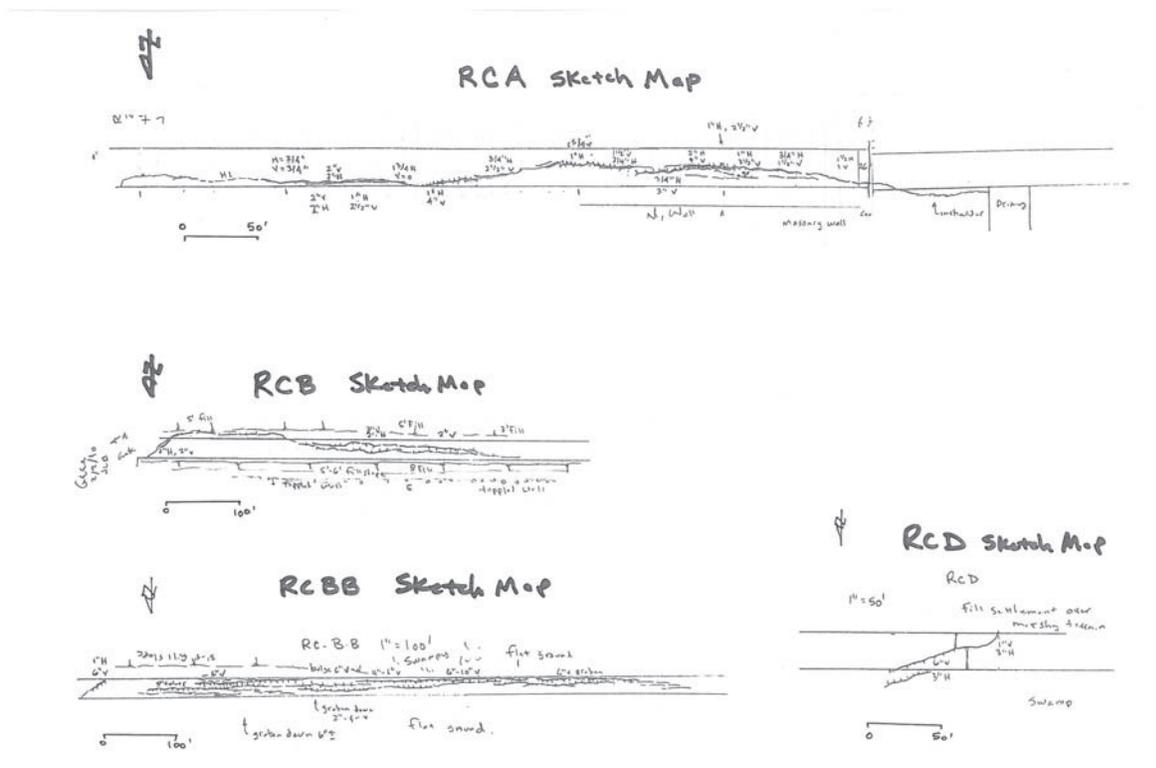
Five locations of poor road fill performance were investigated along Route 2 (Figure 8.1). Figures 8.2 and 8.3 are sketch maps of the crack patterns and fill failures for the investigated sites (note that RCD in Figure 8.2 represents RCC in Figure 8.1). These sketches will be improved in the next version of this report. At each location cracks and deformation extended completely through the asphalt pavement, which is typically 3 to 5 cm thick (Figure 8.4), and apparently through the compacted fill subbase and fill. Many of the road cracks exhibit an arcuate pattern typically associated with lateral spread or slump failures. Our team inspected the natural ground adjacent to the road/fill, and found no extension of cracks, liquefaction features, or cracks/deformation indicating global lateral spreading, deep-seated slumping, or major liquefaction. Rather, cracking appeared restricted to the road bed and adjacent fills, and reflects localized settlement and differential cracking/movement of the road fill and underlying subgrade soil. Most of the failures occur in areas where the road crosses small alluvial drainages/valleys and/or marshy areas. In some cases, the road is underlain by thick fill with steep fill slopes that underwent a degree of creep and possible discrete slumping. Based on observed conditions, the road failures appear to be the result of deformation of soft, organic and saturated alluvial and marsh soils. The magnitude of damage will require extensive regrading and paving to restore a stable and safe roadway.

Figure 8.2. Road fill failure sketch maps for sites RCA through RCD.

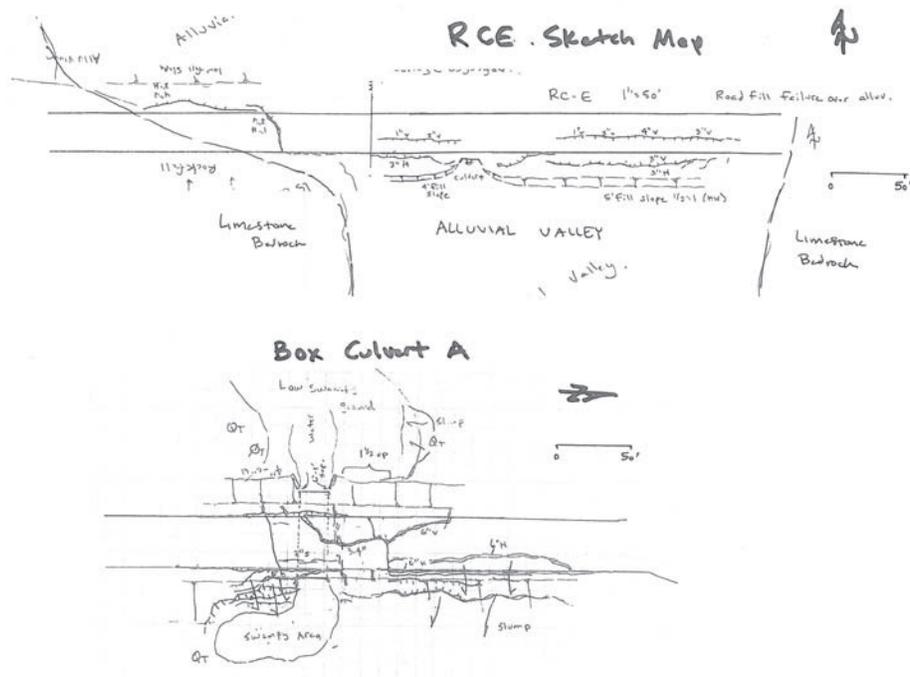
**Figure 8.3.** Road fill failure sketch maps for site RCE and BOXCLVTA.

One notable site (BOXCLVT A) of road damage occurred between Leogane and Dufort, where a masonry box culvert passes under the roadway along a swampy area. The portion of the road bed over the culvert did not settle notably, but the prisms of fill against the culvert settled up to 30 cm. Discrete slumping of the road fills north and south of the culvert (Figure 8.5) damaged the outboard edges of the fill, contributing to the road failure. Fill exposed in large cracks (up to 30 cm wide) and slump headscarps consisted of well-compacted granular fill (Figure 8.6), and appeared to be suitably compacted. The settlement appears to have been caused by deformation in the soft, organic subgrade soils of the swampy zone, and slumping failure of the steep 1:1 to 1.5 :1 (horizontal to vertical) fill slopes that range from about 3 to 4.5 m high. This particular failure was previously reported to possibly represent surface fault rupture, as it occurs westward of the general trend of the Enriquillo-Plantain Garden fault trace. However, the reconnaissance team found no evidence of surface fault rupture west or east of the site, or along the fault trace in this area.

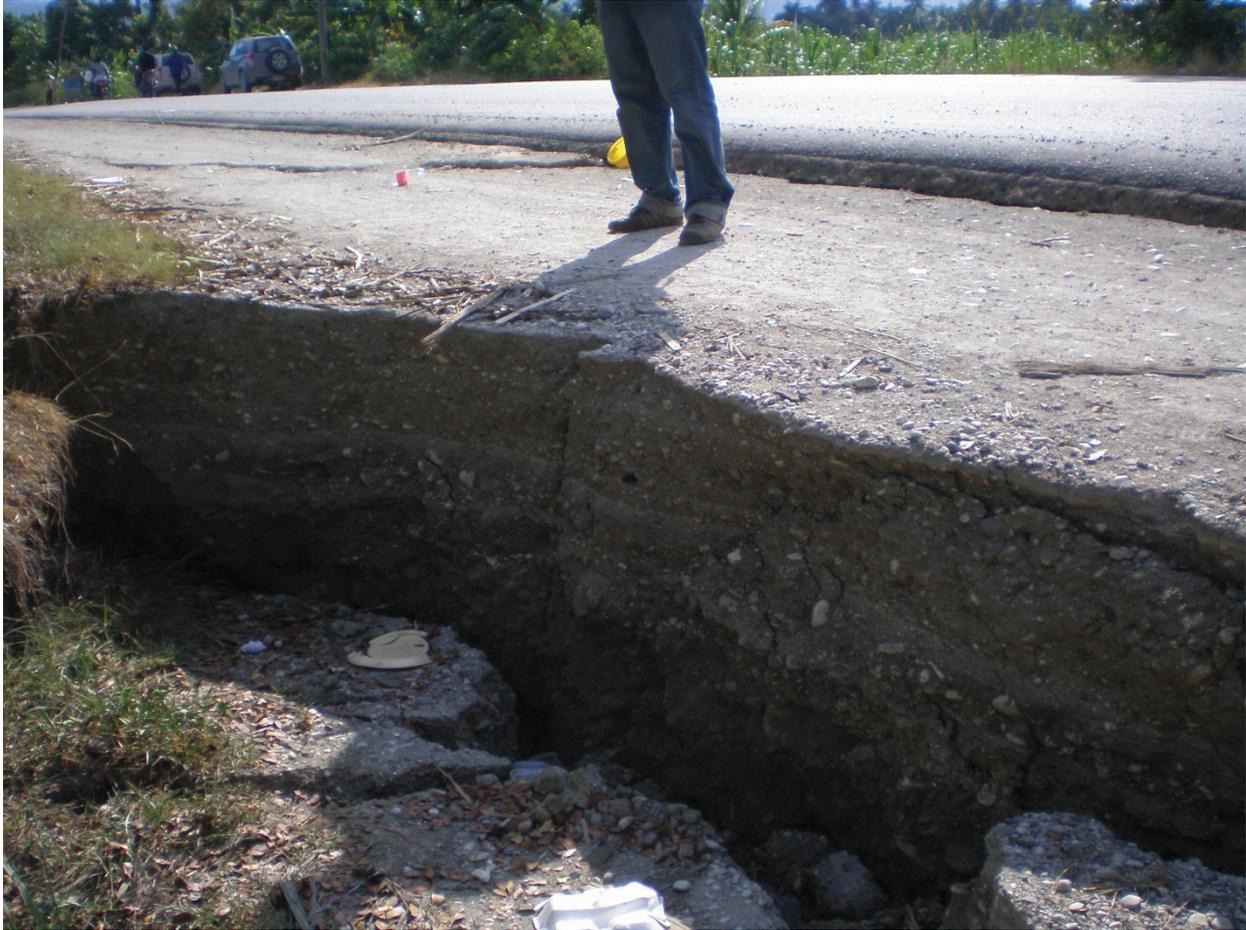
**Figure 8.6** Well-compacted granular fill at road damage site BOXCLVTA.

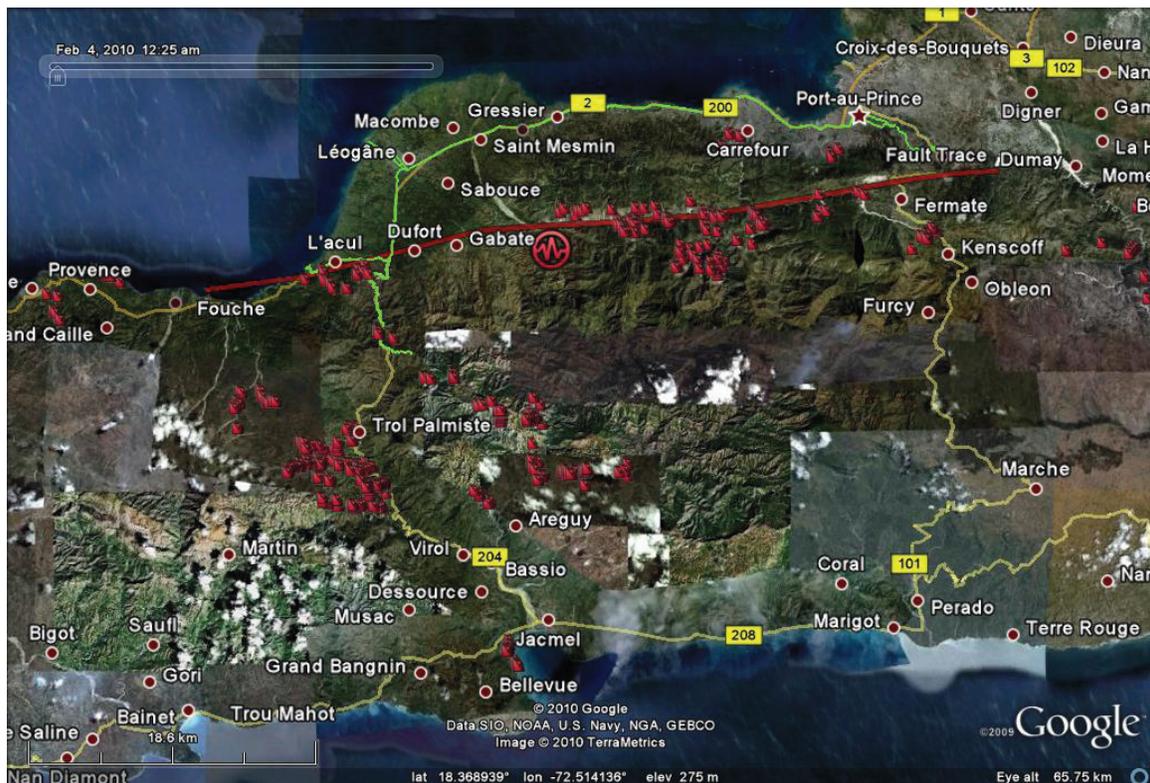
Figure 9.1 shows the landslides identified from aerial imagery by Dr. Ed Harp of the USGS. These landslides are concentrated in several regions: (1) along the deep, incised river valley that follows the fault trace, (2) along Route 204 about 15 km northwest of Jacmel, and (3) east of Route 204 about 10 km north of Jacmel. Smaller concentrations of landslides were observed near Provence in the west (Figures 9.2 and 9.3) and near Jacmel in the south. Failures observed in satellite imagery generally represent shallow slides (1 to 3 m thick) in which the overlying vegetation is stripped from the hillside. These types of failures have distinct features (i.e., bright, light colored areas surrounded by vegetation) that are easily identified in satellite imagery, but they must be large enough to be observed in the imagery.

**Figure 9.1** Landslides (red) identified by aerial imagery by Ed Harp of the USGS. Green track is route traveled by GEER team on day of landslide investigation. (Imagery from Google Earth)
