# GEOTECHNICAL ENGINEERING RECONNAISSANCE OF THE 2010 HAITI EARTHQUAKE

Version 1: February 22, 2010

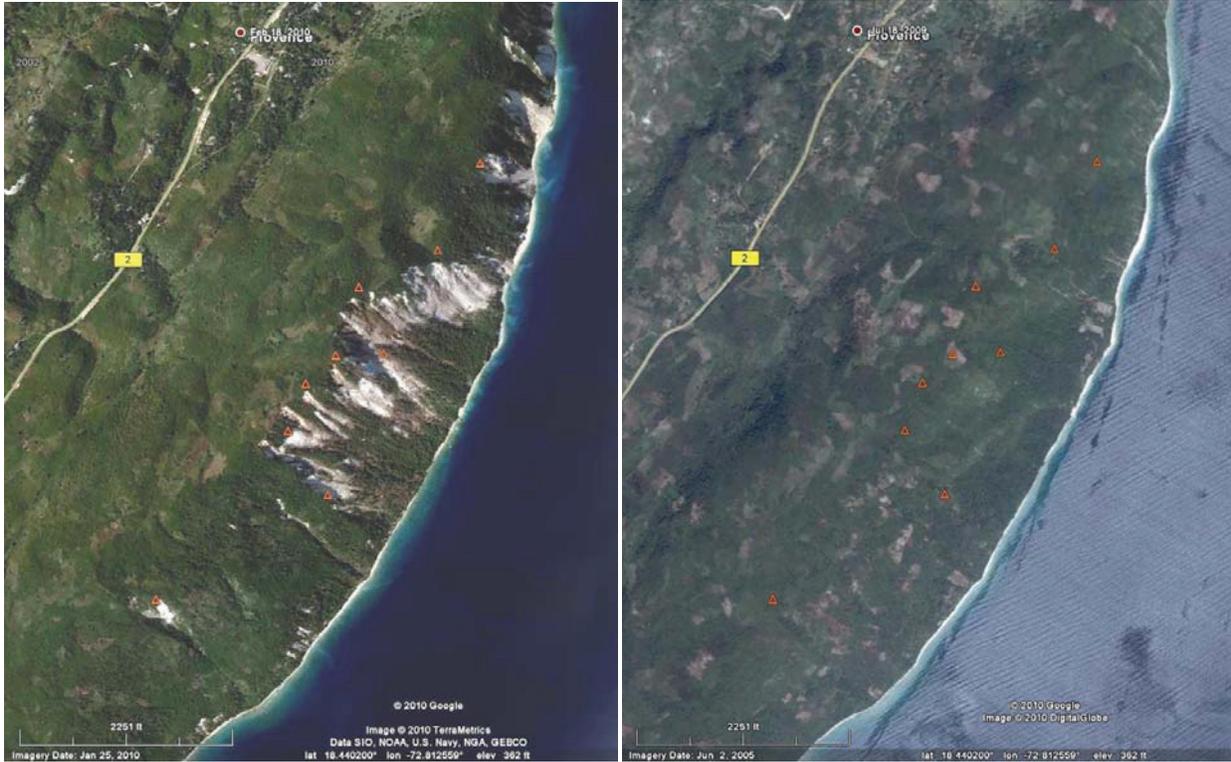
**Figure 9.2** Post-earthquakes denuded slopes due to landslides near Provence (left) along with pre-earthquake image (right). These are relatively steep ocean bluffs. (Scarp locations mapped by Ed Harp. Photos provided by Google Earth)

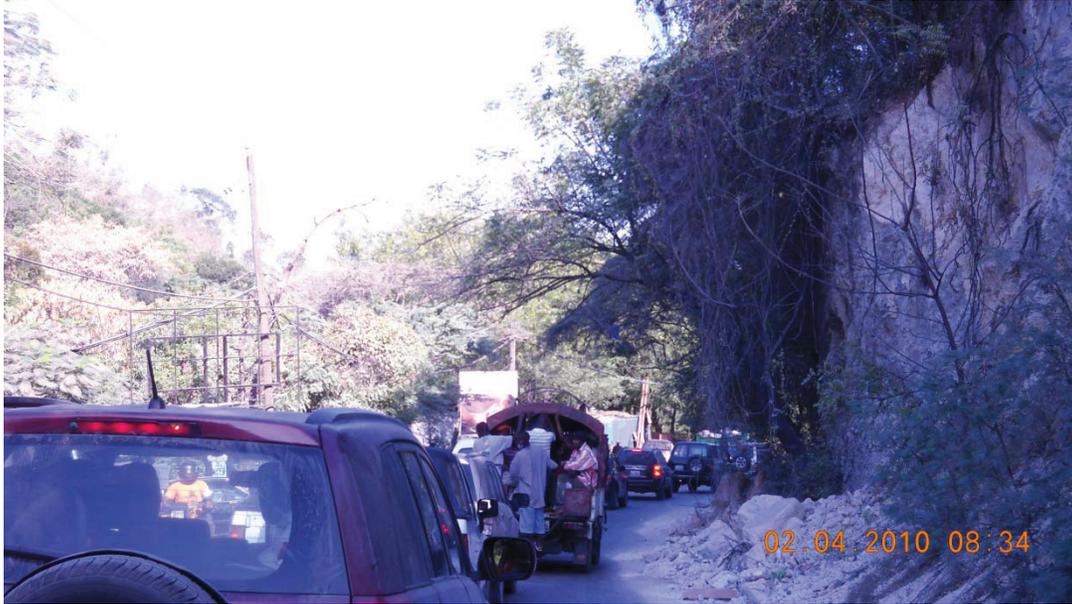
Numerous topples or falls were observed in over-steepened road cuts in weathered and sheared bedrock within the hills of Pétiion-Ville (Figure 9.5), an upland suburb to the southeast of Port-au-Prince. These over-steepened cut slopes had estimated inclinations of  $\frac{1}{4}H:1V$  or steeper; many were nearly vertical and some remaining un-failed cuts were actually locally overhanging. These slopes had estimated heights on the order of 1.5 to over 6 m. The falls generally included relatively slender slivers, typically involving 0.3 to 1.0 m thick of material. The material fell to the base of the slopes, forming a wedge on the roadside or sidewalk, and frequently encroaching onto the roadway.

**Figure 9.5** Vertical cut remaining relatively stable with minor rock fall/topples.

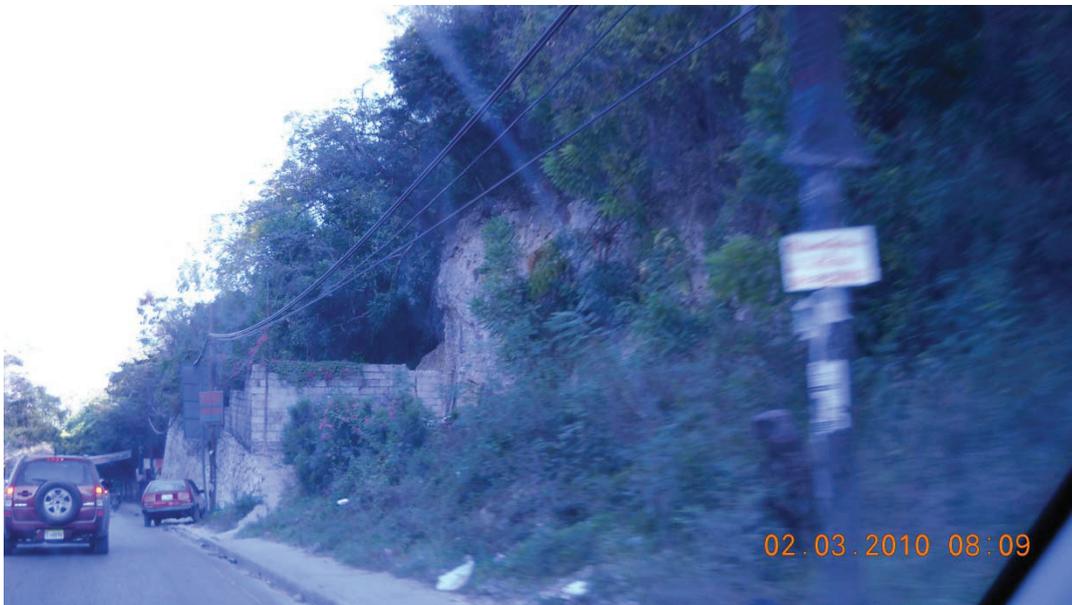
There were also many of these very steep road cuts that remained unfailed following the earthquake, as evidenced by the presence of vegetation, dust, and debris on the faces of the slopes (Figure 9.6). However, most of the unfailed slopes exhibited a wedge of raveled material at the base of the slope with established vegetation, suggesting the raveling had been occurring for some time and was not related to the recent earthquake, or with only minor toppling in the recent earthquake (e.g., Figure 9.5).

**Figure 9.6** Stable near-vertical road cut and masonry wall. (N18.531873, W72.313045).

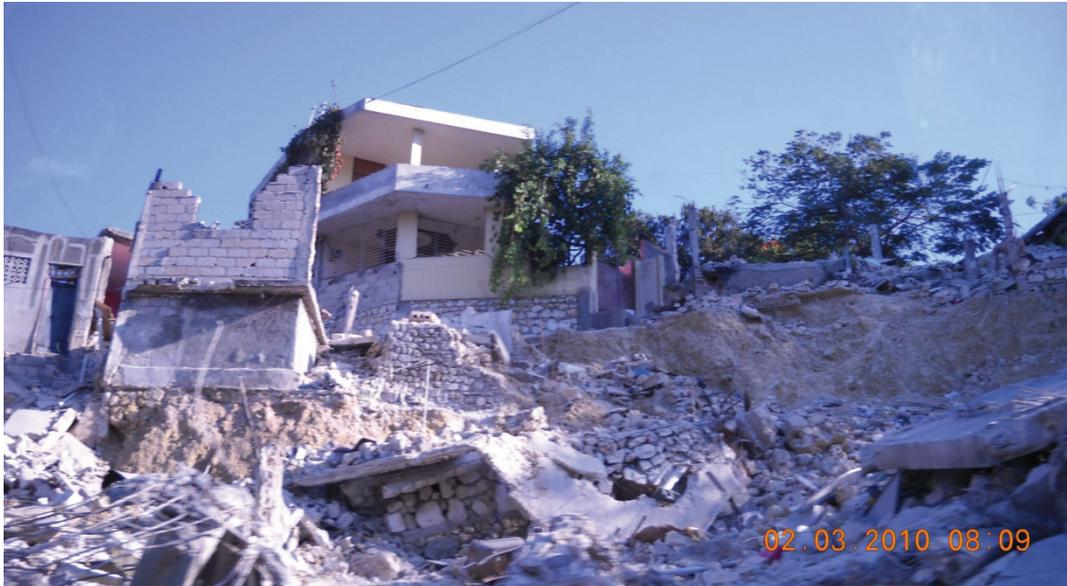
One area of more significant landslides was observed downhill from Petion-Ville along Rue Fernand. This landslide contained the rubble of several adjacent structures that had collapsed (Figure 9.7). There were scarp-like, near vertical surfaces near the top of slope, which could suggest that a rotational failure occurred beneath the now-collapsed structures. However, scarps of the observed height generated through a rotational failure would require a large volume of soil to be pushed out near the toe of slope. This volume of material did not appear to be present or to have been removed from the site. Furthermore, the soils are conglomeratic and likely have high friction angles, which would make the site an unlikely candidate for a rotational failure mechanism. It is more likely that the failure was initiated by basement/retaining walls for the overlying structures.

**Figure 9.7** Several buildings have collapsed in this location. Although there are scarp-like near vertical surfaces near the top of slope that may suggest the possibility of a deeper rotation failure, in our opinion the observed conditions are likely due movement of soils adjacent to failed walls, as discussed in the text. (N18.528406, W72.309920).

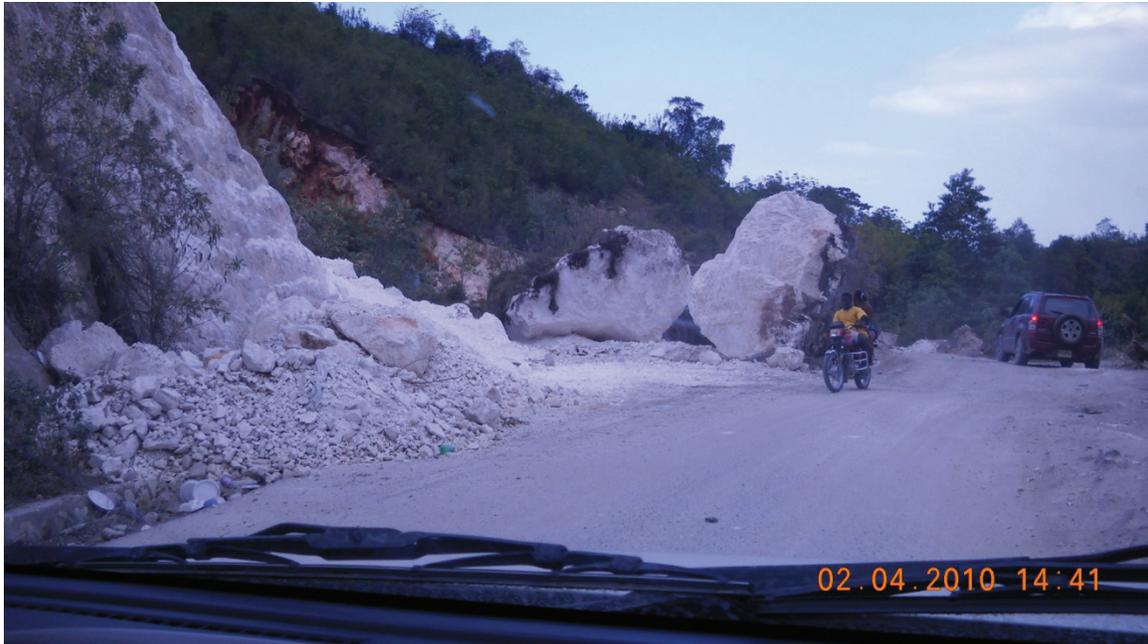
Some chalky limestone quarries (recent activity of the quarries was not checked) had moderately high steep slopes that also failed in rock topples or rock falls. Occasionally these resulted in large boulders rolling onto roadways (Figure 9.8). Similar failures occurred in over-steepened road cuts through chalky limestone.

**Figure 9.8** Topple or fall included several large boulders in this old quarry.  
(N18.439010, W72.646168).

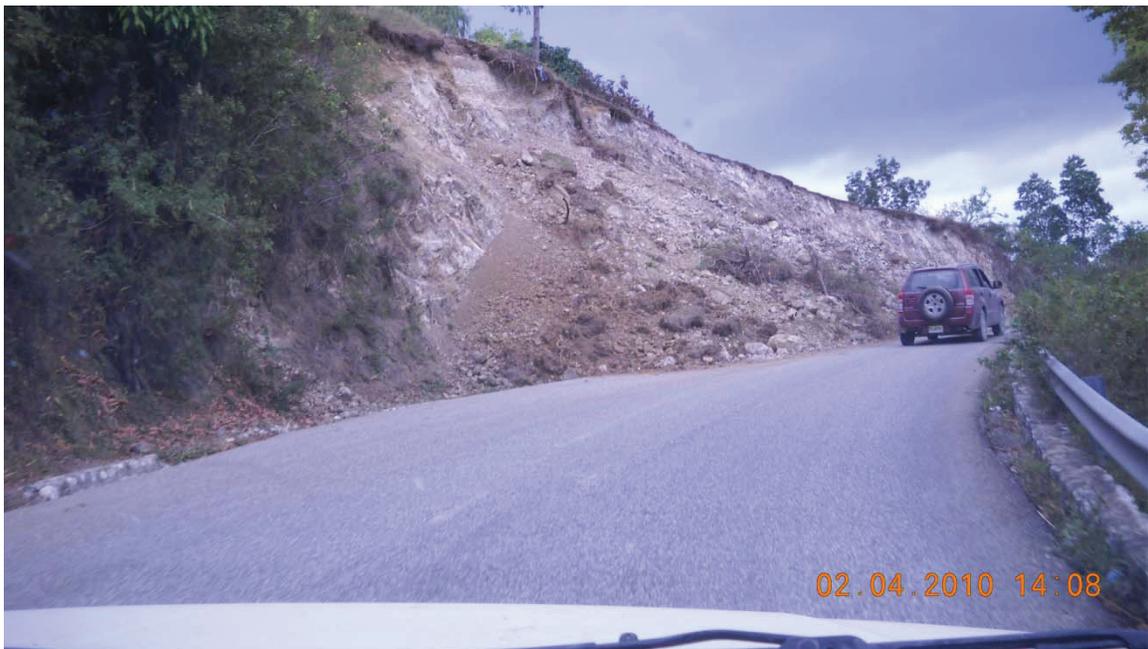
There were numerous rock falls, rock topples, and shallow rockslides in over-steepened road cuts along Highway 204 (e.g., Figures 9.8 through 9.12), although few of these were obvious in the aerial imagery. Many of these failures, as well as similar failures elsewhere, inhibited relief supplies from reaching many upland communities. The cut inclinations where the majority of the failures occurred are estimated to be on the order of about  $\frac{1}{4}H:1V$  to  $\frac{3}{4}H:1V$ , and ranged from a few meters high to over 10 m high. The failures were frequently in fractured, friable, blocky sedimentary materials. These blocks were stacked in a statically stable configuration that did not resist the seismic accelerations, and the blocky material simply deaggregated and cascaded to the bottoms of the slopes. In some locations rockslides occurred along bedding planes, but more often the exposed scarp revealed that the bedding was relatively level or dipping into the slope and the failed material pulled away from random discontinuous surfaces.

**Figure 9.9** Rock topple or rock fall from over-steepened road cut.  
(N18.412741, W72.638576).

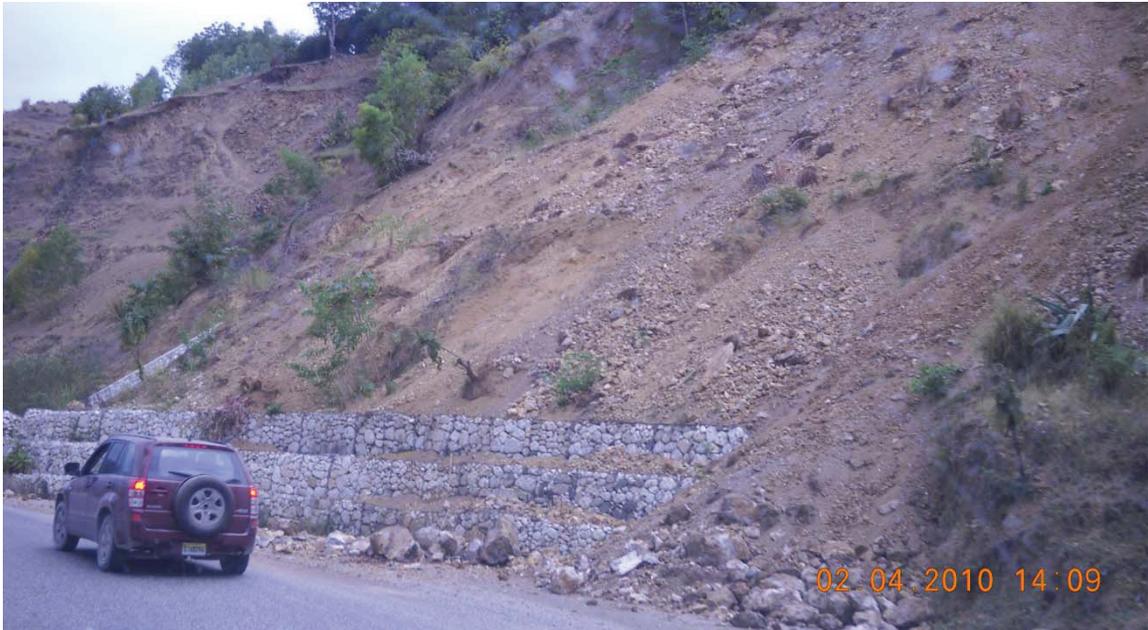
**Figure 9.10** Shallow rock topple or rock fall from over-steepened road cut. Debris slid over the top of stable gabions at the toe of the slope. (N18.409159, W72.638815).

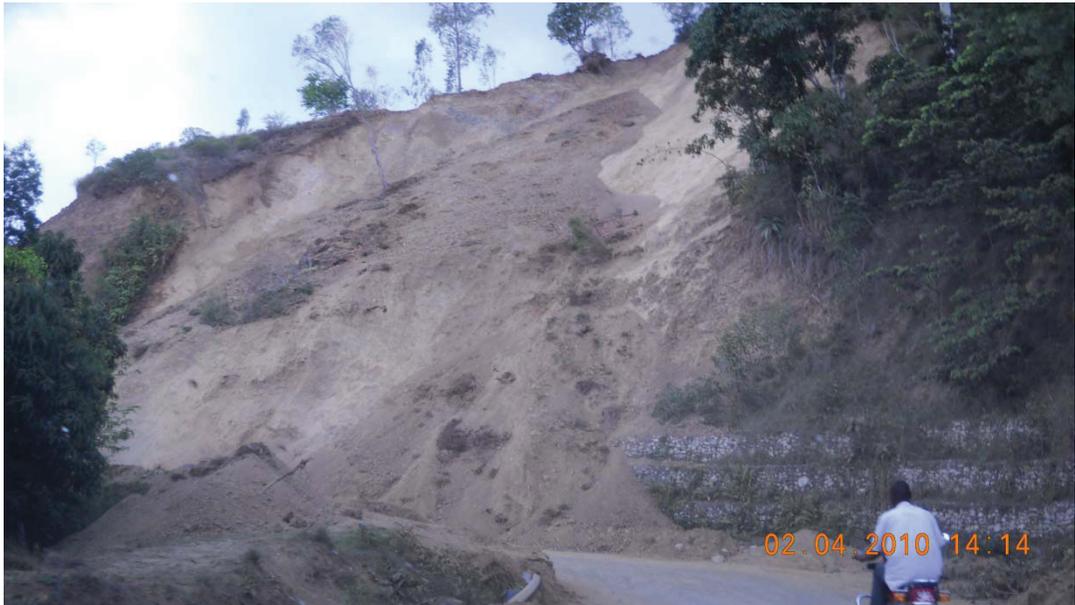
**Figure 9.11** Relatively shallow slip-out of regolith. Disaggregated material flowed over stable gabions and blocked over half the road. (N 18.409159, W72.638815).

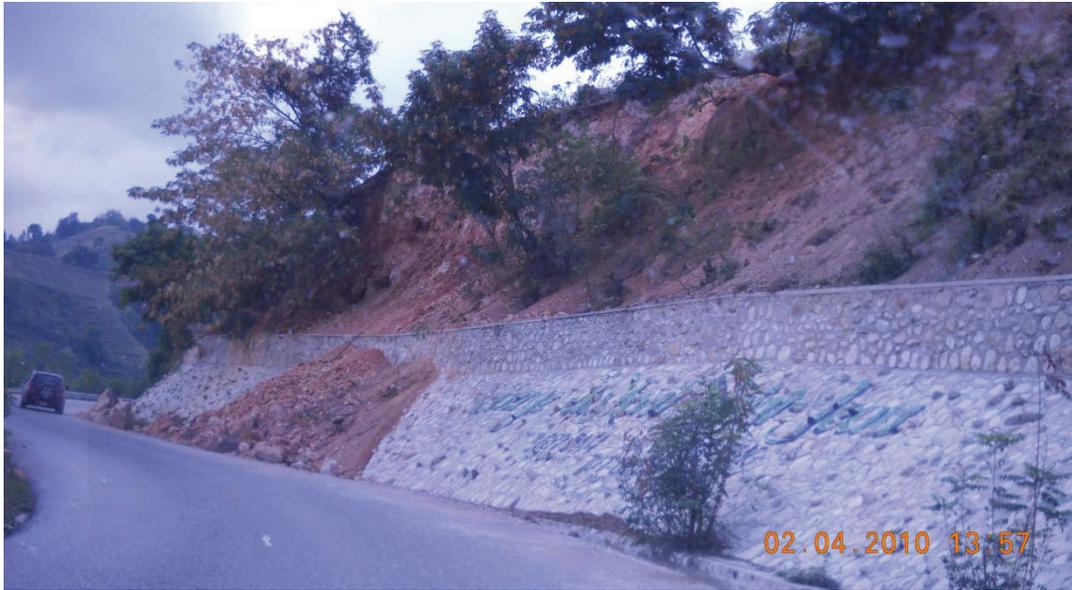
**Figure 9.12** Shallow slip-out of soil in upper road cut. Soil slid over the top of the surviving masonry wall and slope protection. (N18.440270, W72.636207).
